Clattering Sound at Seatbelt Height Adjuster in B-Pillar Trim (SA Code 580)

| Topic number | LI68.30-P-080465 |
| Validity | Applies to BR 214 vehicles with SA code 580 (THERMO-TRONIC automatic climate control) since SOP |

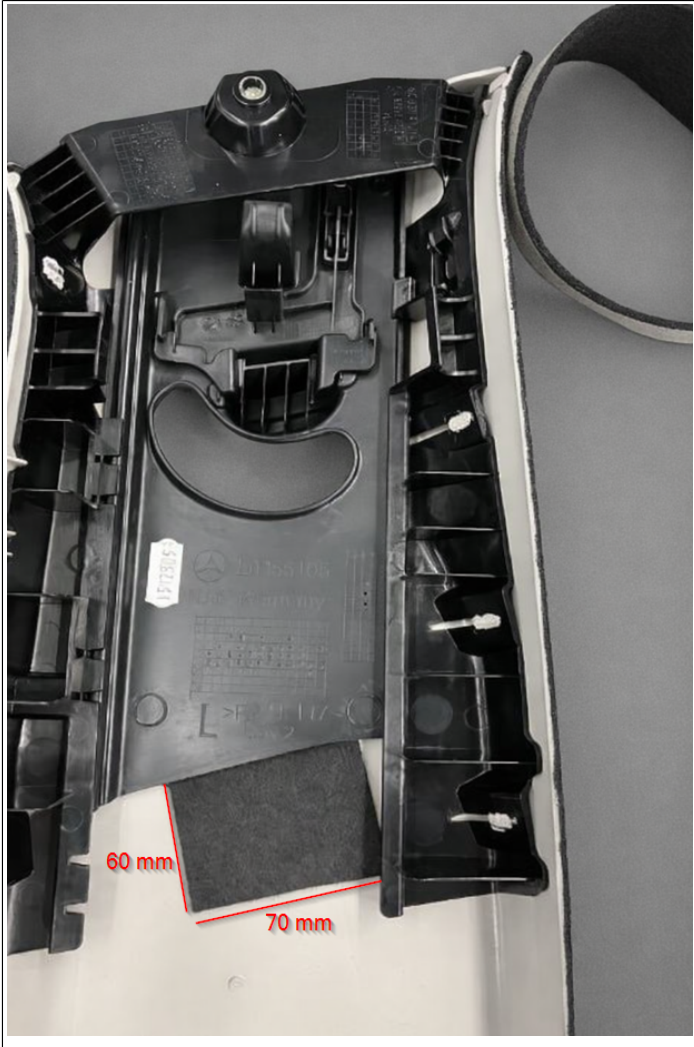
| Attachments | |
|---|---|
| <a href="#">BR214_B-Säule_Filz_580.png</a> | Position of felt |

Clattering noise at seat belt height adjuster in B-pillar trim

Play between seat belt adjuster and guide rail

Installing a 70x60x3 mm felt pad below the seat belt adjuster.  
The felt is supplied by the meter and must be cut to the specified dimension.

- 1) Set the seat belt height adjuster to the highest position
- 2) Position the felt (long side, 70 mm) centrally along the folded adhesive edge of the fabric trim (see picture)

Bond the felt so that the height adjuster always slides over it. Otherwise, there is a risk that the felt will be pushed off when adjusting the seat belt height adjuster.  
Do not position the felt too high, as it may become visible on the opposite side.
