## AMG models with wet clutch 725.0 (NAG3 Classic) and M177 engine - Harsh shift concerns due to speed sensor installation

Topic number	LI27.60-P-080449
Version	1
Function group	27.60 - Gearshift, control
Date	4/14/26
Validity	Affects all 290 with M177 engine and transmission 725.096 (NAG3 Classic w/ wet clutch) produced as of July 1, 2025

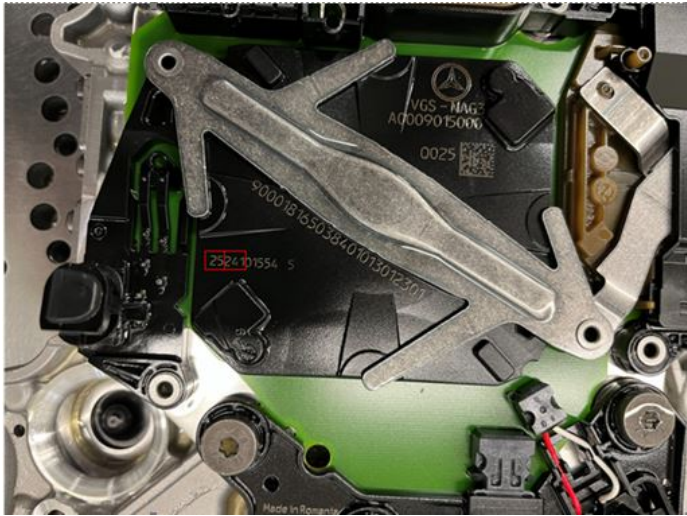
File	Description
Valve body - ECU serial number and date code.jpg	Figure 2

Incorrectly installed (rotated) rotational speed sensors on the EHS (VGS Control Unit) can cause abnormalities in signals. As a result, poor adaptation values are stored and harsh gearshifts are felt.

This only affects vehicles with VGS control units produced between days 182-296 of 2025 (July 4, 2025-October 23, 2025).

1. Collect initial transmission EEPROM file
  2. Check EEPROM .txt file for VGS control unit serial number and production date (attachment figure 1)
- If the valve body is already removed, you can inspect the control unit for its stamped serial number (attachment figure 2)

The complete valve body will require replacement.

1. Remove transmission oil pan & inspect fluid/pan/filter condition
- compare findings to extended fluid condition examples provided in Xentry blue book under general information for VGS
2. Replace complete EHS valve body, fill to near max fluid level, & complete initial start-up
- Ensure all oil guide pipes are installed in the new valve body to prevent a new concern after replacement. (See photos in WIS instructions)

- Verify the new valve body production date is outside of day 182-296 of 2025 (attachment figure 2)
