TECHNICAL SERVICE BULLETIN

"Steering Assist Fault Service Required" Message In The IPC And Reduced Steering Assist With DTCs U3008:1B And/Or U3009:1B Stored In The PSCM

26-2150
08 April 2026

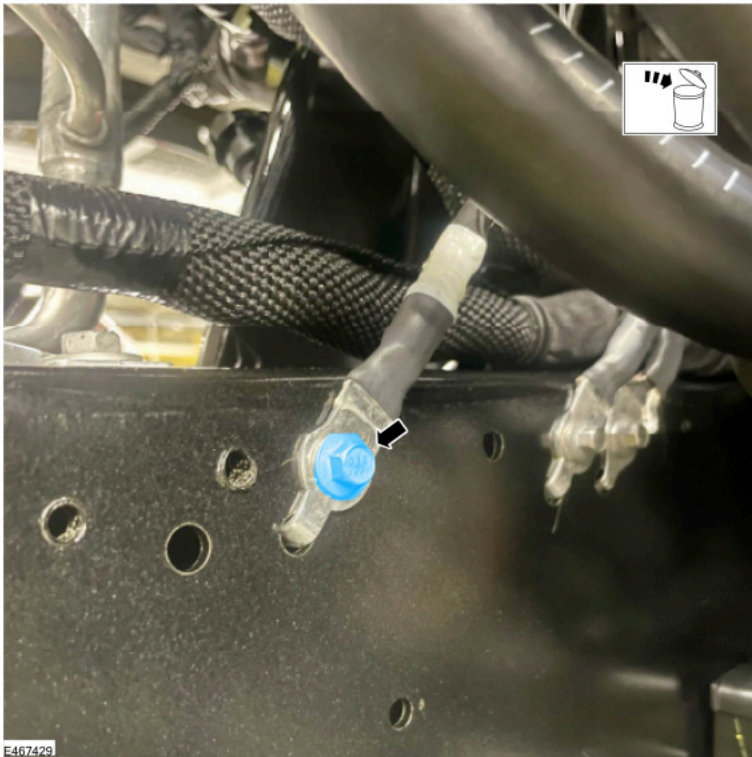
Figure 1 - Vehicles equipped with 2.3L engine

6. Remove and discard the M6 fastener from ground G104 (Explorer/Police Interceptor) or G116 (Aviator) on the passenger side frame rail. Refer to Wiring Diagram Cell 151 for connection locations. (Figures 1-2)

7. Carefully enlarge the existing holes in the frame rail sheet metal and the harness eyelet by drilling with a 7 mm (9/32 in) drill bit.
8. Reinstall ground G104 (Explorer/Police Interceptor) or G116 (Aviator) using the new self-tapping M8 fastener. Make sure the ground eyelet locating tab is properly aligned with the alignment hole in the frame. Tighten to 71 lb.in (8.0 Nm).

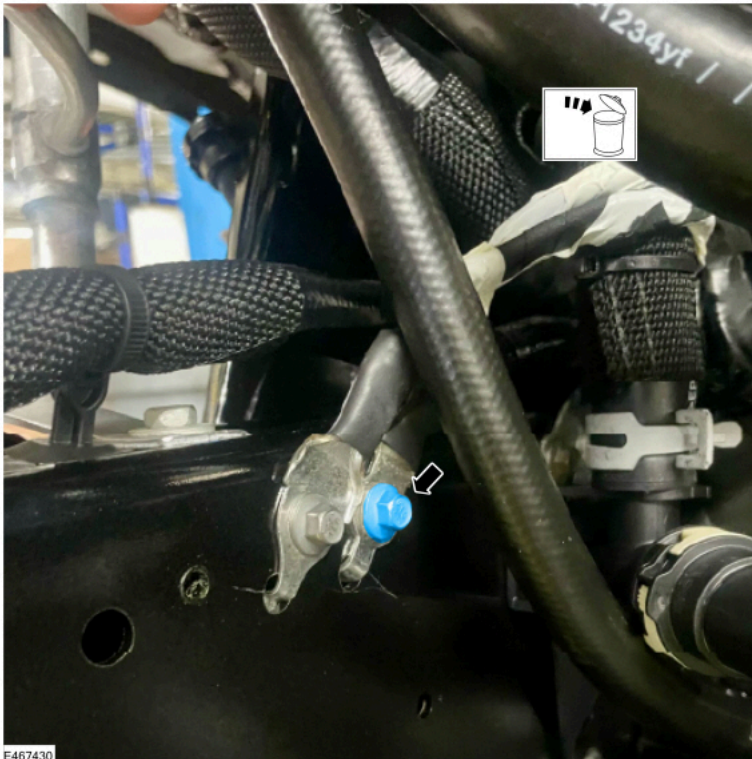
Figure 2 - Vehicles equipped with 3.0L and 3.3L engine

NOTE: The position of the ground eyelets shown may vary. The suspect ground is the smaller of the 2 eyelets.

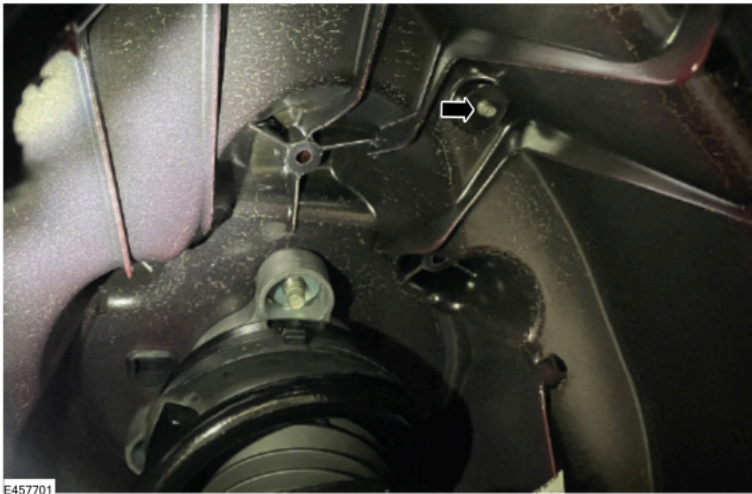
Figure 6

NOTE: Do not remove any paint from the body as the ground path conduction is through the bolt threads.

17. Install the new M6 nut on the bottom of the ground G103 bolt (Explorer/Police Interceptor) or G119 stud bolt (Aviator) on the passenger side shock tower. Tighten to 106 lb-in (12.0 Nm). (Figure 6)
