AMG models with torque converter 725.0 (NAG3 Classic) and M177 engine - Harsh shift concerns due to speed sensor installation

| Topic number | LI27.00-P-080462 |
| Validity | Affects all 167 with M177 engine and transmission 725.085 (NAG3 Classic w/ torque converter) produced as of July 1, 2025 |

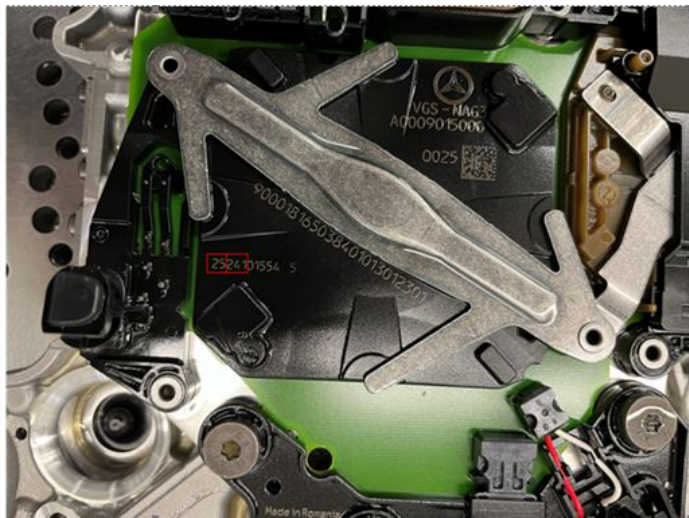
| Attachments | |
|---|---|
| Valve body - ECU serial number and date code.jpg | Figure 2 |

1. Collect initial transmission EEPROM file
  2. Check EEPROM .txt file for VGS control unit serial number and production date (attachment figure 1)
- If the valve body is already removed, you can inspect the control unit for its stamped serial number (attachment figure 2)

- Verify the new valve body production date is outside of day 182-296 of 2025 (attachment figure 2)
