# Technical Bulletin

Bulletin No: TCH-27-013 Rev 000

## Subject: **Bendix® EC-80™ Software Update for International® Motors**

This bulletin provides instructions on how to download and run the Bendix® ECU (Electronic Control Unit) Updater tool to set the **conf\_HSA** parameter to **“enable.”** This document is **ONLY** applicable for vehicles identified in **International Motors Recall 26501, NHTSA Recall 26V084.**

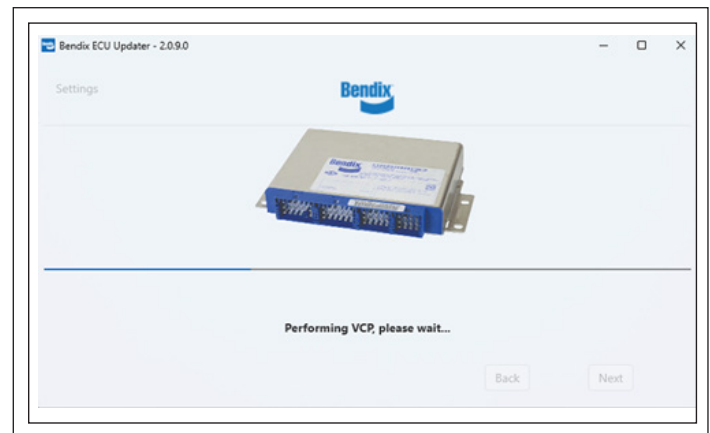
**Figure 2 – Update in Progress**

7. The software update will change the parameters of the EC-80. To proceed with the update, click **Yes**.
8. Once the update has started, the screen will show the progress. See Figure 2.

**NOTE:** This process may take a couple of minutes to complete. Additionally, audible alerts may sound and warning lamps may illuminate on the vehicle dash during the update process.

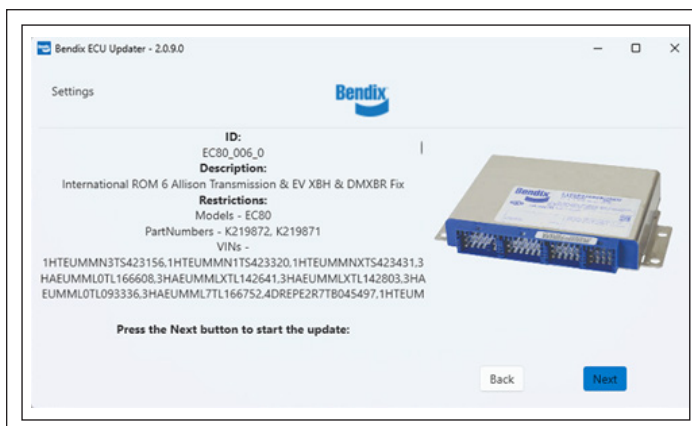
**Figure 1 – Start Software Update**

1. Install the software **Bendix\_ECU\_Updater\_2.0.9.0** using the setup.exe application provided by International.
2. Place the folder in a convenient location on the laptop, such as the Desktop.
3. Plug a compatible adapter to the diagnostic port located under the steering wheel.
4. Key on the vehicle and inspect the vehicle dash to see if any warning lamps are illuminated before beginning the update process.  
**NOTE:** Resolve all active Bendix device Diagnostic Trouble Codes (DTCs) before proceeding with the software update.
5. Open the software from the connected laptop and select the **EC80\_006\_0.pkg** file provided with the installer.
6. Once selected, click **Next**. See Figure 1.

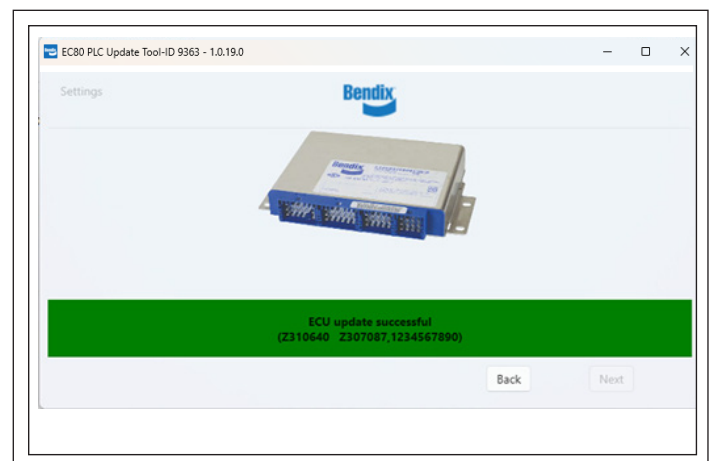
**Figure 3 – Update Successful**

9. If the update is successful, the screen will show that the software has been updated, and the procedure is complete. See Figure 3.

10. To complete the update, follow these steps:
- Key off the vehicle.
  - Wait at least ten (10) seconds.
  - Key on the vehicle (engine crank not required).

- Wait at least sixty (60) seconds and confirm that there are no active Bendix DTCs on the vehicle. If there are any active Bendix DTCs, reattempt the software update starting at *Step 4*.

- On the connected laptop, exit the software.
  - Key cycle the vehicle again, start the engine, and leave the vehicle running for at least sixty (60) seconds to fully complete the update.

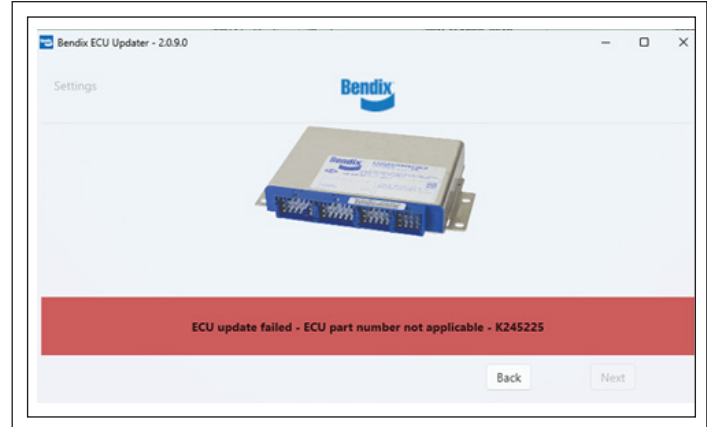
**Figure 4 – ECU Ineligible for Software Update**

11. If the software update fails, the screen will show a failure message that may include one of the following failure types:
- **(Figure 4) ECU Ineligible for Update** - Detected ECU is not included in the software update. See *Step 12*.

12. If the detected ECU is not eligible for an update, an ECU failure message may appear and no further action is required. See *Figure 4*.

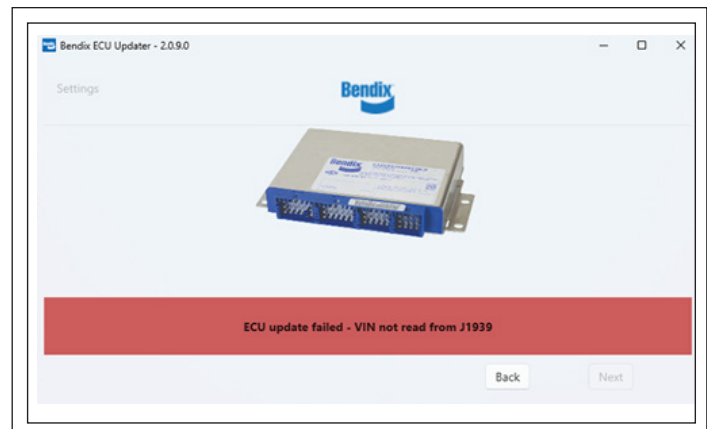
**Figure 5 – VIN Not Included in Software Update**

- **(Figure 5) VIN Not Included in Software Update** - Detected VIN is not included in the software update. See *Step 13*.
  - **(Figure 6) RP1210 Configuration Error** - Adapter is not connecting or configuration settings are not correct. See *Step 14*.

13. If the VIN of the vehicle is not in the impacted population, there will be indication that the VIN is either not received or VIN is not included in the software update. No further action is required. See *Figure 5*.

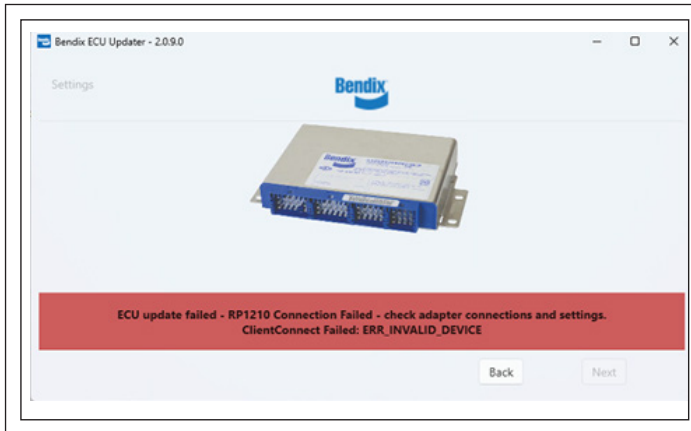
**Figure 6 – RP1210 Configuration Error**

14. If the utility is having issues connecting to the adapter or there is a configuration error, an error message similar to *Figure 6* or *Figure 7* may appear.

Perform the following troubleshooting steps:

- a. Verify the adapter has power and is reading the vehicle data. *Refer to applicable adapter manufacturer's the technical documentation* for more information.

- b. Open the settings within software and verify the appropriate adapter, baud, and channel are selected. See *Figure 8* for an example of the Configuration settings.

- c. Disconnect and reconnect the adapter from both the USB port and the vehicle diagnostic port.
- d. Close all open diagnostic programs and reattempt the software update from *Step 4*.

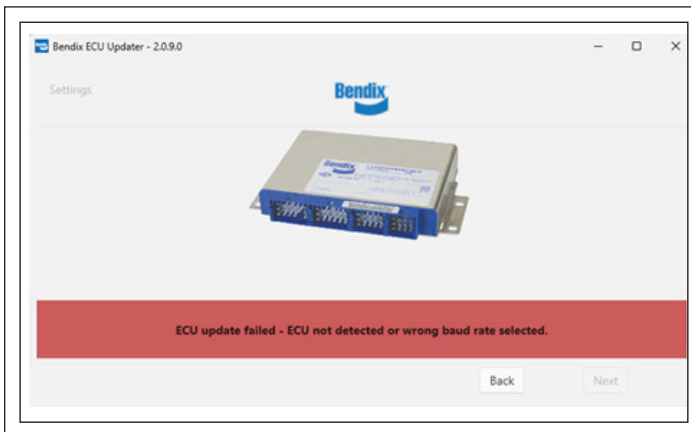
**Figure 7 – ECU Not Detected/Wrong Baud Rate Error**

- **(Figure 7) Wrong Baud Rate Error** - Configuration settings are not correct. See *Step 14*.
