# RETIGHTENING OF THE ROTOR SCREW CONNECTION #0912060206 AH SCREW DIN 912 M6X20

**2025 1390 SUPER DUKE R/EVO**

**2026 1390 SUPER DUKE R/EVO**

**2026 1390 SUPER ADVENTURE S/S EVO/R**

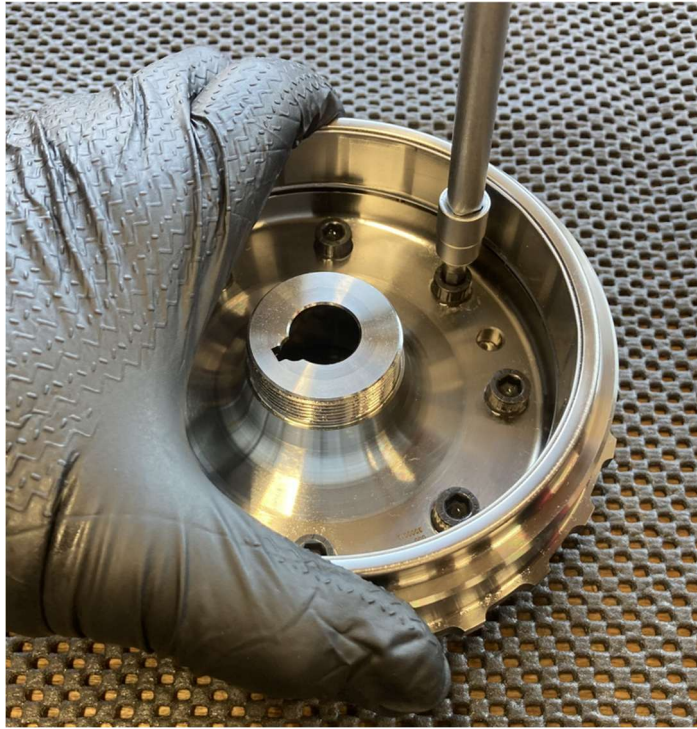
**Fig.:1 Place and secure the rotor.**

- Remove the rotor from the motor according to the repair manual.
- Place the rotor on a clean, non-slip surface and secure it by hand to prevent it from turning, see Fig. 1.

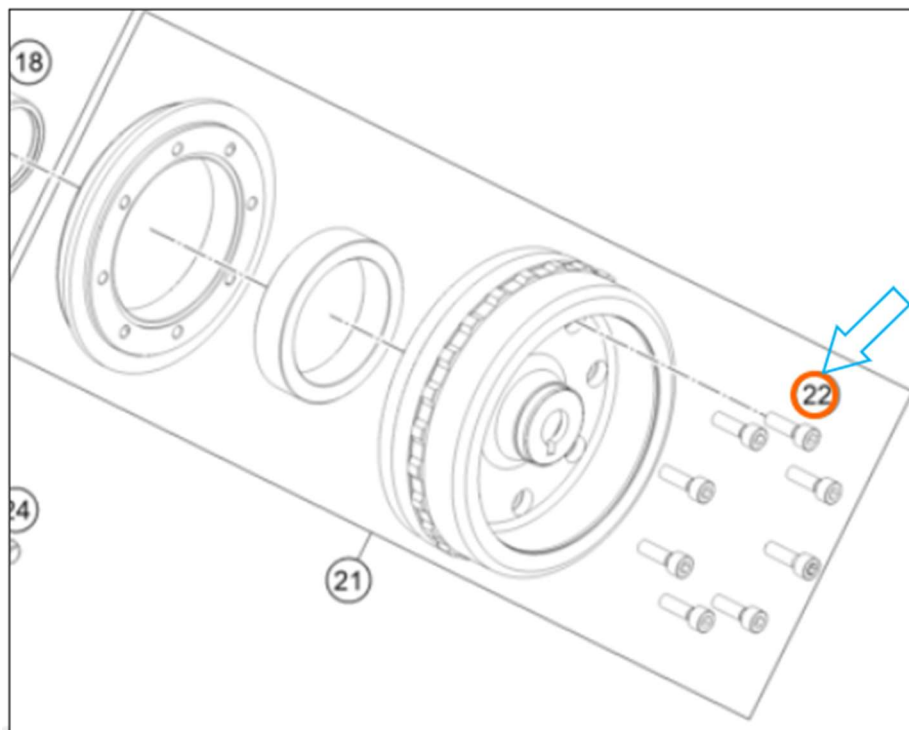
Fig.: 2 #0912060206 AH SCREW DIN 912 M6X20

During routine quality checks, it was discovered that the rotor screws #0912060206 AH SCREW DIN 912 M6X20 on the above-mentioned vehicles were not correctly tightened in isolated cases.

- Loosen 8 pcs. #0912060206 AH SCREW DIN 912 M6X20 (see Fig. 2) one after the other, remove them from the rotor, and clean them.
- Clean the internal thread on the rotor and ensure that the thread surface is free of oil and grease.
- Apply threadlocker to 8 pcs. #0912060206 AH SCREW DIN 912 M6X20 and tighten to the specified torque (14 Nm. – see Table 1).
- Install the rotor and tighten to the specified torque according to the repair manual and complete the vehicle (115 Nm – see Table 1).
- Perform a test drive and create a warranty claim in DealerNet.

| Component | Screw | Torque | Comment |
|---|---|---|---|
| #0912060206 AH SCREW DIN 912 M6X20 | M6X20 | 14 Nm | Loctite®2701™ |
