AMG 214 236 with throttle lift-off cracking noise from rear axle shaft

| Topic number | LI35.30-P-078692 |
| Function group | 35.30 - Final drive, drive shafts |
| Validity | Model series 214 and 236 AMG up to production date 12/9/2024 |

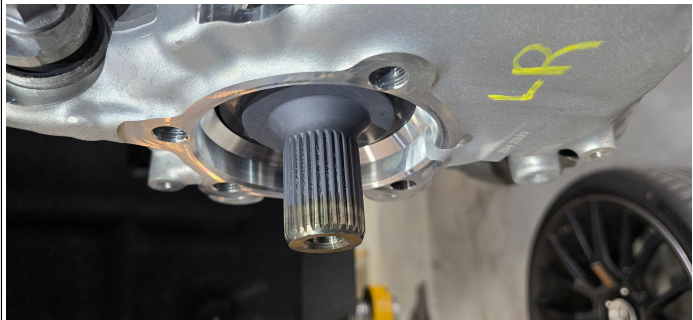
| Attachments | |
|---|---|
| <a href="#">Coating Application.jpg</a> | Figure 1 |

Unfavorable manufacturing tolerances in the production process of the drive shaft.

- 1. Remove both axle shafts
- 2. Clean the contact surface of the axle shaft and wheel bearing (remove old molykote with potential debris from wheel bearing)
- 3. (Stir molykote in container before use) Apply a generous layer of Molykote to the axle shaft from the contact surface up to the middle of the splines (Attachment Figure 1). Allow to dry for 30 minutes.
- 4. Apply a second layer and allow to dry completely for at least 1 hour
- 5. Reinstall both axle shafts
- 6. Tighten the axle shaft bolt to a torque of 80 Nm + 90°
