GENERAL MOTORS  
DCS7478  
URGENT - DISTRIBUTE IMMEDIATELY

Subject: N262547670 - Service Update  
Door Ring and Roof Ditch Metal Splits

Models: 2026 Chevrolet Silverado 1500  
2026 GMC Sierra 1500

### N262547670 Door Ring and Roof Ditch Metal Splits

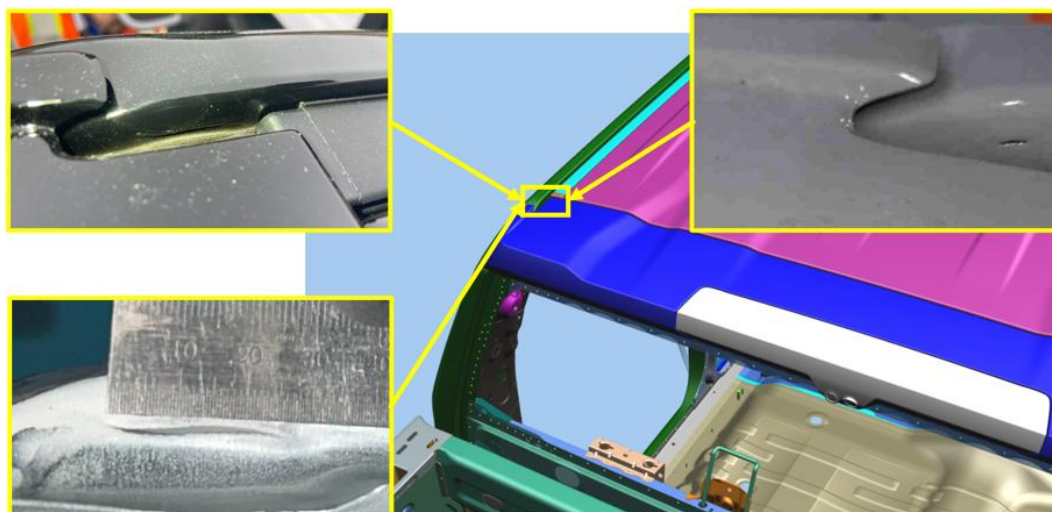
7129501

2. Using a bright light, visually inspect the rear portion of the roof ditch near the spoiler for a split in the sheet metal as shown above.
  - If no split is found, install the Driver's Side Roof Panel Joint Finish Molding. Refer to *Roof Panel Joint Finish Molding Replacement* in SI. Then proceed to step 10.
  - If a split is found, remove the Roof Rear Spoiler. Refer to *Roof Rear Spoiler Replacement* in SI.
    - i. Position a welding blanket between the upper rear corner of the cab where the split is and the headliner, being careful not to buckle or crease the headliner.
3. Remove the factory-applied seam sealer from the repair area.

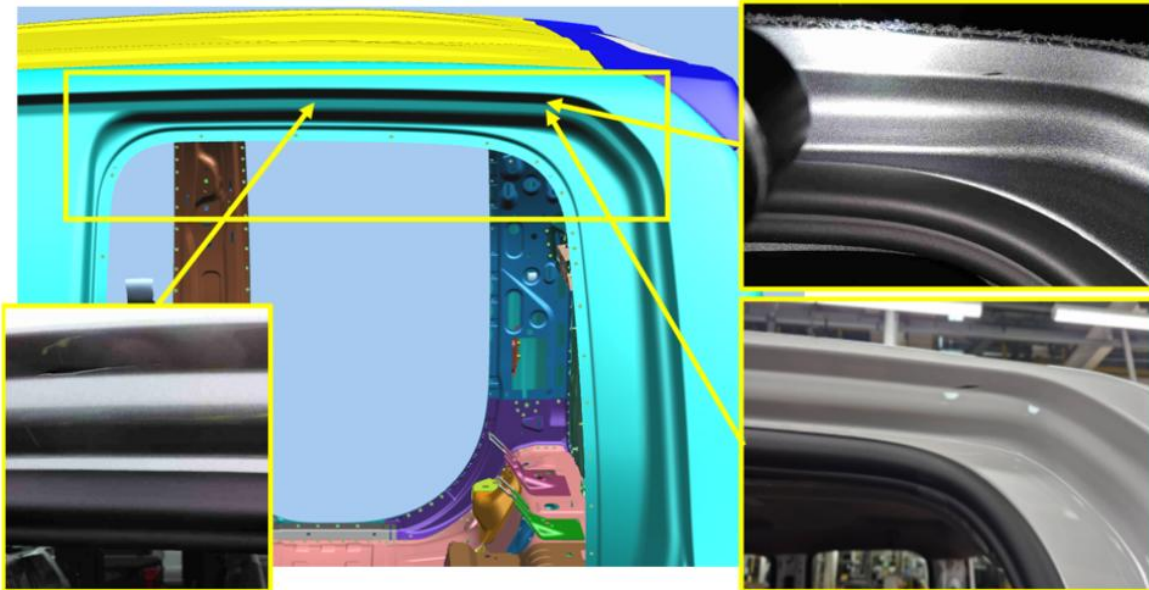
7129505

11. Using a bright light, visually inspect the top of the driver's side rear door jamb for a split in the sheet metal as shown above.
  - If no split is found, then proceed to step 22.
  - If a split is found, proceed to step 12.
12. Remove the Driver's Side Front and Rear Row Roof Rail Airbag. Refer to *Front and Rear Row Roof Rail Airbag Replacement* in SI.
13. Inspect the Headlining Roof Panel for any signs of water damage or intrusion. Repair or replace as necessary.
14. Cover all interior surfaces with weld blankets for protection against weld spatter.
15. Using an 1/8<sup>th</sup> inch drill bit, drill a hole at each end of the crack from the outside of the vehicle. This will stop the crack from spreading.
