## AMG models with torque converter 725.0 (NAG3 Classic) and M177/ M279 engine - Harsh shift concerns due to speed sensor installation

Topic number	LI27.00-P-080462
Version	2
Function group	27.00 - General
Date	4/17/26
Validity	Affects all 167 with M177 engine and transmission 725.085 (NAG3 Classic w/ torque converter) produced as of July 1, 2025  Affects all 223 with M279 engine and transmission 725.095 (NAG3 Classic w/ torque converter) produced as of July 1, 2025  Older models with 725.085/095 (NAG3 Classic w/ torque converter) transmissions were NOT affected in production, but may have received affected replacement parts (A725 270 55 09) during valve body replacement
Reason for change	Updated validity

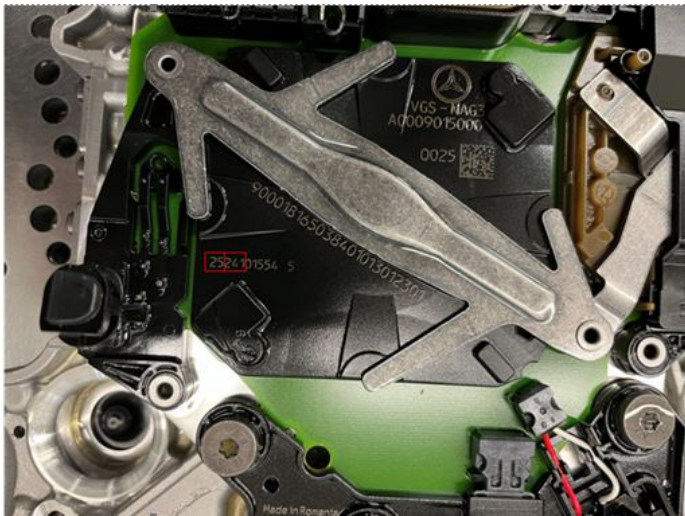
Attachments	
File	Description
Valve body - ECU serial number and date code.jpg	Figure 2

1. Collect initial transmission EEPROM file
  2. Check EEPROM .txt file for VGS control unit serial number and production date (attachment figure 1)
- If the valve body is already removed, you can inspect the control unit for its stamped serial number (attachment figure 2)

- Verify the new valve body production date is outside of day 182-296 of 2025 (attachment figure 2)
