| <br><b>HARBINGER</b> | <h1>Technical Service Bulletin</h1> |
| Bulletin Number: TSB-03-00002 | |
| Subject: Upgrade ADAS System Camera Cables | |
| Applicability: All 2025,2026 Chassis | |

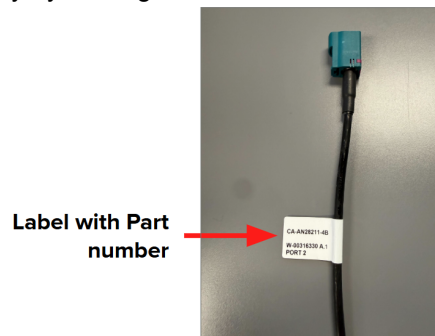
Fig. Label with part number

- Cables can be identified using the part number marked on the label which can be located near the straight connector towards the ADCU side.
- Cables can also be identified visually by looking at the connector. Please refer to the figure

Comparing Old and NEW cables.
