HYUNDAI Technical Service Bulletin

GROUP BODY ELECTRICAL	NUMBER 26-BE-010H
DATE APRIL 2026	MODEL(S) SEE BELOW

SUBJECT: INOPERATIVE HORN ASSEMBLY REPLACEMENT
(WARRANTY EXTENSION Z07)

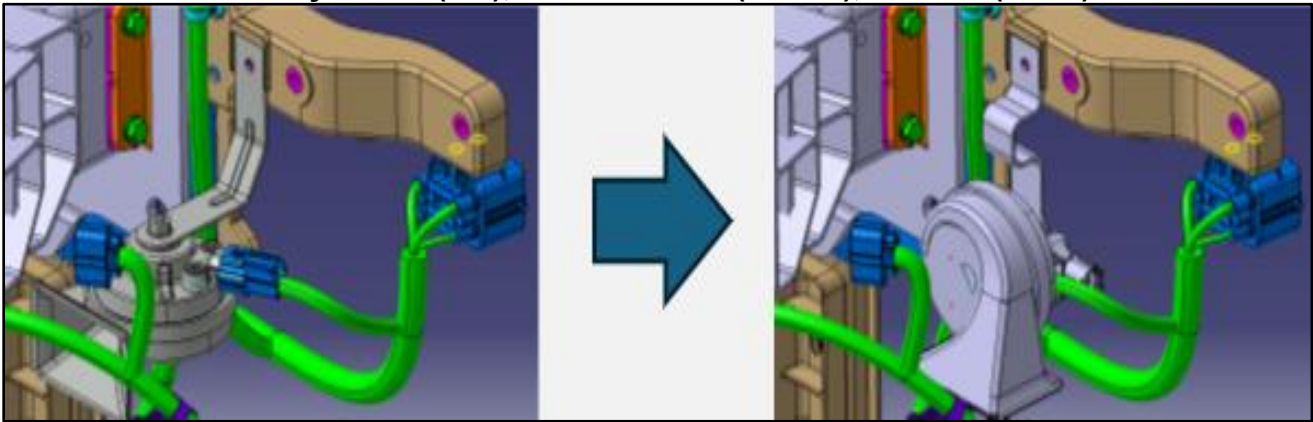
Low Pitch Horn Assembly: Kona (OS), Kona Electric (OS EV), Kona N (OS N)

NOTE: The low-pitch horn will change from horizontally mounted to vertically mounted orientation.

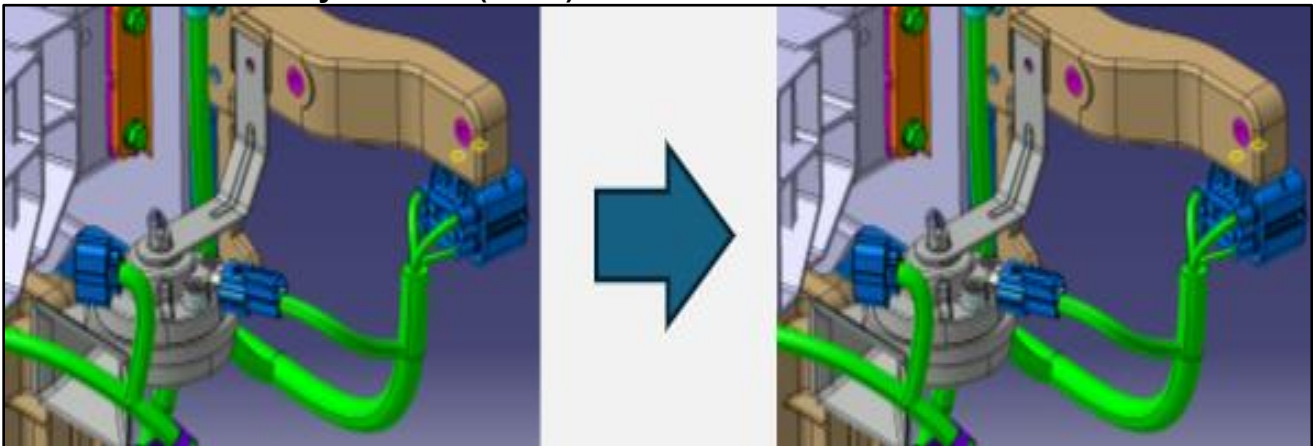
High-Pitch Horn Assembly: Kona N (OS N)

NOTE: The high-pitch horn will remain in its horizontally mounted orientation.

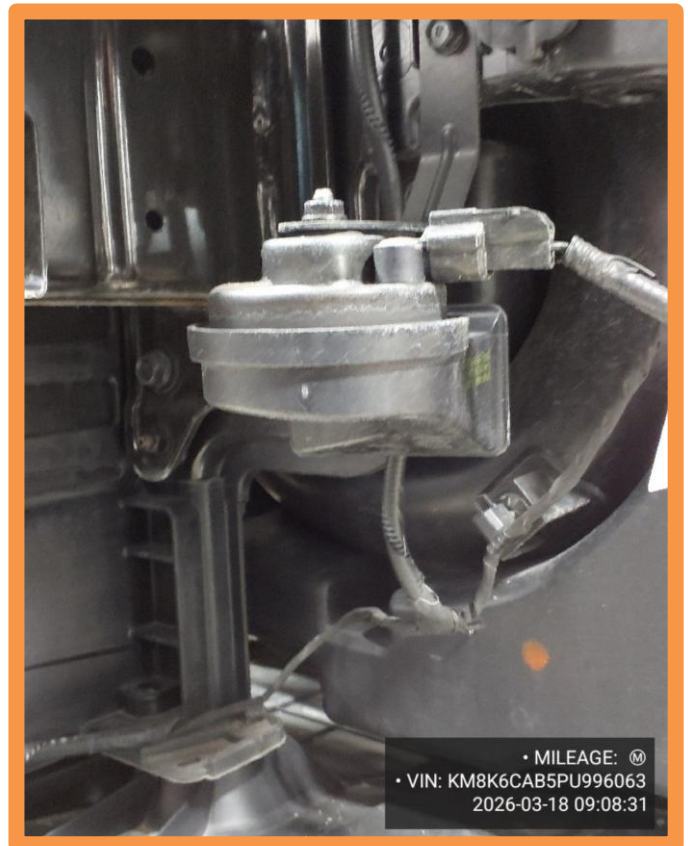
Using the STUI camera function, take a photo of the original (either LH or RH) horn mounted in the horizontal position.

- Remove horn(s) (C, D) by disconnecting the horn connector and removing the mounting bolt (E).

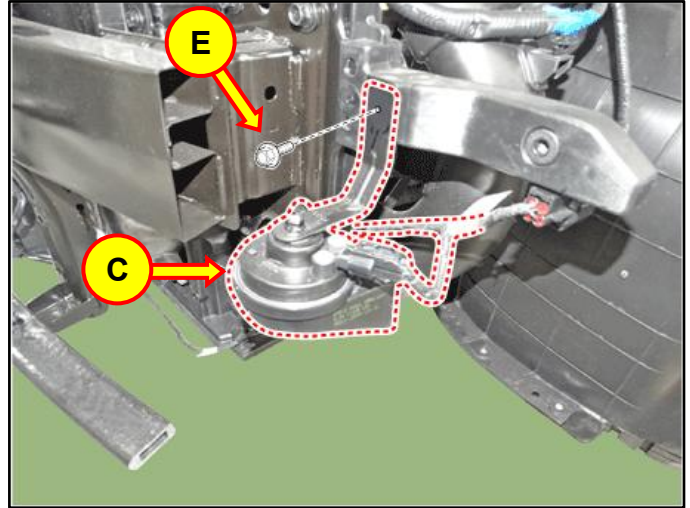
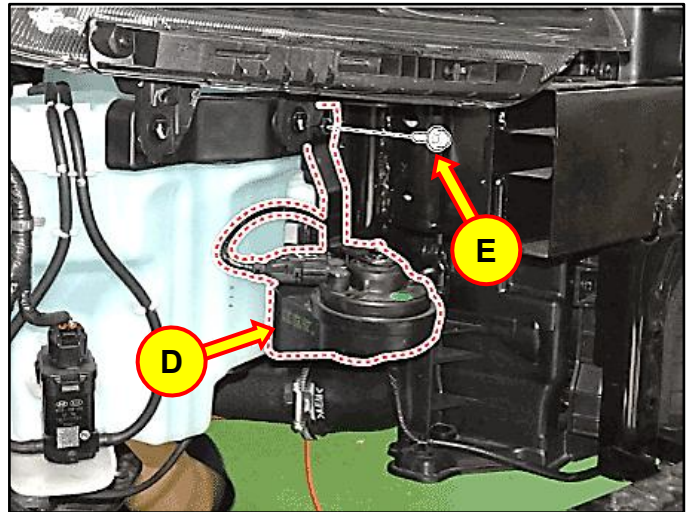
The low-pitch horn is now mounted vertically instead of horizontally. The high-pitch horn remains in its original horizontal position.

- Reinstall parts in the reverse order of the removal process.
- Test the horn(s) to confirm proper operation.
- This service procedure is now complete.
