## Technical Service Bulletin

<b>GROUP</b>	<b>NUMBER</b>
<b>CAMPAIGN</b>	<b>26-01-003G-1</b>
<b>DATE</b>	<b>MODEL(S)</b>
<b>APRIL 2026</b>	<b>GV70 (JK1, JK1A) GV80 (JX1) GV80 COUPE (JX1)</b>

**SUBJECT:** LOOSE WINDSHIELD GLASS GARNISH SEAL  
(SERVICE CAMPAIGN T84G)

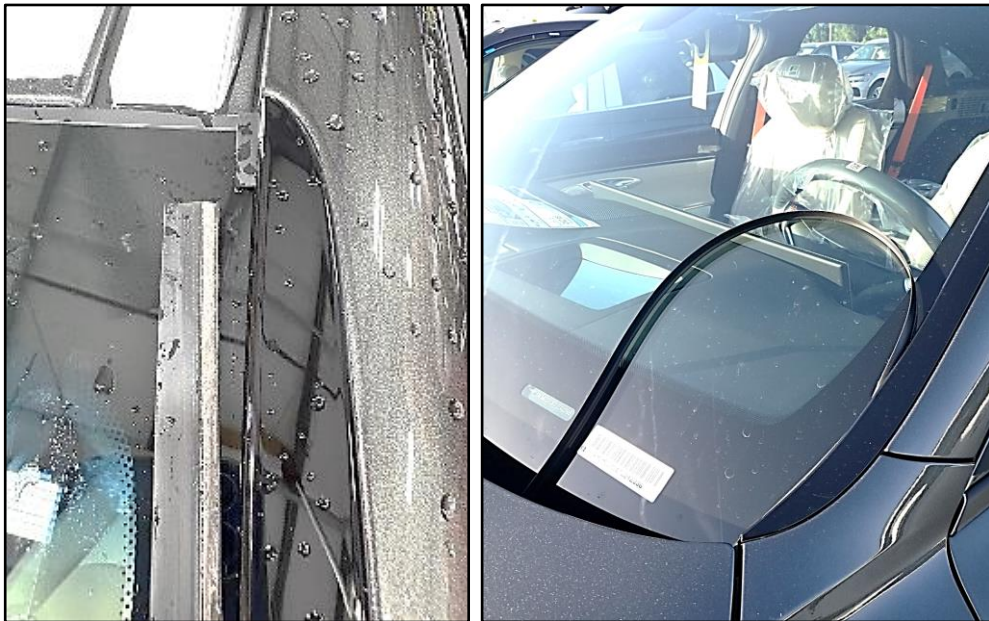
**Description:** Certain GV70 (JK1, JK1A), GV80 (JX1), and GV80 Coupe (JX1) vehicles may exhibit a loose windshield glass garnish seal. This bulletin provides instructions to remove the old garnish and install new parts.

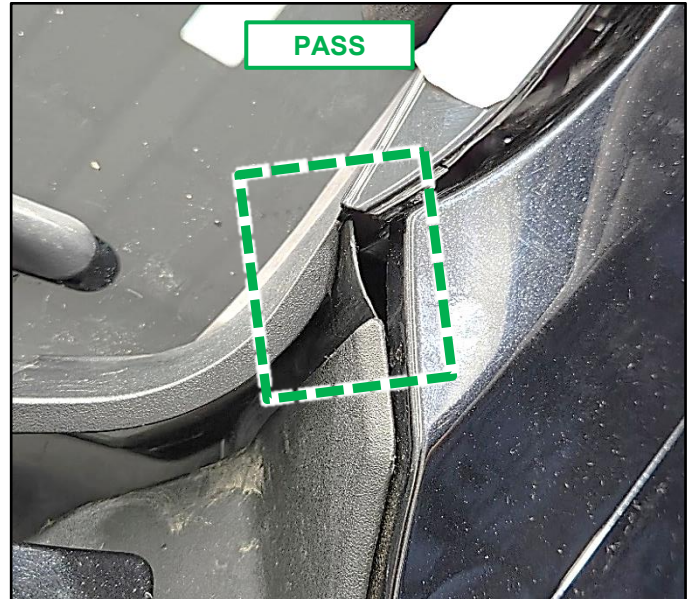
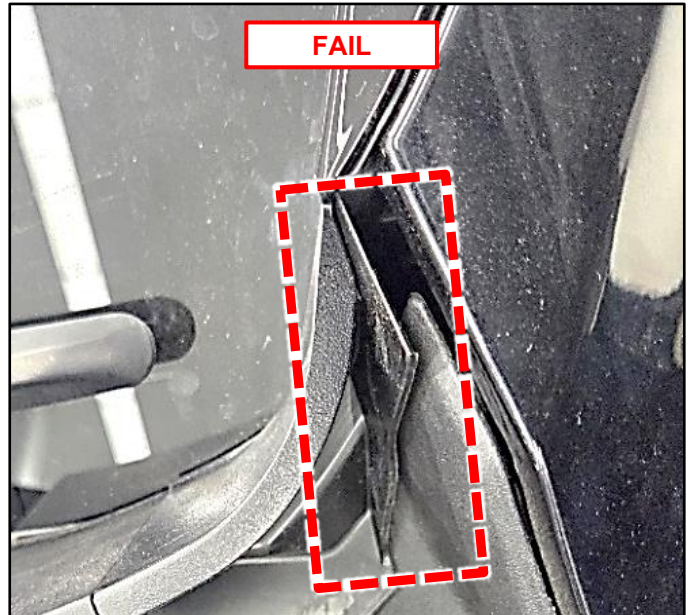
- **PASS:** The lower end of garnish is inserted between the cowl top cover and fender panel.
- **FAIL:** The lower end of garnish is **NOT** inserted between the cowl top cover and fender panel.

3. Install the new windshield glass garnish in the reverse order of removal.

Refer to the photos for proper installation:
