Insufficient Heating Output Due To Broken Refrigerant Line Between Refrigerant Compressor And The condenser (Hot Gas Line)

Topic number	LI83.20-P-076623
Version	4
Function group	83.20 - Heating
Date	4/20/26
Validity	EQA (H243), EQB (X243)
Reason for change	Remedy

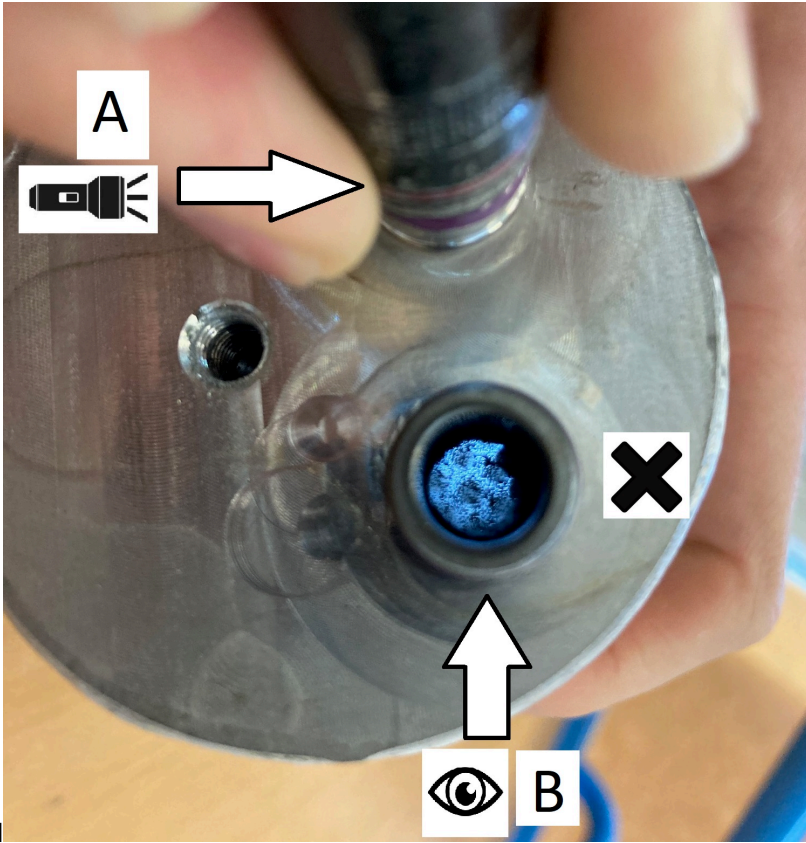
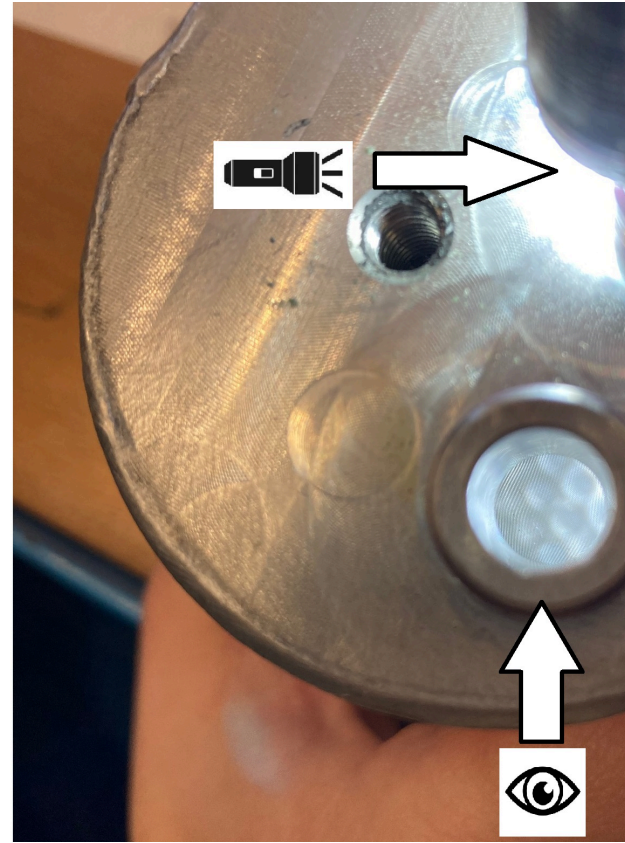
2. Check dryer cartridge at condenser for particles: Remove dryer cartridge, illuminate inlet of dryer cartridge using flashlight (A), and examine filter screen through outlet of dryer cartridge (B) -> see comparison picture bad/good
