REFERENCE:	TSB: 08-139-26 REV. A GROUP: 08 - Electrical	Date:	April 16, 2026	REVISION:	08-139-26
VEHICLES AFFECTED:	2026 (DT) RAM 1500 Pickup This bulletin applies to vehicles built on or before January 19, 2026 (MDH 0119XX) equipped with Proximity Approach/Departure Lamps (Sales Code LNR).			MARKET APPLICABILITY: <input checked="" type="checkbox"/> NA <input checked="" type="checkbox"/> MEA <input checked="" type="checkbox"/> SA <input type="checkbox"/> IAP <input checked="" type="checkbox"/> EE <input type="checkbox"/> CH NOTE: This bulletin applies to Middle East & Africa, North and South America and Enlarged Europe markets.	
CUSTOMER SYMPTOM:	Customer may experience the following: <ul style="list-style-type: none"> **Excessive Ignition Off Draw (IOD) on 12v vehicle battery if keys are left within proximity range.** 				
CAUSE:	RFHM software

This bulletin involves inspecting and possibly reprogramming the RFHM module with the latest available software.

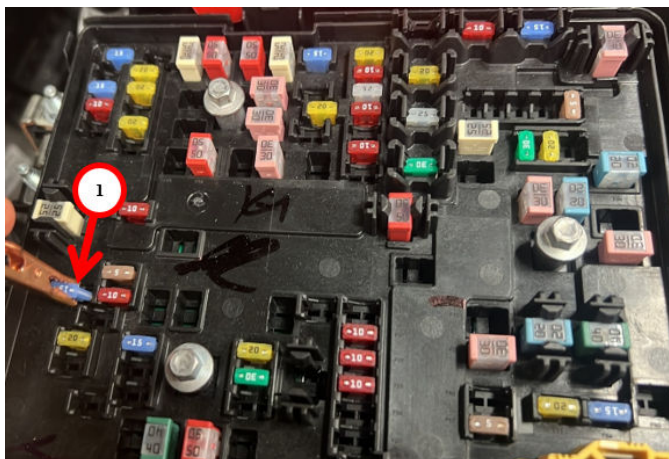
Fig. 1
F08 MOD Cluster Fuse Location

1 - F08 MOD Cluster Fuse

3. Remove fuse F08 MOD CLUSTER from the underhood Power Distribution Center (PDC) [Fig. 1](#).

6. ****Reinstall fuse F08 MOD CLUSTER from the underhood PDC [Fig. 1](#).****
7. Clear all DTCs that may have been set in any module due to reprogramming. The wiTECH application will automatically present all DTCs after the flash and allow them to be cleared.
