<b>REFERENCE:</b>	<b>TSB:</b> 08-140-26 REV. A <b>GROUP:</b> 08 - Electrical	<b>Date:</b>	April 16, 2026	<b>REVISION:</b>	08-140-26
<b>VEHICLES AFFECTED:</b>	<b>2025 (DT) RAM 1500 Pickup</b> This bulletin applies to vehicles equipped with Proximity Approach/Departure Lamps (Sales Code LNR).			<b>MARKET APPLICABILITY:</b> <input checked="" type="checkbox"/> NA <input checked="" type="checkbox"/> MEA <input checked="" type="checkbox"/> SA <input checked="" type="checkbox"/> IAP <input type="checkbox"/> EE <input type="checkbox"/> CH <b>NOTE:</b> This bulletin applies to Middle East & Africa, North and South America and India & Asia Pacific markets.	
<b>CUSTOMER SYMPTOM:</b>	<b>Customer may experience one or more of the following:</b> <ul style="list-style-type: none"> <li>● <b>**Excessive Ignition Off Draw (IOD) on 12v vehicle battery if keys are left within proximity range.** (NA vehicles only).</b></li> <li>● RFHM software update fails when attempting to perform a flash.</li> <li>● Low vehicle battery.</li> <li>● Key fob is inoperable.</li> <li>● Proximity is inoperable.</li> </ul>

<b>CAUSE:</b>	RFHM software

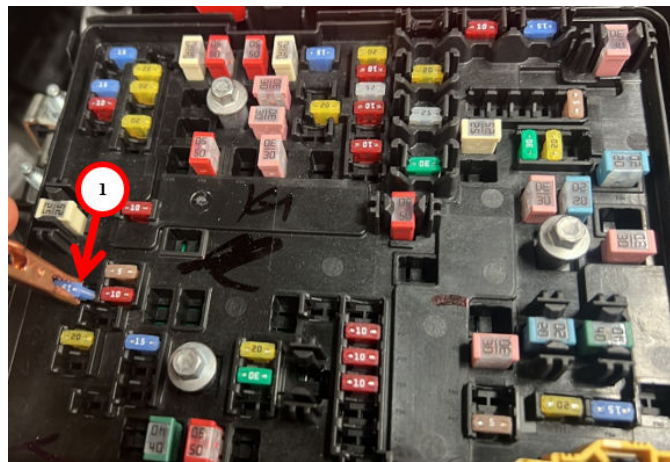
**Fig. 1**  
F08 MOD Cluster Fuse Location

1 - F08 MOD Cluster Fuse

1. Is this vehicle on the RSU VIN list?
  - YES >>> Proceed to [Step 2](#).
  - NO >>> Proceed to [Step 3](#).
2. Does the RFHM have the latest software already installed?
  - YES >>> This bulletin has been completed. Use Inspect LOP (18-19-12-BF) to close the active RSU.
  - NO >>> Proceed to [Step 3](#).
3. Remove fuse F08 MOD CLUSTER from the underhood Power Distribution Center (PDC) [Fig. 1](#).

6. **\*\*Reinstall fuse F08 MOD CLUSTER from the underhood PDC [Fig. 1](#).\*\***
7. Clear all DTCs that may have been set in any module due to reprogramming. The wiTECH application will automatically present all DTCs after the flash and allow them to be cleared.
