**Technical Service Bulletin (TSB)**  
**Rear Mid Range Radar (MRR) Bracket Revision**

<b>REFERENCE:</b>	<b>TSB:</b> 08-166-26 <b>GROUP:</b> 08 - Electrical	<b>Date:</b>	April 18, 2026	<b>REVISION:</b>	—
<b>VEHICLES AFFECTED:</b>	<b>2025 (DT) RAM 1500 Pickup</b> This bulletin applies to vehicles built on or before April 30, 2025 (MDH 0430XX) equipped with Blind Spot And Cross Path Detection (Sales Code XAN).			<b>MARKET APPLICABILITY:</b> <input checked="" type="checkbox"/> NA <input type="checkbox"/> MEA <input type="checkbox"/> SA <input type="checkbox"/> IAP <input type="checkbox"/> EE <input type="checkbox"/> CH <b>NOTE:</b> This bulletin applies to North America markets.	
<b>CUSTOMER SYMPTOM:</b>	<b>Customers must experience a Malfunction Indicator Lamp (MIL) illumination and the vehicle must exhibit/set one or more of the following Diagnostic Trouble Codes (DTCs):</b> <ul style="list-style-type: none"> <li>● C00C4-76 - Rear Radar Module "A" - Wrong Mounting Position.</li> <li>● C00C5-76 - Rear Radar Module "B" - Wrong Mounting Position.</li> </ul> <b>Customers may also comment on the following:</b> <ul style="list-style-type: none"> <li>● Blind Spot Warning indicator display

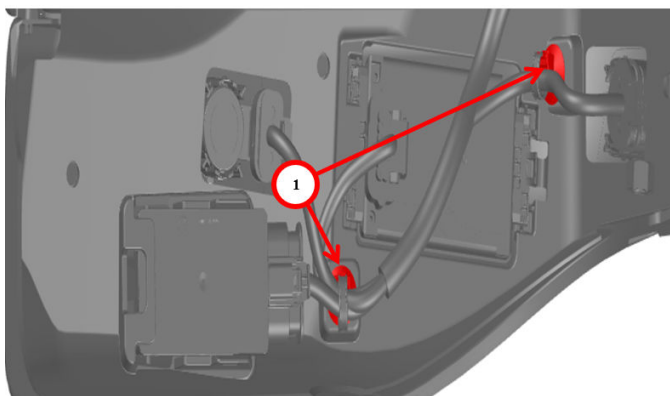
**Fig. 2**  
Release Wire Harness

1 - Wire Harness Retainers

3. Disengage the wire harness retainers [Fig. 2](#).

16. Engage the wire harness retainers [Fig. 2](#).

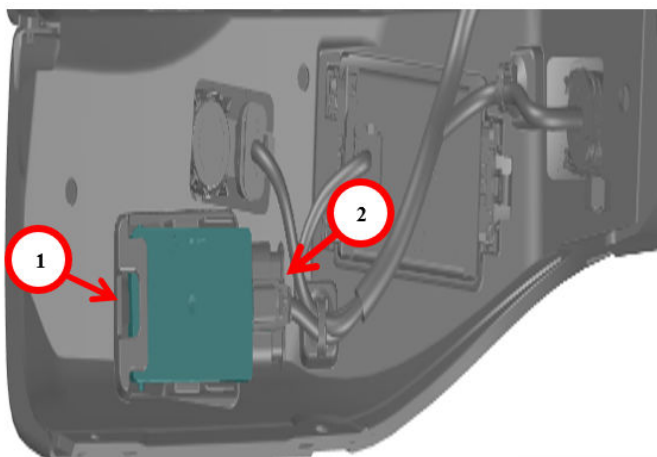
**Fig. 3**  
SPAAK Module

1 - SPAAK Shoe Retainer  
2 - SPAAK

4. Depress the shoe retainer to release and remove the Smart Phone As A Key (SPAAK) module [Fig. 3](#).

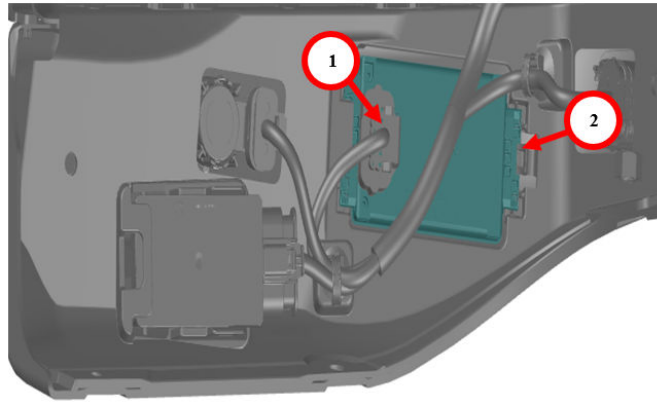
**Fig. 4**  
MRR Removal

- 1 - MRR
- 2 - MRR Shoe Retainer

- Depress the shoe retainer to release and remove the MRR [Fig. 4](#).

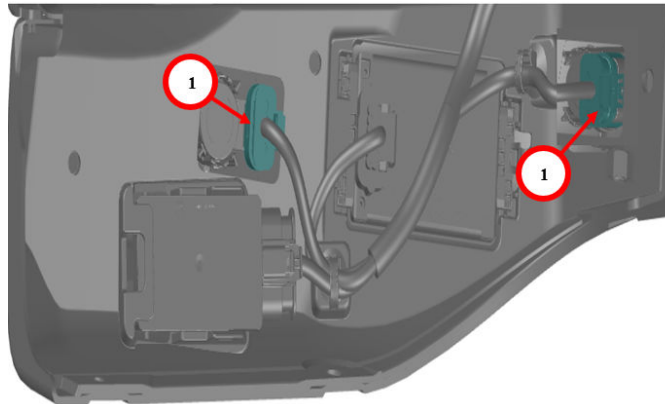
**Fig. 5**  
RPA Wire Harness Connector

- 1 - RPA Sensor Wire Harness Connectors

- Disconnect the Rear Park Assist (RPA) sensor wire harness connectors [Fig. 5](#).

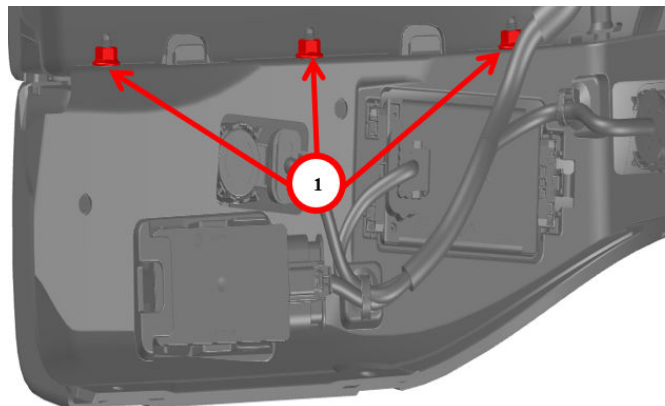
**Fig. 6**  
Loosen M6 Nuts

- 1 - M6 Nuts

- Loosen the M6 nuts [Fig. 6](#).

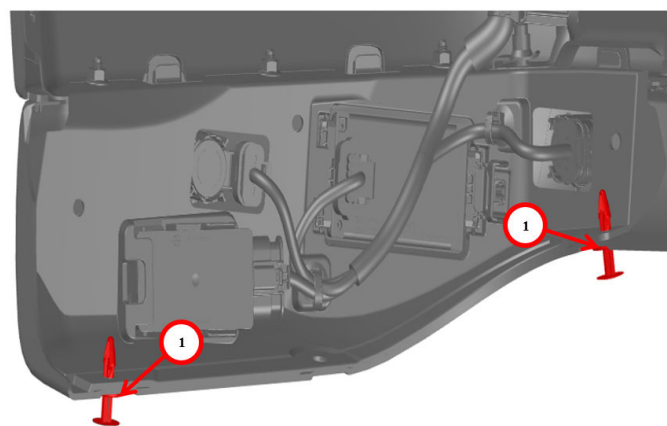
**Fig. 9**  
Push Pins

1 - Install Push Pins

10. Install two push pins [Fig. 9](#).
