## STAR ONLINE PUBLICATION

**Case Number:** S2608000016

**Symptom/Vehicle Issue:** Heated Steering Wheel Operates Intermittently

2025-2026 Ram 1500 (DT)

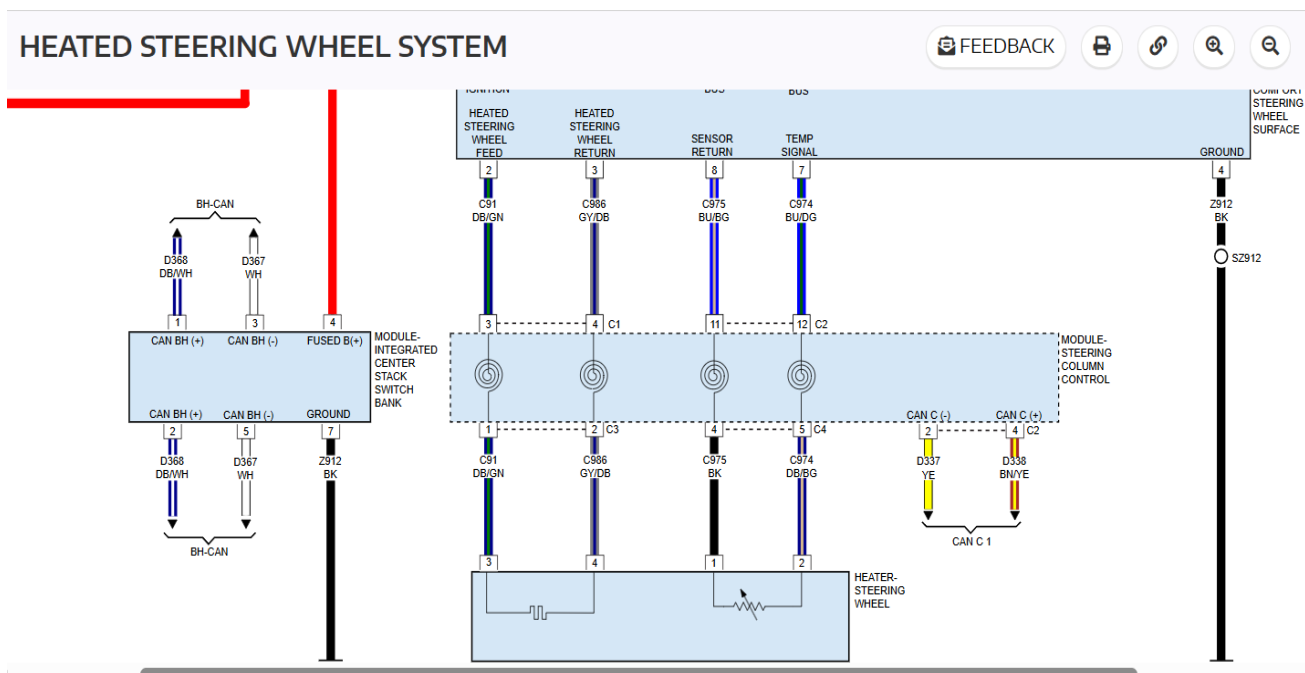
1. The ignition must be off when checking the continuity of a circuit.
2. Isolate the circuits by disconnecting the SCCM C3 harness connector and the C1 connectors.
3. Before measuring the resistance of any circuit, first measure the resistance between the two leads of the DVOM. Note: The meter leads can add resistance to the measurement value that should be noted prior to testing.
4. Measure the resistance of the SCCM C1 pin 3 (C91 circuit) to C3 SCCM pin 1 (C91 circuit) a good SCCM pass through should be less than 3 ohms.
5. Measure the resistance of the SCCM C1 pin 4 (C986 circuit) to C3 SCCM pin 2 (C986 circuit) a good SCCM pass through should be less than 3 ohms.

**NOTE: When probing a circuit at an Electronic Control Unit (ECU) harness connector, always use a proper back probing tool to prevent any possible damage to terminals.**
