TECHNICAL SERVICE BULLETIN

Illuminated MIL And/Or Powertrain Malfunction (Wrench) Indicator With Various Diagnostic Trouble Codes (DTCs)

26-2167

Ford 2022 e-Transit

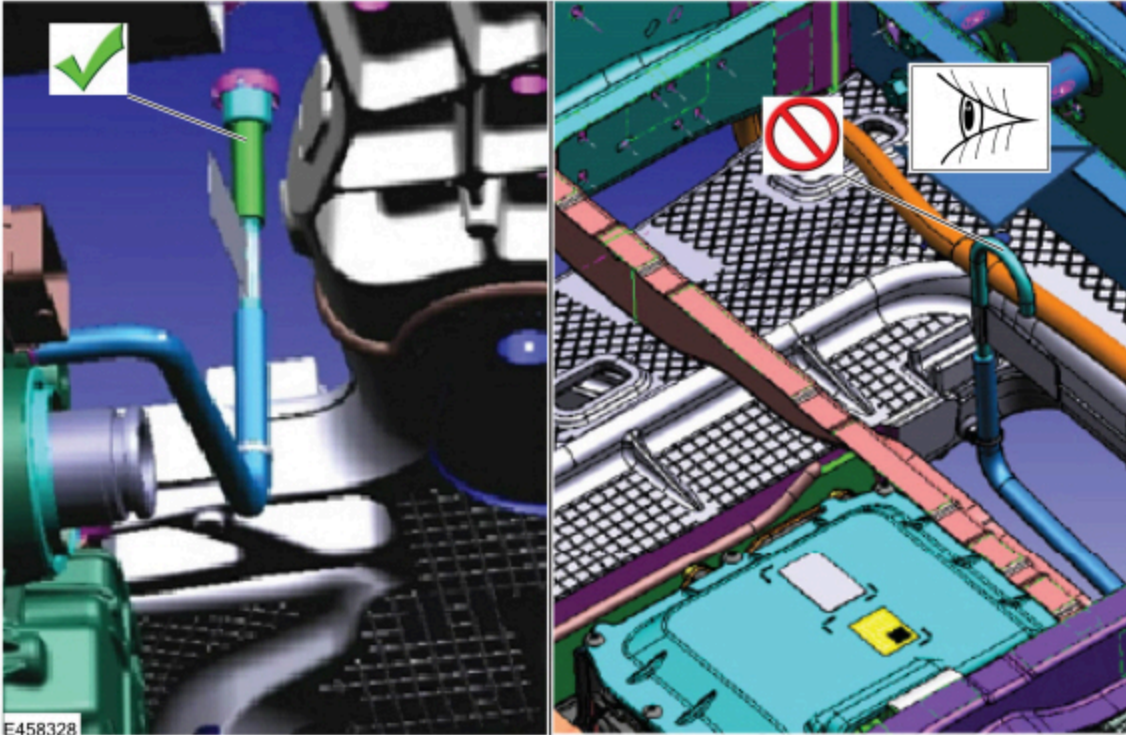
Figure 1

- Illuminated MIL and/or illuminated powertrain malfunction (wrench) indicator with DTCs P0711, P0A2B, P0A2D, P0A2C, P0712, P0713 and P1A10 stored in the SOBDMC.
- DTC P0AA6 stored in the BECM and/or IPC.
- Equipped with early design vent assembly attached to rear electric drive assembly. Refer to Figure 1.

2. Is the vehicle equipped with the rear electric drive assembly vent hose as shown in the image with the green check mark in Figure 1?

3. Remove and discard the rear electric drive assembly vent hose and replace with the updated part.
