TECHNICAL SERVICE BULLETIN

Navigator Front Bumper Lower Cover Detached On One Or Both Sides

26-2178

Lincoln 2025-2026 Navigator	Built on or before: 5-Feb-2026
--------------------------------	--------------------------------

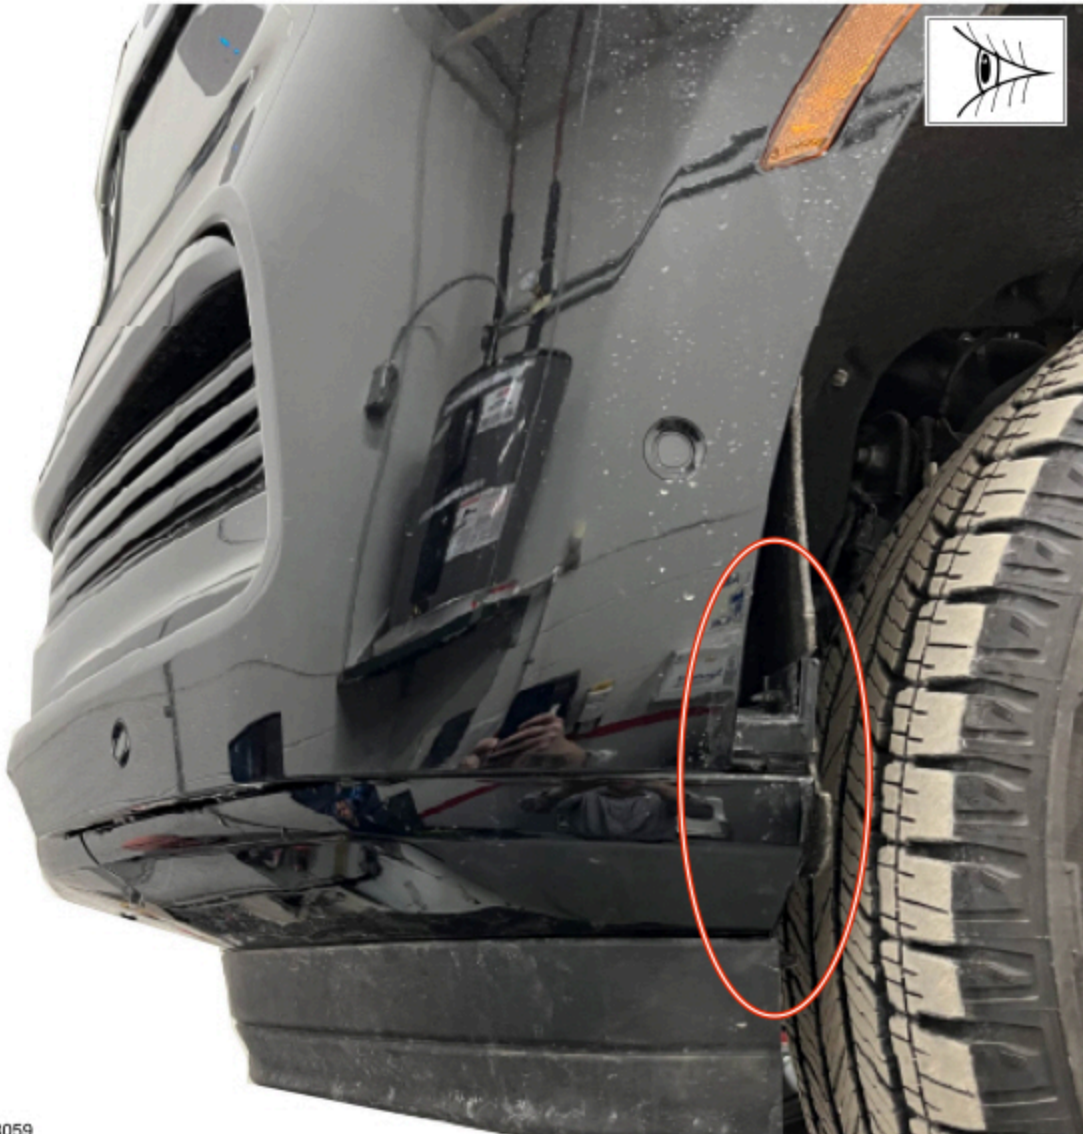
Figure 1 - Left side shown, right side similar

Issue: Some of the vehicles listed in the Model statement above may exhibit one or both sides of the front bumper lower cover becoming detached. This may be due to a lack of retention of the front bumper fasteners.

1. Is the front bumper lower cover detached on the left and/or right sides as shown in Figure 1?

- (1). Yes - proceed to Step 2.
 - (2). No - this article does not apply. If damage is present or the front bumper lower cover is detached in the center section, refer to the Warranty and Policy Manual.
2. With the transmission in Neutral (N), position the vehicle on a hoist with a straight-ahead steering wheel angle and raise the vehicle until all 4 wheels are off the ground following the WSM, Section 100-02 > General Information > Service Information > Jacking and Lifting.
 3. Apply masking tape to the front bumper lower cover to protect from damage as shown in Figure 2.
