## Panoramic Sliding Sunroof Reverses During Closing Without Obstruction – No Anti-Pinch Event Triggered

| Topic number | LI77.21-P-075806 |
| Function group | 77.21 - Panoramic roof |
| Validity | BR296 with SA code 413 (panoramic roof), produced up to 03/08/2023; BR294 without world manufacturer code LE4, with SA code 413 (panoramic roof), produced up to 03/09/2023; BR294 with world manufacturer code LE4, with SA code 413 (panoramic roof), produced up to 02/01/2023 |

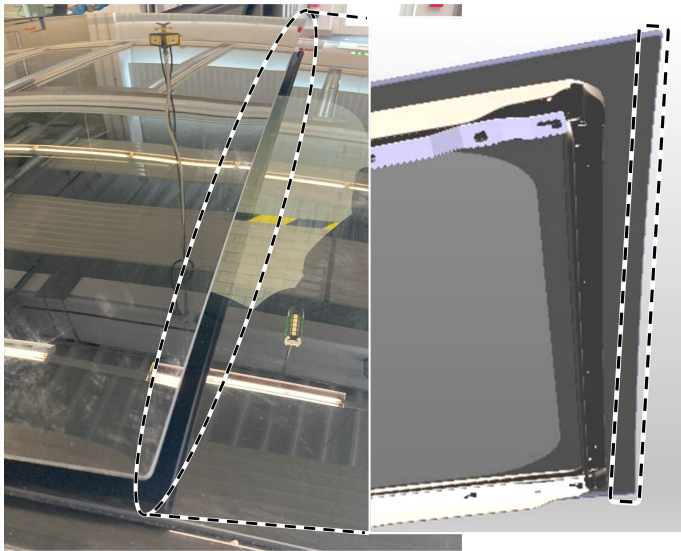
| Attachments | |
|---|---|
| <a href="#">Abbildung 1.jpg</a><br> | Clean the underside of the rear edge of the sliding sunroof panel at the marking (e.g., with isopropyl alcohol). |

- Clean the underside of the rear edge of the sliding sunroof panel (marking, Figure 1) (e.g., isopropanol).
- Subsequently install the cover rail on the underside of the sliding sunroof panel (Figure 2).

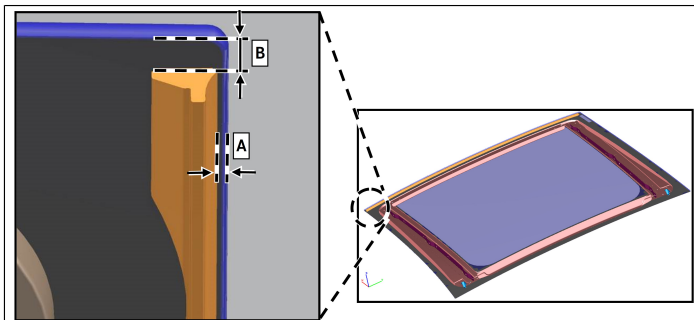
| Attachments | |
|---|---|
| <a href="#">Abbildung 2.jpg</a><br> | Subsequently install the cover rail on the underside of the sliding sunroof panel. |

- Distance from the cover rail to the rear edge of the sliding sunroof panel A = 5 mm
  - Distance from the cover rail to the right and left edges of the sliding sunroof panel B = 9 mm

- Apply firm pressure by hand along the entire bonding surface of the COVER RAIL
  - The wider flange at the ends of the cover rail (see Figure 3) must point in the direction of travel

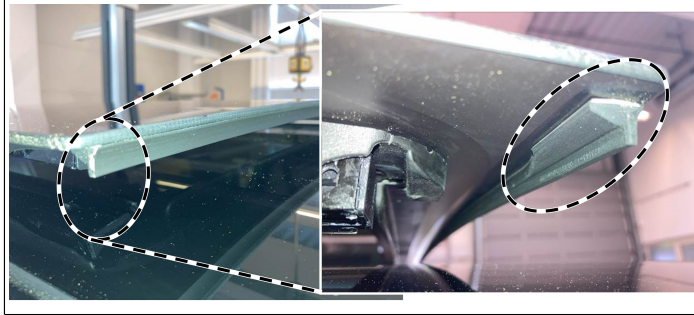
Abbildung 3.jpg

The wider flange at the ends of the cover rail must be oriented in the direction of travel.
