Service Bulletin

Bulletin No.: PIT5689N

Subject: No Restart after an Auto Stop Event / No Crank / Dead Battery / Glow Plug / Transfer Case / SES MIL / DTC

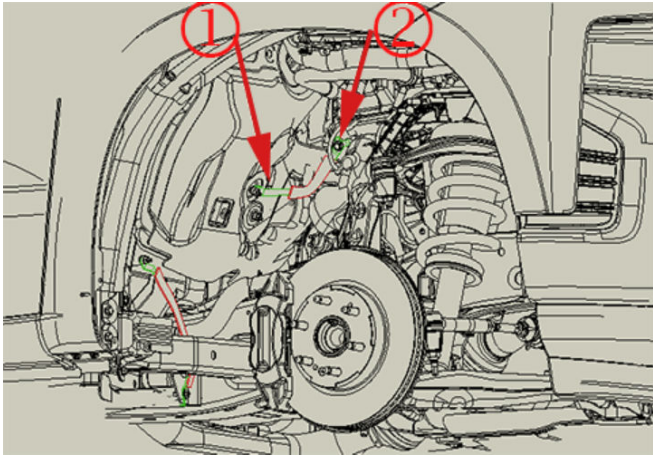
5338646

Involved Region or Country	North America, Europe, Australia & New Zealand
Condition	<p>Some customers may comment of the following:</p> <ul style="list-style-type: none"> - After an auto-stop event the engine does not restart (if equipped). - No crank (may be intermittent) - Dead Battery - Transfer Case Range Actuator Learn Failed - SES MIL with any of the following DTCs: P0562, P0615, P0617, P0621 P0622, P0700, P1005, P26E4, P26E5, P26E6, P305D, P305E, P2796, U010E, U0102, U0106, U0284, U0285, U0672, U029D, U029E, U02A1, U02A3, U0623, U220E, U111A, U111E, U1348, U18DE, U3003, U3006, U3007, U0403, U0101, P066B, P066D, P066F, P067B, P067D, P068D, P068F, C15AC, C118D, P0671, P0672, P0673, P0674, P0675, P0676 P067F, P0677, and P0678
Cause	These concerns could be caused by a broken or loose engine ground cable/strap, which grounds the engine (2) to the body (1), as shown below.

1 - G132

2 - G134

Inspect the engine to body ground cable/strap, G132 and G134. Tighten any loose ground connections or replace any damaged ground cable/strap. Ensure that the ground cable/strap is properly orientated to prevent damage to the ground cable/strap caused by powertrain movement.

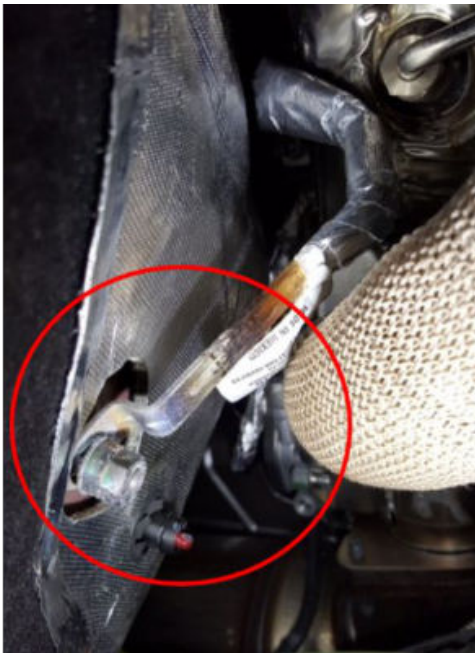
5748460

Shown above is ground G132 loose.
