Service Bulletin

Bulletin No.: PIP6108

Subject: Diagnostic Tip PTO inoperative with DTC P251A

Brand:	Model:	Model Year:		VIN:		Engine:	Transmission:
		from	to	from	to		
Chevrolet	Silverado 4500HD 5500HD 6500HD	2019-2023		All	All	All	All

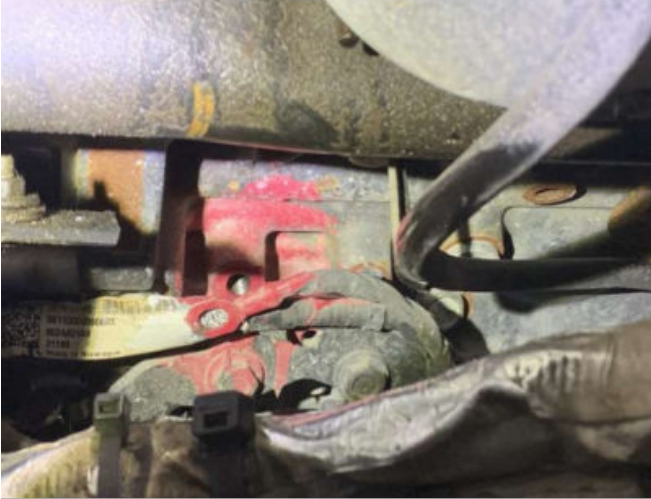
7108938

1. Check G120 which is the Main PTO ground.
 - a. G120 is on the left side of the engine.
 - b. Make sure the ground bolts is not too long and the ground eyelet has proper clamp load.
 - c. Inspect for the red anti-corrosion paint between block and eyelet and the eyelet and the bolt head review the pictures below. Clean and repair as necessary.

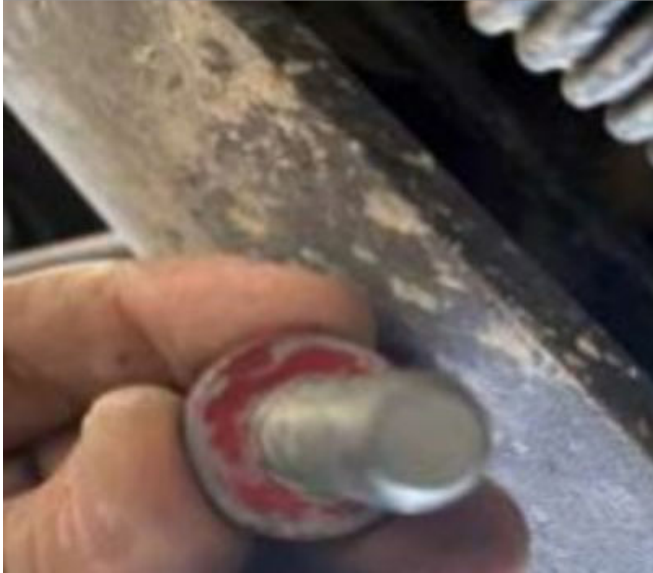
7108931

- Ground G108 is on the right front inner frame rail and G110 is on the right side of the engine.
- Inspect for the bolt being the proper length and not bottoming out, this will cause the bolt to be tight but no clamp load on the eyelet
- Inspect for the red anti-corrosion paint being between the eyelet and the engine block and the bolt and the eyelet please see the pictures below. Clean and repair as necessary.

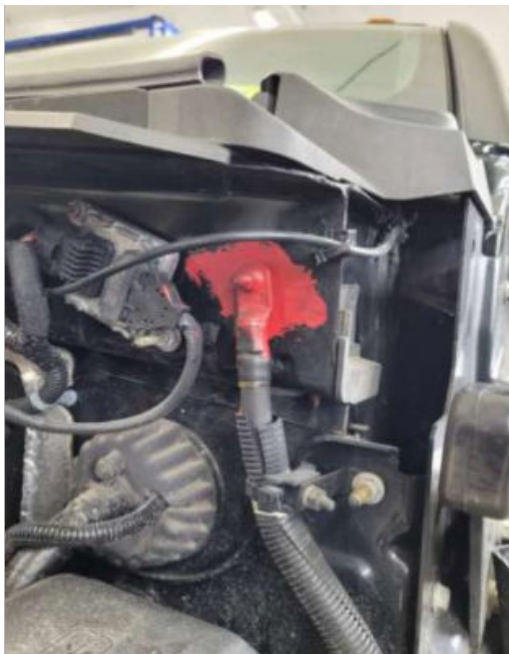
7108935

- Check G198 and G199 which is the main Body to left frame rail ground.
- G198 is on the body and G199 is on the left front frame rail
- Inspect for proper eyelet clamp load and for red anti-corrosion paint between the bolt head, eyelet and the engine block or body stud. Please see the below pictures. Clean and repair as necessary.
