Service Bulletin

Bulletin No.: PIT6493A

PRELIMINARY INFORMATION

Subject: Wind Noise From Driver Front Door

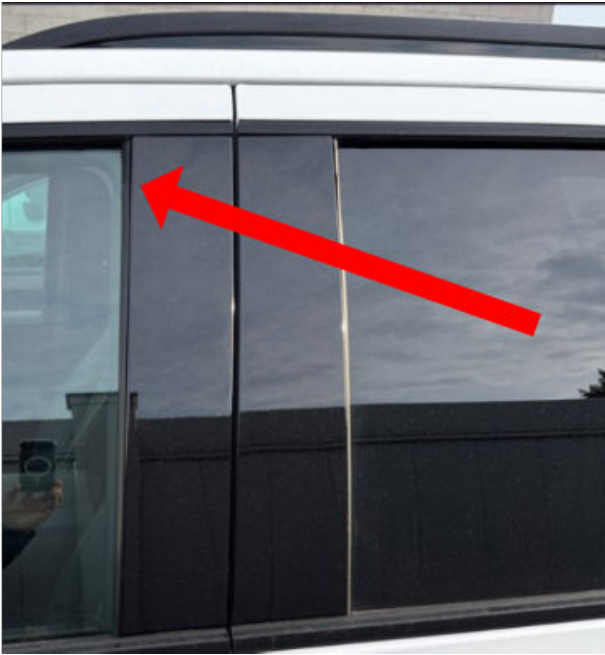
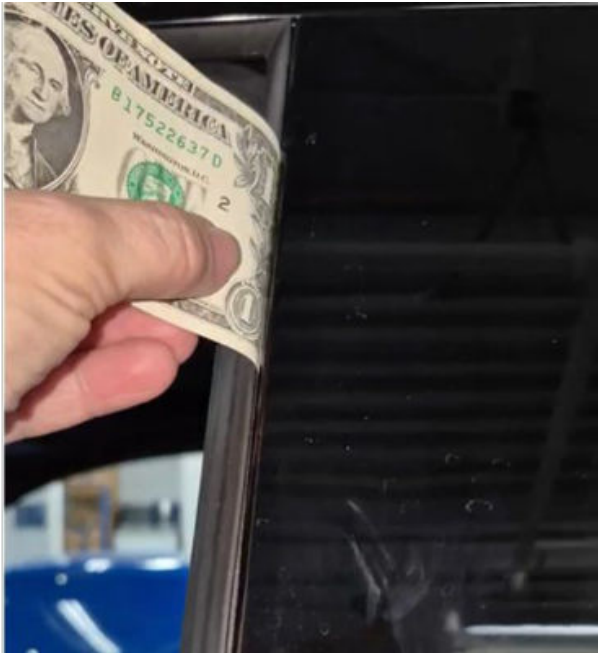
| Cause | The cause may be a gap between Front Side Door Window Frame Rear Applique and the Front Side Door Window Weatherstrip/Glass run channel (as shown below) |

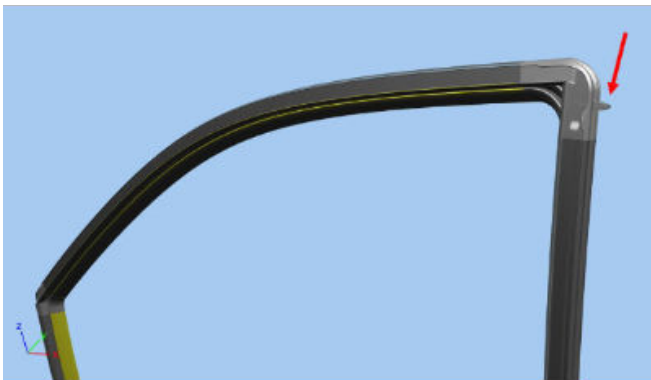
7111709

2. Ensure that the Front Side Door Window Weatherstrip is fully seated into the door metal run channel and that the rear upper molded-in alignment pin is fully seated into the square hole at the rear of the upper door opening (as shown below.) If the rear upper molded-in alignment pin is not seated in the hole or the weatherstrip is not fully seated in the channel, it will push the window weatherstrip forward creating a large gap between the weatherstrip and applique.

If weatherstrip or rear upper molded-in alignment pin is not fully seated, remove and reinstall the window weatherstrip

Reinstall the weatherstrip making sure the rear upper molded-in alignment pin is fully seated in the square hole in the door and that the weatherstrip is fully seated into the door metal run channel.
