## Clattering Sound at Seatbelt Height Adjuster in B-Pillar Trim (SA Code 581)

Topic number	LI68.30-P-080466
Version	1
Function group	68.30 - Coverings, trim
Date	4/23/26
Validity	Applies to BR 214 vehicles with SA code 581 (THERMO-TRONIC automatic climate control) since SOP
Reason for change

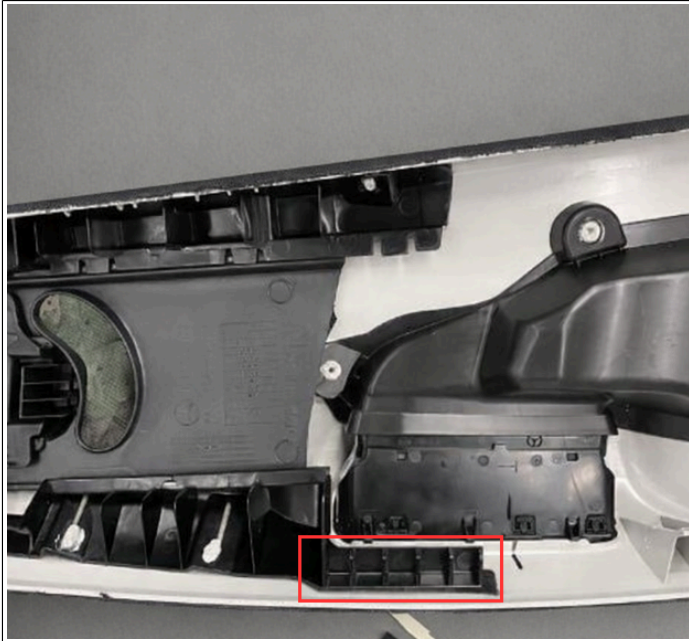
Attachments	
File	Description
<a href="#">BR214_B-Säule_Filz_581_1.png</a>	Substructure

Play between substructure and B-pillar trim

- 1) Lift the substructure (black).
- 2) Install the felt lengthwise below the substructure on the B-pillar trim.

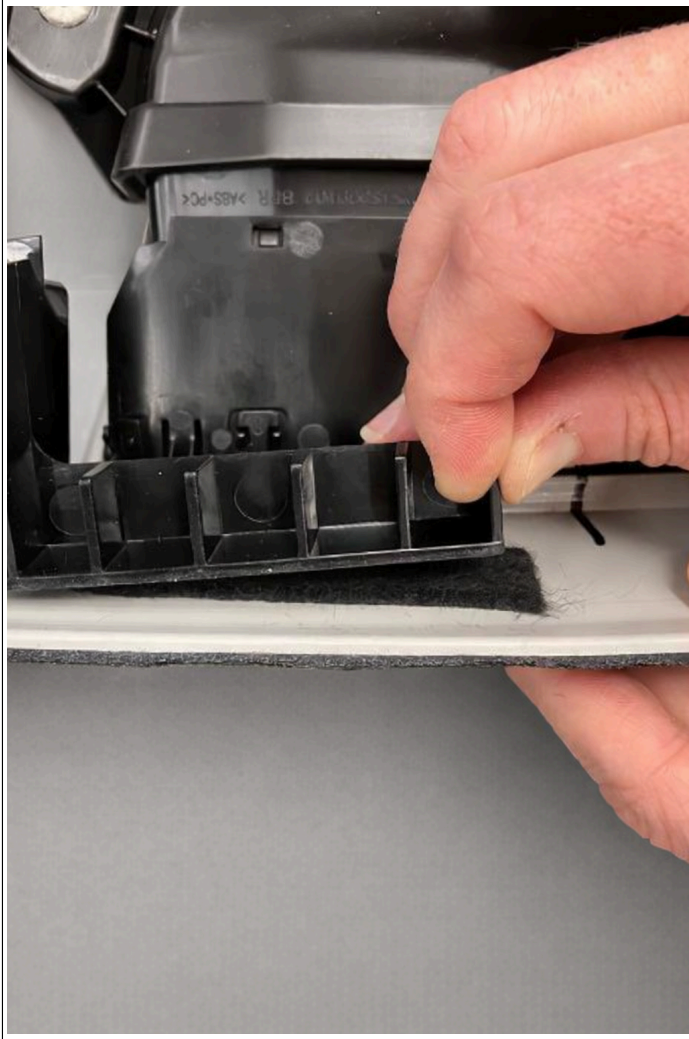
BR214\_B-Säule\_Filz\_581\_2.png

Position of felt

Installing a 70x15x3 mm felt strip next to the air duct under the substructure.

The felt must be installed as far under the substructure as possible.
