SIB 51 06 26

NOISE COMING FROM TAILGATE TRIM PANELS

E-Series	Model Description
G26	4 Series Gran Coupe, including i4 Battery Electric Version (BEV)

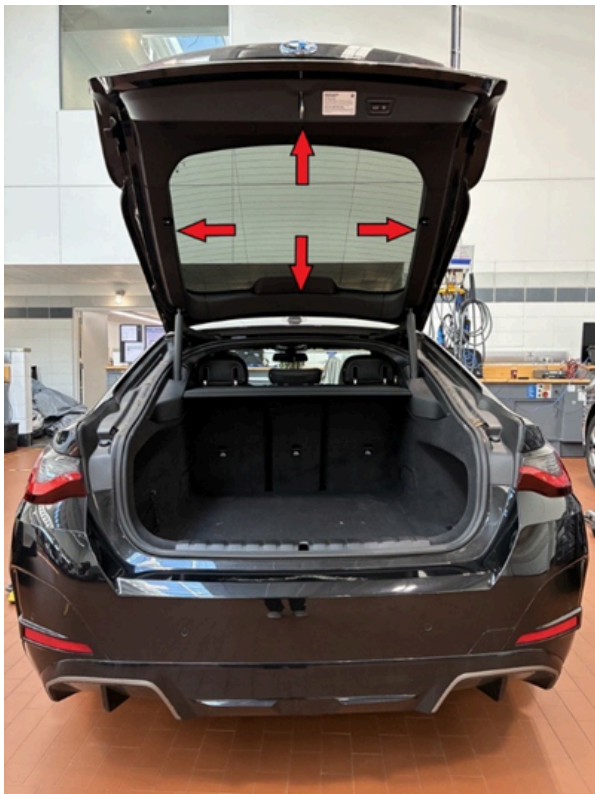
While driving on rough surfaces, a “tapping” noise can be heard from the tailgate area (arrows).

Over time, the clips on the tailgate trim panels develop excessive play.

Replace the white-colored clips with updated blue clips.
