SIB 61 02 26

SERVICE ACTION: RETROFIT WAKE-UP LINE TO ALEA MODULE

2026-04-23

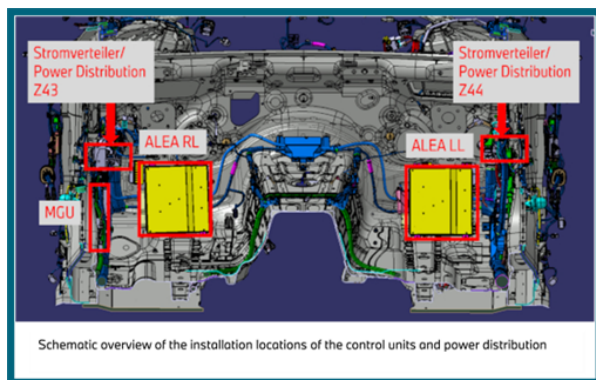
This shows the location of all the components involved.

Please note that left-hand drive and right-hand drive components are shown all together in the same picture, even though in the actual vehicle, only the applicable components for the drive version will be installed.
