SIB 61 06 26

BEV HV CHARGING NOT POSSIBLE, CHARGING SOCKET WHITE LED ON, NO FAULTS STORED
2026-04-22

E-Series	Model Description
G26	i4 Gran Coupe (Battery Electric Vehicle (BEV))
G60	i5 Sedan BEV
G70	i7 Sedan BEV
i20	iX Sports Activity Vehicle (SAV, BEV)

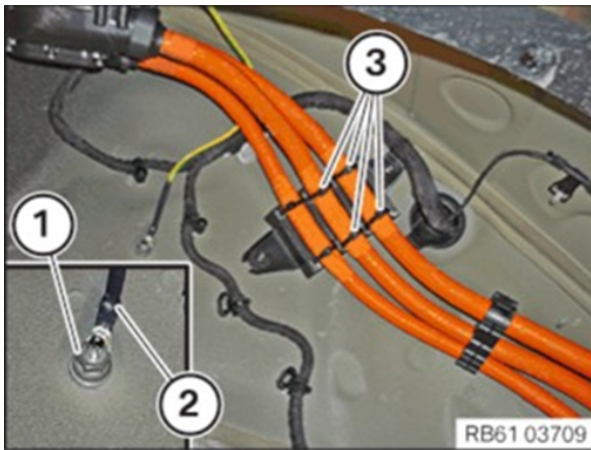
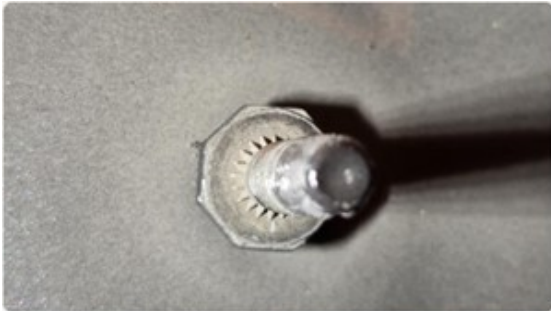
1. Unfavorable high-voltage charging socket PE (Protective Earth = protective ground) pin grounding wire connection at vehicle body contact point.
2. Unfavorable Control Pilot (CP) or Proximity Pilot (PP) low voltage signal connection.
3. Worn contact pins in the charging socket or charging station charging plug.
4. Charging plug is not correctly connected to the vehicle.

Right rear fender well view of HV charging socket wiring - PE grounding wire connection point to body (1 and 2) highlighted.

1. Gain access to the high-voltage charging socket grounding point under the right rear inner fenderwell – **(BEV) REP-REP-P-5171041**.
2. Disconnect the PE grounding wire connection point from the high-voltage charging socket on the vehicle body (see items 1 and 2 in the example illustration).
3. Clean the M6 bolt and grounding point body contact surface, as well as the M6 nut and wire terminal contact surface with a suitable wire brush or similar (e.g. abrasive pad).
4. Reassemble the PE grounding wire to the clean grounding point.
5. Torque the M6 nut to 8 Nm (class A threaded connection).
6. Follow the “four-eyes” work verification principle, the grounding point must be checked by a high voltage trained technician. See **Form for potential equalization screw connections REH-HIN-P-0001-1 - V.3**
7. Perform a charging test at a high-power charging station / DC charging station.

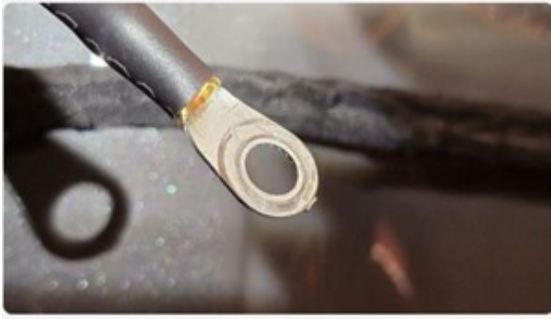
Any paint found on the PE grounding point must be cleaned to restore proper connection.

Perform a follow-up charging test at a high-power charging station / DC charging station operational check.

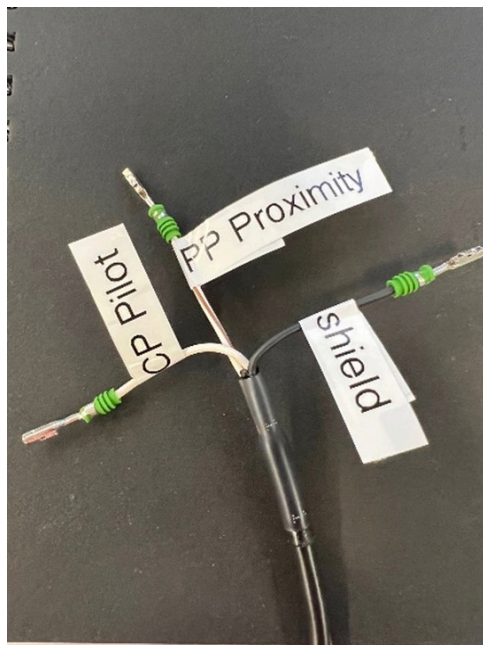
Photo shows CP/PP harness view from the Charging Socket 12 V connector

The Control Pilot (LD_CP), Proximity Pilot (LD_PP) signals and shielding wire (are bundled together in the CP/PP harness). The shield wire has a connection to body ground.

These signal lines should be insulated from each other the entire length of the CP/PP harness from the Charging Socket 12V pin connector to the corresponding CCU 12V pin connector.

Make sure the harness is not pinched, frayed or the shrink tubing at both ends damaged in any way.

Note: These signals should NOT be shorted to each other or to ground through the shielding wire of the CP/PP harness or to the vehicle body or the signal will be lost.

Test for signal lines integrity, there should be uninterrupted continuity from Charging Socket to CCU.

- Pin 4 to 18 should be 0 Ohms
- Pin 9 to 19 should be 0 Ohms
- Pin 8 to 31 should be 0 Ohms

Test for short circuits between signal lines from the CCU 12 V connection.

- Pin 18 to 31 should be OL
- Pin 19 to 31 should be OL
- Pin 18 to 19 should be OL

- Pin 4 to 8 should be OL
- Pin 4 to 9 should be OL
- Pin 8 to 9 should be OL

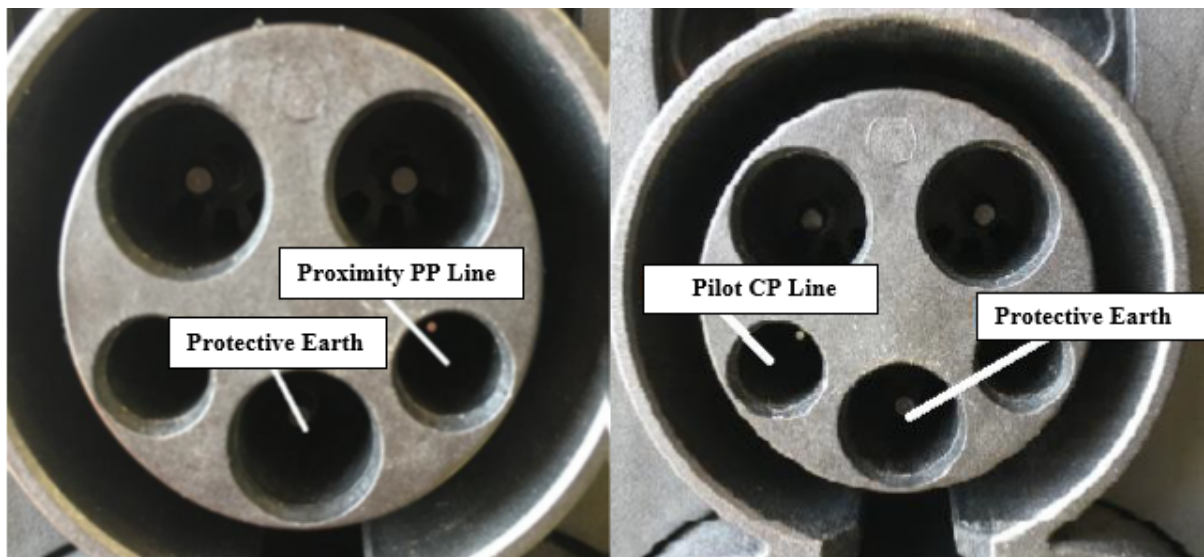
Hint: High voltage charging socket pin connection view (CP, PP, PE pin connections are labeled)
