SIB 61 10 26

009CBB - SHORT CIRCUIT IN THE FOOTWELL MODULE (FRM)

2026-04-23

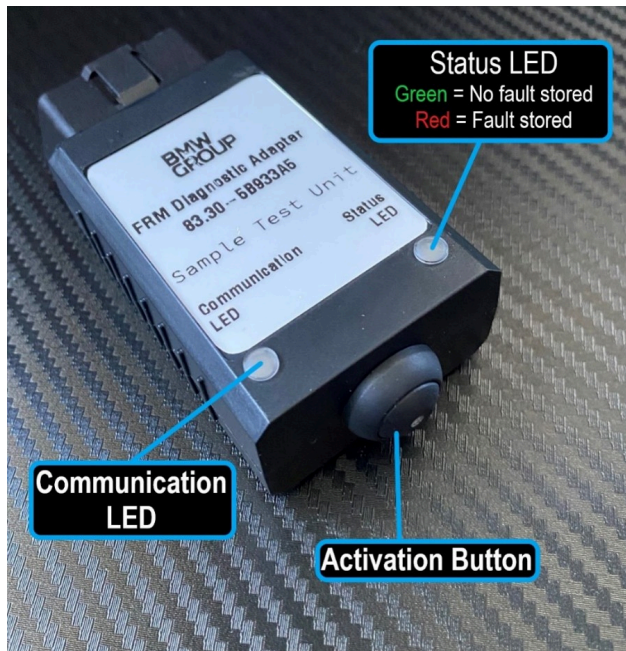
1. Exit the test plan.
2. Disconnect the ICOM from the Connection Manager and remove the (OBD-II) On-board Diagnostics connector from the vehicle.
3. Insert the FRM dongle (**5B933A5**) into the vehicle's OBD-II port.
  - The Communication LED will light solid “**blue**”.
4. Activate Terminal 15 by inserting the vehicle key and turning the ignition ON.
  - The Communication LED will begin flashing slowly “**blue**”.

If the **blue** "Communication LED" stays solid and **does not flash** after Terminal 15 activation, please refer to the troubleshooting section below.
