SIB 32 01 23

CRACKING/CREAKING NOISE FROM FRONT AXLE/STEERING SYSTEM

2026-04-06

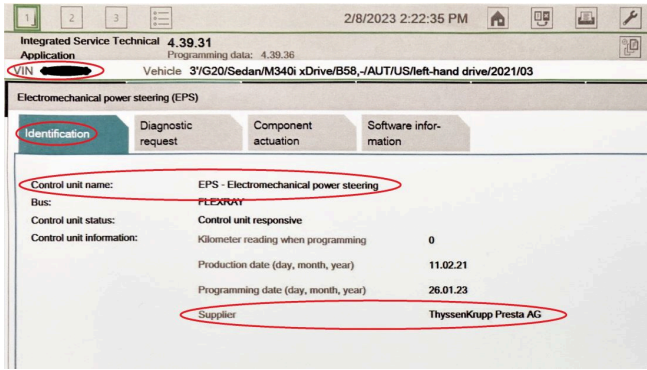
1. Verify a TKPS EPS is installed via ISTA control unit functions (G20, G22, G23, G26 and G42 only).
