TO: Mercedes-Benz Dealer Principals, General Managers, Service Managers, Warranty Administrators and Bookers	FROM: Joe Haller, Department Manager, Warranty Greg Gunther, Department Manager, Vehicle Compliance & Analysis
RE: Extended Warranty – Accelerator Pedal Wiring Harness Various Models (see provided list)	Updated: August 5, 2022

IMPORTANT EXTENDED WARRANTY INFORMATION

SUBJECT: **Model E-Class and GLC-Class (213, 238, and 253 platform)
Model Year 2016-2019**

Accelerator Pedal Wiring Harness

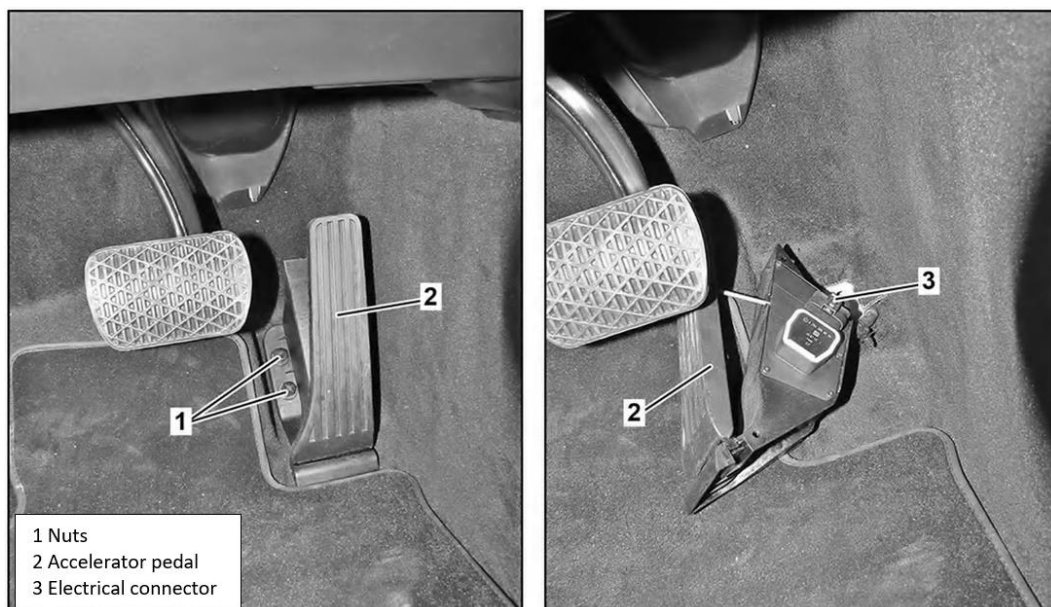
Mercedes-Benz AG (“MBAG”), the manufacturer of Mercedes-Benz, has determined that on certain Model Year (“MY”) 2016-2019 E-Class (213, 238 platform) and GLC-Class (253 platform) vehicles, the electrical wiring and plug connection on the accelerator pedal may not meet current production specifications.

1. Switch off ignition and store transmitter key outside of transmission range (min. 2 m).
2. Unscrew nuts (1), remove accelerator pedal (2) and place to one side.
Note: Nuts torque 8Nm.
3. Disconnect electrical connector (3).
4. **Model 213 and 238:** Replace the connector wire to the accelerator pedal sensor (B37) using the wiring harness repair kit and cable connector (see parts table).

Model 253: Replace the female contacts at the connector wire of the accelerator pedal sensor (B37). These could be female contacts of the contact family MLK 1.2, which must be replaced by female contacts of the contact family MCP 1.2 (see parts table). The coupling housing is suitable for both families of female contacts and can be reused.
