TECHNICAL SERVICE BULLETIN

Fuel Filling Concerns, Hard Start/Extended Crank, And/Or Engine Stalls After Start

26-2184

22 April 2026

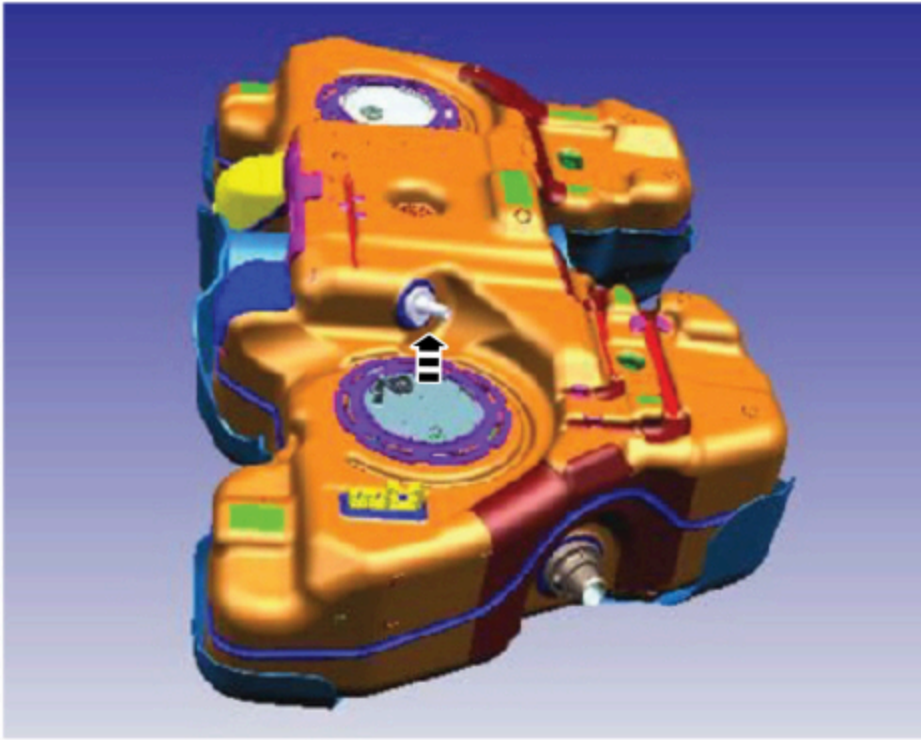
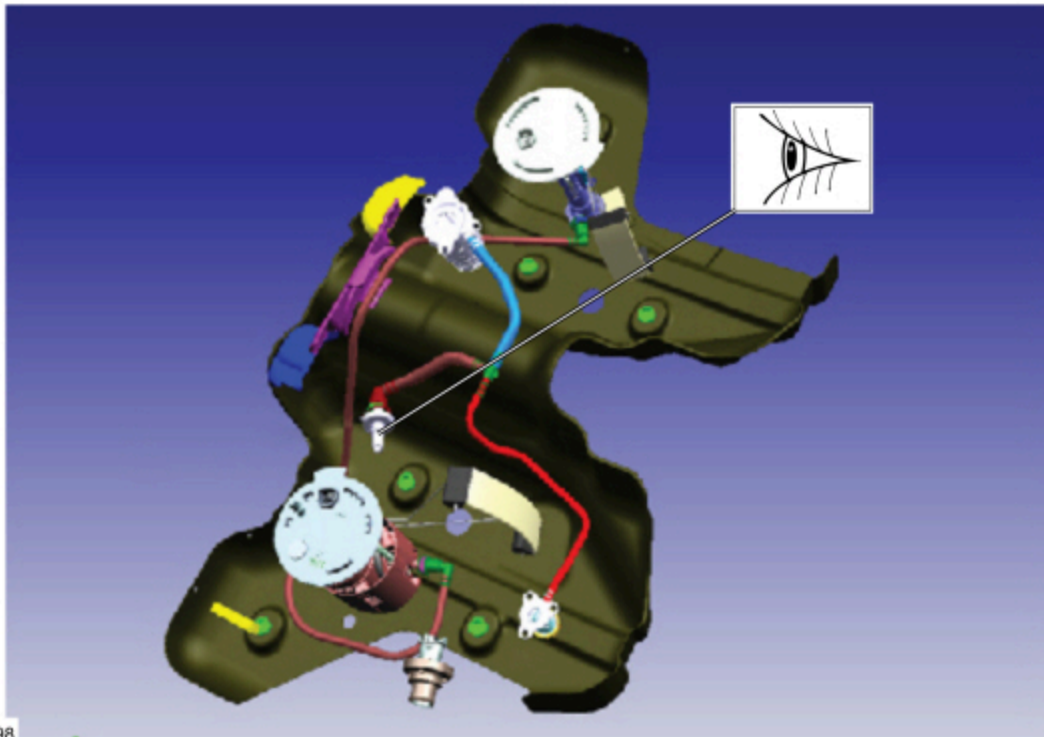
1. Remove the fuel tank. Refer to the WSM, Section 310-01A.
2. Remove the fuel pump and sender unit. Refer to the WSM, Section 310-01A.
3. Inspect the inside of the tank for a disconnected fuel vapor hose. (Figures 1-2)

4. Is the fuel vapor hose disconnected?

(1). Yes - reattach the hose. Proceed to Step 5.

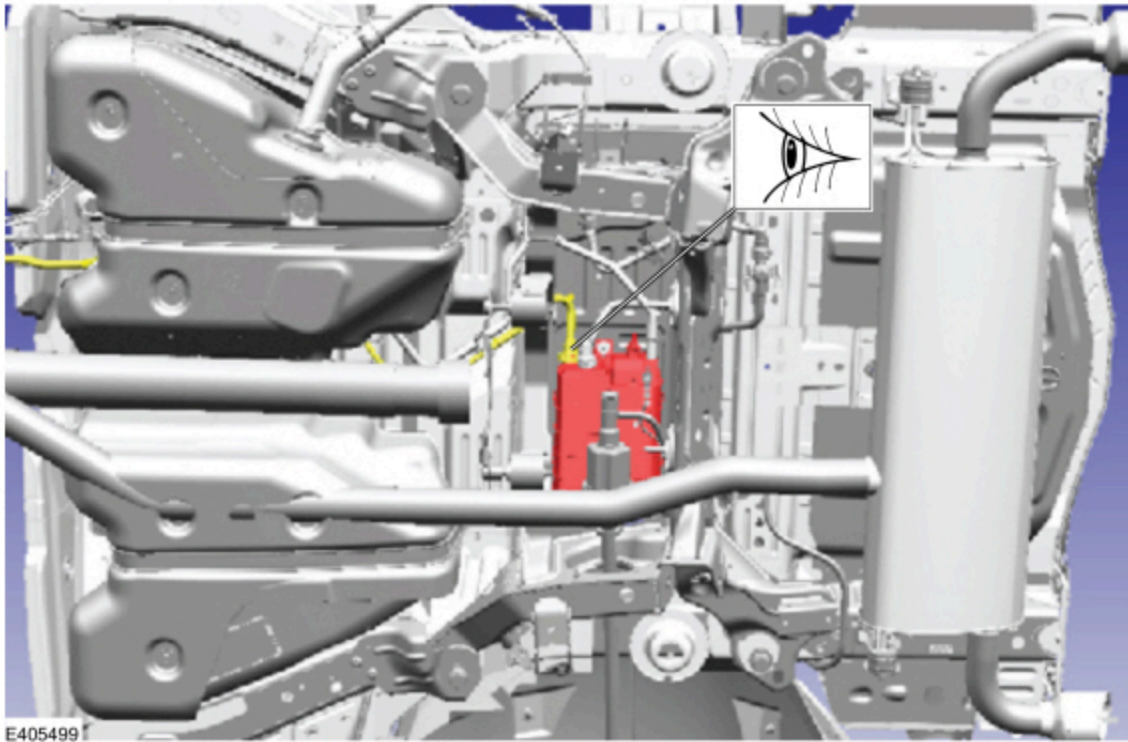
Figure 3

5. Disconnect the vapor line quick connector at the EVAP canister and inspect for signs of liquid fuel contamination. Is liquid fuel contamination present? (Figure 3)

(1). Yes - replace the EVAP canister. Refer to WSM, Section 303-13A. Proceed to Step 6.

(2). No - reattach the vapor line quick connector. Proceed to Step 6.
