A 205 A238 - Replacement of Soft Top Cords on Interior Trim / Roof Liner

Topic number	LI77.30-P-070145
Version	3
Function group	77.30 - Vario roof, soft top - complete
Date	4/28/26
Validity	Affected model designations 2054**, 2384**
	Only vehicles up to production period 30.04.2020 can be affected
Reason for change	WIS document AR77.33-P-2500LWR replaces WIS document AR68.30-P-4303-01LWR

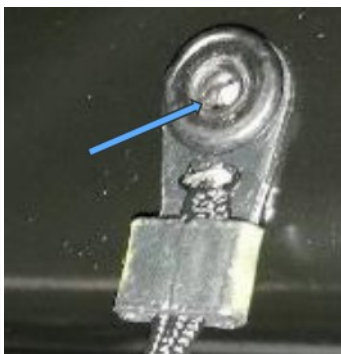
Abb.6.jpg

Illustrates a riveted fastening of the eyelet

2.) Cut off the fastening rivets/eyelets:

- See Fig. 6 - Illustrates a riveted fastening of the eyelet. See also document AR77.33-P-2500LWR - Remove/install tensioning cables of the headliner.

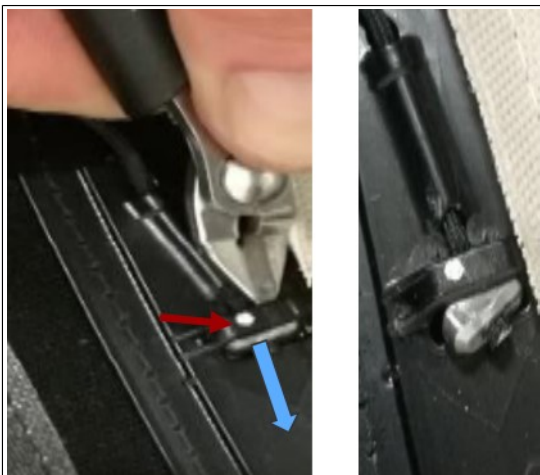
Abb.7.jpg

Illustrates the receptacle/ roof lining clamping ring

3.) Press the clamping ring connection out of the receptacle in the soft top interior trim:

- See Fig. 7 - Illustrates the receptacle/clamping ring of the soft top interior trim.

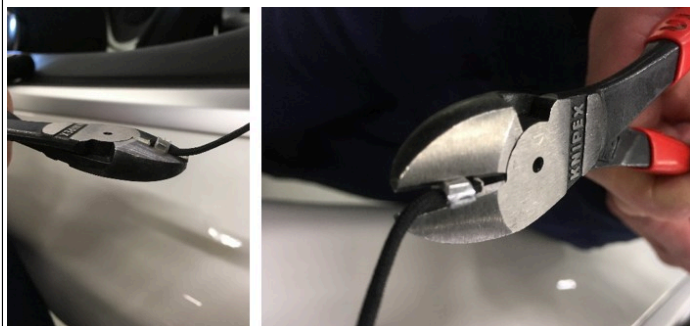
Abb.8.jpg

Separating the clamping ring connection using side cutting pliers

4.) Cut/remove the clamping ring connection from the cord using side cutting pliers:

- See Fig. 8 - Separating the clamping ring connection using side cutting pliers.
