Technical Service Bulletin (TSB)
Loss Of Cabin Heating

REFERENCE:	TSB: 08-171-26 GROUP: 08 - Electrical	Date:	April 21, 2026	REVISION:	—
VEHICLES AFFECTED:	<p>2025 - 2026 (D2) RAM 3500 Pickup 2025 - 2026 (DD) RAM 3500 Cab Chassis 2025 - 2026 (DJ) RAM 2500 Pickup 2025 - 2026 (DP) RAM 4500/5500 Cab Chassis This bulletin applies to vehicles built on or before November 24, 2025 (MDH 1124XX).</p>	MARKET APPLICABILITY:			
		<input checked="" type="checkbox"/> NA <input type="checkbox"/> MEA <input type="checkbox"/> SA <input type="checkbox"/> IAP <input type="checkbox"/> EE <input type="checkbox"/> CH NOTE: This bulletin applies to North America markets.			
CUSTOMER SYMPTOM:	<p>Customers must experience a Malfunction Indicator Lamp (MIL) illumination and the vehicle must exhibit/set one or more of the following Diagnostic Trouble Codes (DTCs):</p> <ul style="list-style-type: none"> • U0615 - Lost Communication With Engine Coolant Bypass Valve "A". • U11E9 - Lost Communication With AGS. <p>Customer may also comment on the following:</p> <ul style="list-style-type: none"> • Loss of cabin heating.

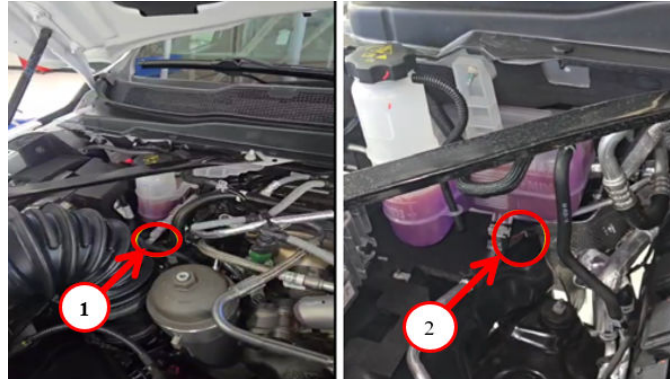
Fig. 1

D1673A Wire Harness Connector Location

1- Gasoline Engine
2 - Diesel Engine

1. Remove the front right wheelhouse splash shield. Refer to the detailed service procedures available in DealerCONNECT/Service Library under: Service Info> 23 - Body / Exterior / Shield, Splash, Front Wheelhouse / Removal.
2. Locate wire harness connector D1673A, which is a four way female connector underneath the coolant bottle Fig. 1.

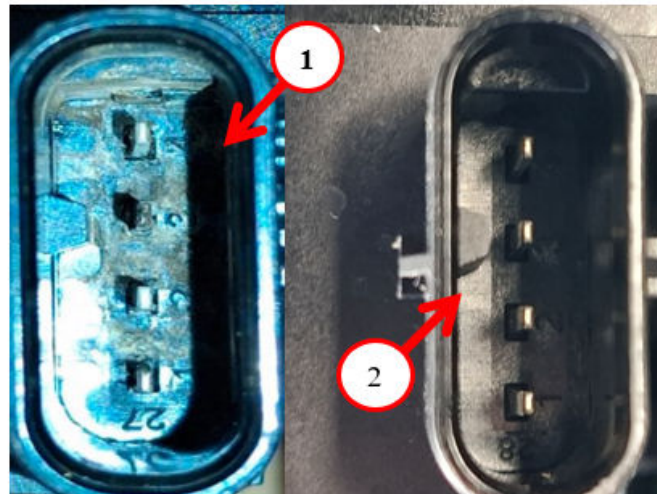
Fig. 2

CAUSE:	Connector contamination

3. Disconnect the D1673A wire harness from the coolant 3 way valves wire harness connector.
4. Inspect the wire harness connector terminals for evidence of corrosion Fig. 2.

Wire Harness Connector Contamination Inspection

1 - Contaminated Wire Harness Connector
2 - Uncontaminated Wire Harness Connector

5. Is there evidence of corrosion in the coolant 3 way valves wire harness connector?
 - YES>>> Proceed to [Step 7](#).
 - NO>>> Proceed to [Step 6](#).

7. Replace the coolant 3 way valve. Refer to the detailed service procedures available in DealerCONNECT/ Service Library under: Service Info> 09 - Engine, 6.4L / Engine Cooling / Valves / Removal and Installation.
8. Replace the coolant 3 way valve connector with pig tail.
9. Install the front right wheelhouse splash shield. Refer to the detailed service procedures available in DealerCONNECT/Service Library under: Service Info> 23 - Body / Exterior / Shield, Splash, Front Wheelhouse / Installation.
10. Clear DTCs.

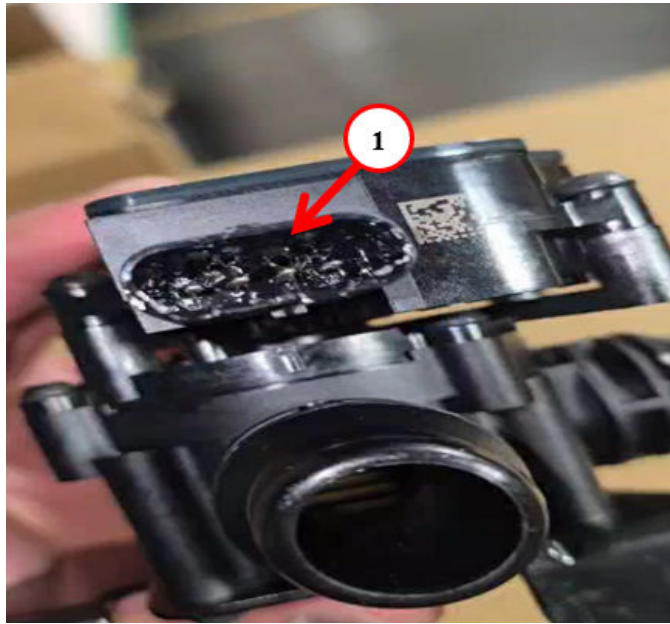
Fig. 3
Coolant 3 Way Valve Wire Harness Connector

1 - Apply Grease To The Coolant 3 Way Valve Wire Harness Connector

6. Apply one gram of dielectric grease NYOGEL 760G to the wire harness connector header at the bottom of the coolant 3 way valve while making sure that the grease is spread along the connector and its cavities [Fig. 3](#) and then proceed to [Step 9](#).
