STAR ONLINE PUBLICATION

Case Number: S2608000022

Symptom/Vehicle Issue: Red Turtle Mode Warning Light Illuminated In The Cluster When Gear Selector Is Shifted Into Drive Or Reverse. Speed Limited To 10 MPH

2025-2026 Jeep Wagoneer S (KM)

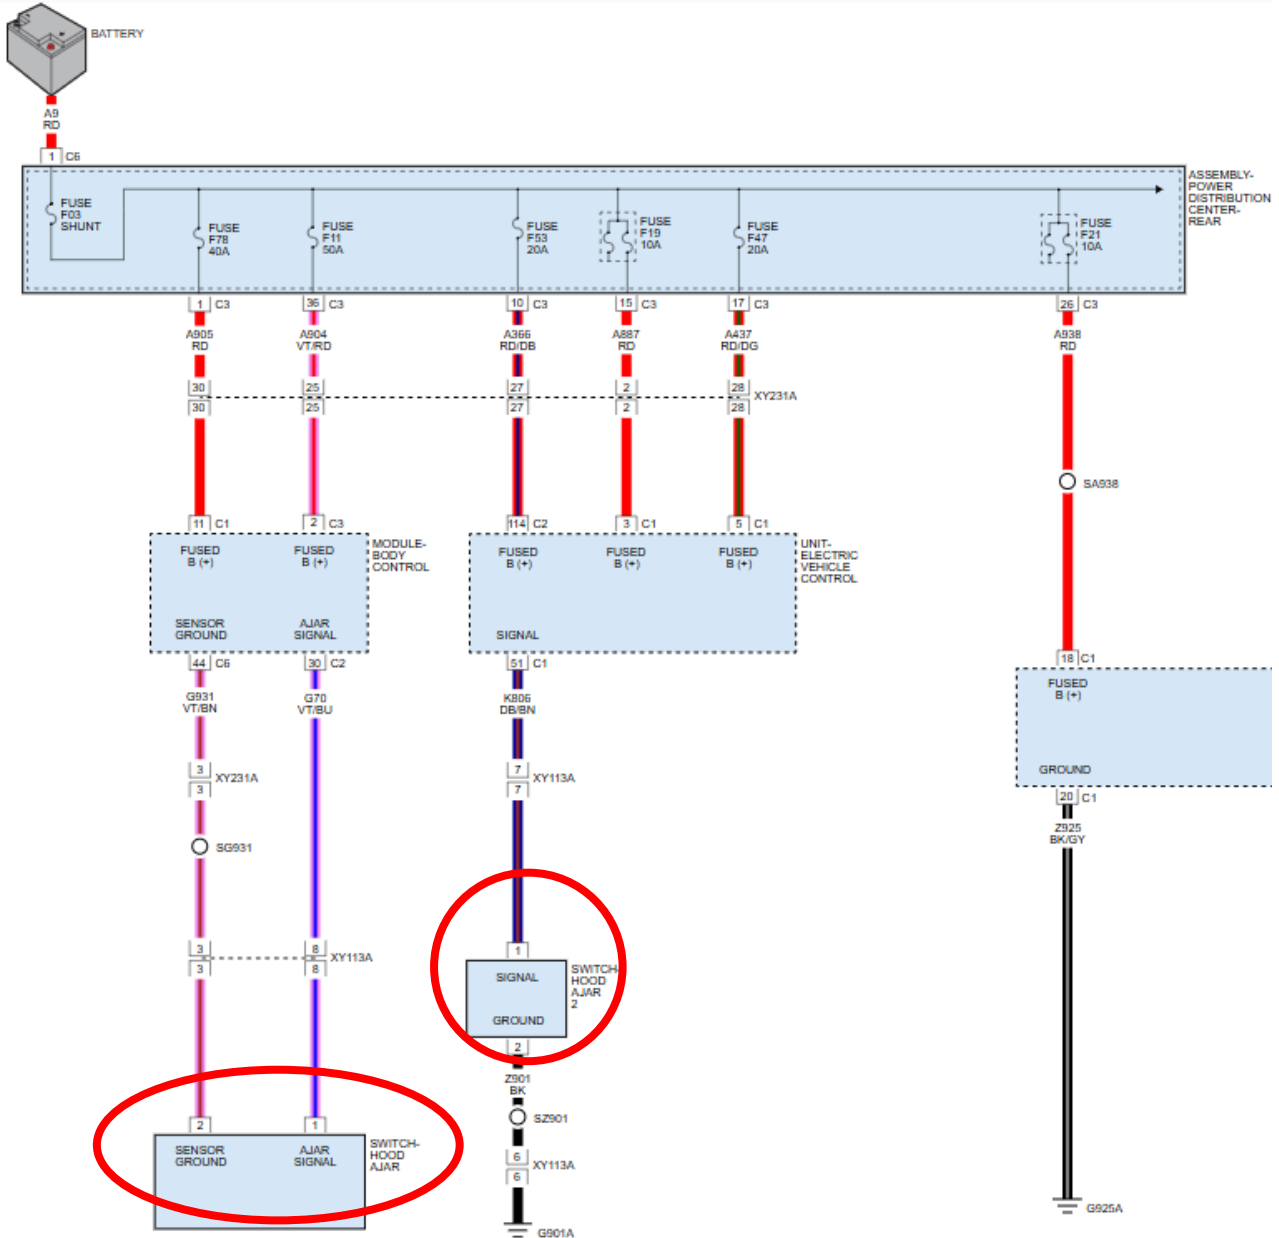
Frunk (Hood Ajar) Switches

The Front Trunk (Frunk) which takes the place of the conventional hood, utilizes two separate ajar switches. They are currently labeled in wiring diagrams as “Switch – Hood Ajar” which provides a direct input to the Body Control Module (BCM) and “Switch – Hood Ajar 2” which provides a direct input to the Electric Vehicle Control Unit (EVCU).

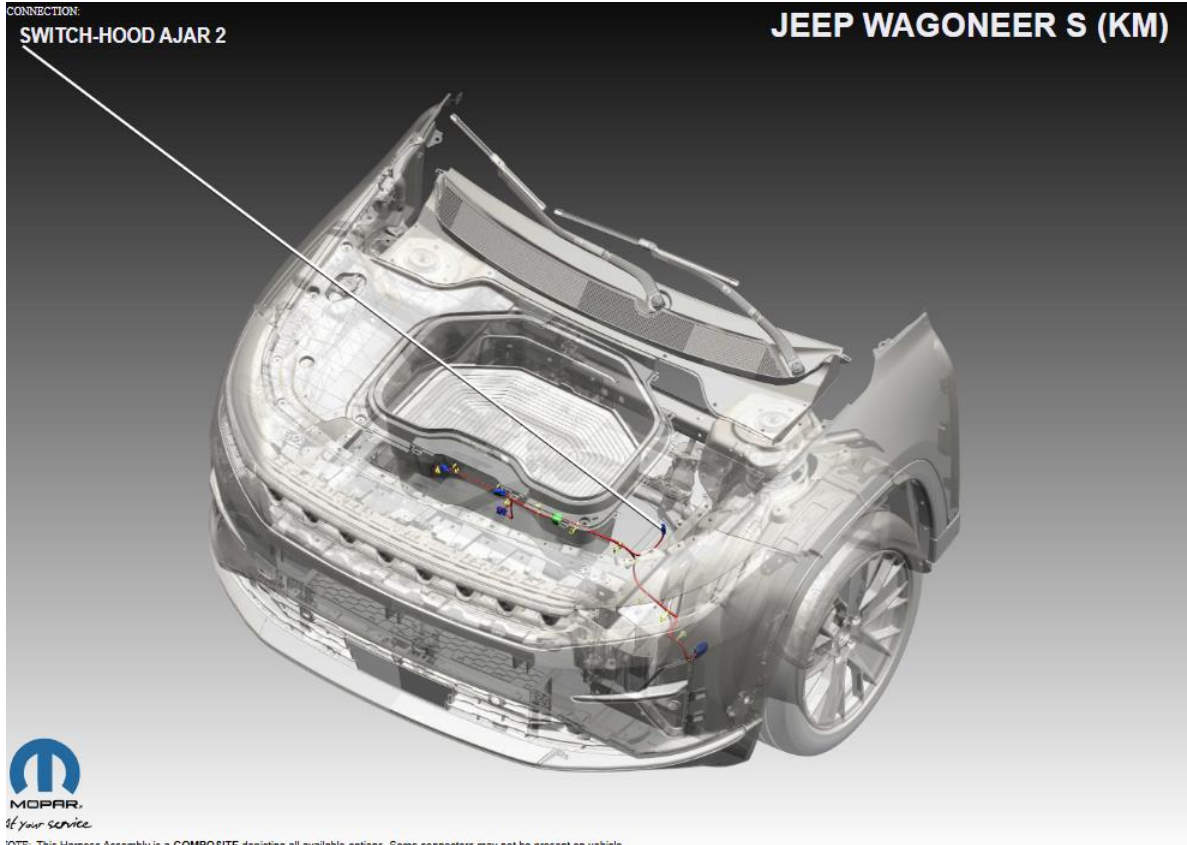
Hood Ajar Switch 2 Location

The customer concern described may be related to Hood Ajar Switch 2. If the EVCU believes the Frunk/Hood is open, it will command the red turtle warning light on and limit vehicle speed. This condition will not set any DTCs.

First, visually inspect Hood Ajar Switch 2 to see if it’s recessed in the housing or out of place, not allowing the Frunk/Hood to physically depress the plunger in order to change the voltage/status. If necessary, compare the installed height of the switch to a known-good vehicle. It is possible that the switch or its mounting clips have become damaged, not allowing the switch to be retained in the correct position.

Repair: If you find that Hood Ajar Switch 2 mounting is compromised. Determine if the switch or housing is damaged. Replace components as necessary. If a connector issue is found at the XY113A, repair using standard procedures.
