## STAR ONLINE PUBLICATION

**Case Number:** S2102000004 Rev. C

**Symptom/Vehicle Issue:** WL Front Control Arm Bushing - Handling Link Has Loose Rubber Appearance

**Models Affected:** 2021-2026 Jeep Grand Cherokee (WL)

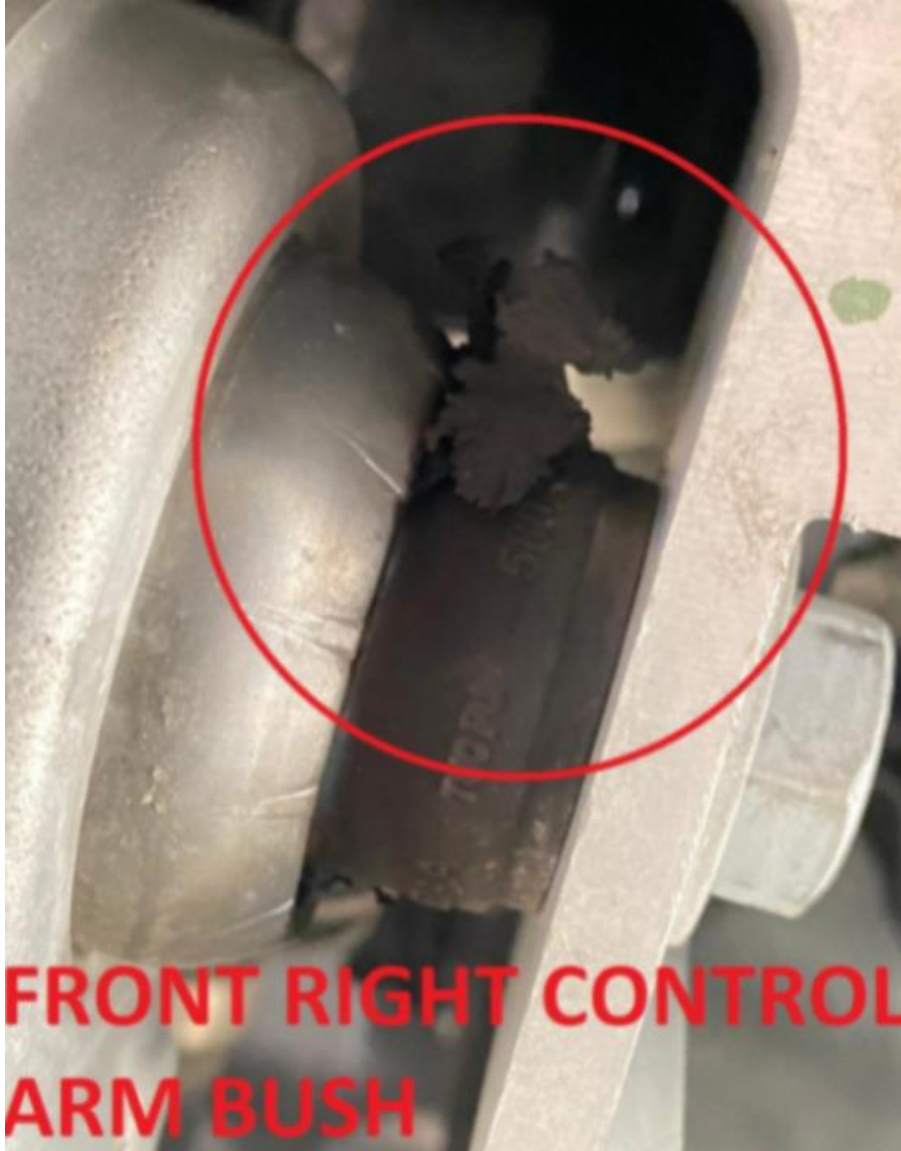
**Discussion:** The outer bushing sleeve has a rubber layer as part of the manufacturing process and is not an “active” part of the bushing. If the rubber from this outer surface has separated it does not require repair or control arm replacement. The condition does not affect the bushing operation or vehicle handling. See the image below.

Front Control Arm Bushing.  
Condition present is deemed normal. No repair necessary.
