STAR ONLINE PUBLICATION

Case Number: S2308000034 Rev. B

Symptom/Vehicle Issue: No Wireless Charging Or Slow Wireless Charging

Models Affected:

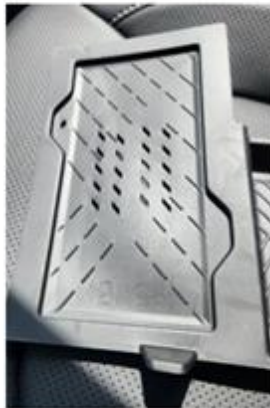
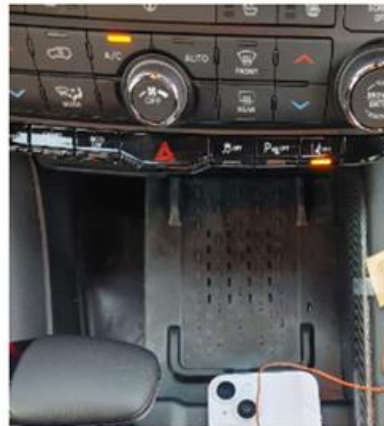
Example Of FAN Integrated Chargers (notice ventilation holes)

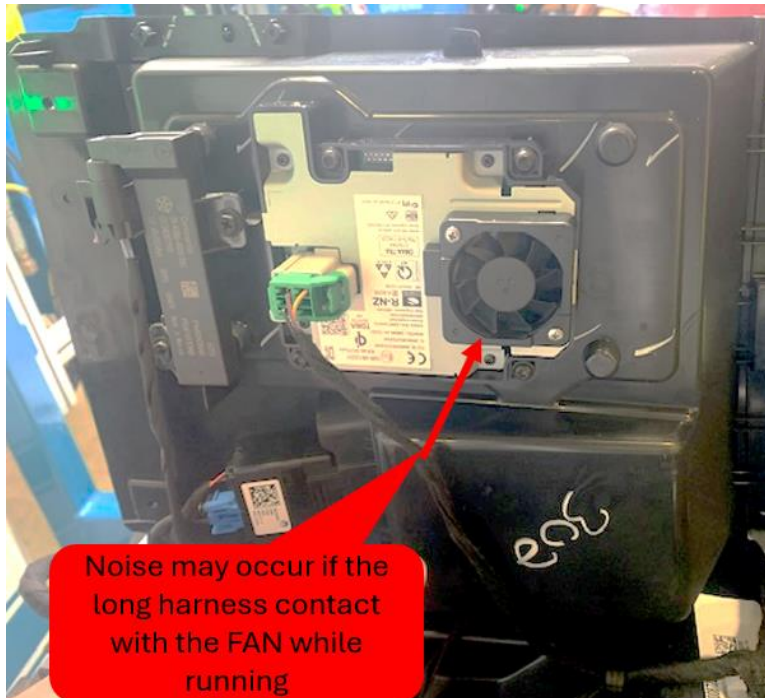
Underside of Wireless Charging Pad

Abnormal Fan Noise

The customer may observe buzzing, whining or similar noise when the wireless charging pad is activated. This may be caused by misrouting of the wiring harness underneath the charging pad allowing it to contact the fan blades, creating an abnormal noise anytime the fan is in operation.

This concern has been most observed on DT and RU.

If the only customer concern is noise, remove the wireless charging pad and inspect harness routing. Re-position the harness as necessary to avoid allowing the harness to contact the fan blades.

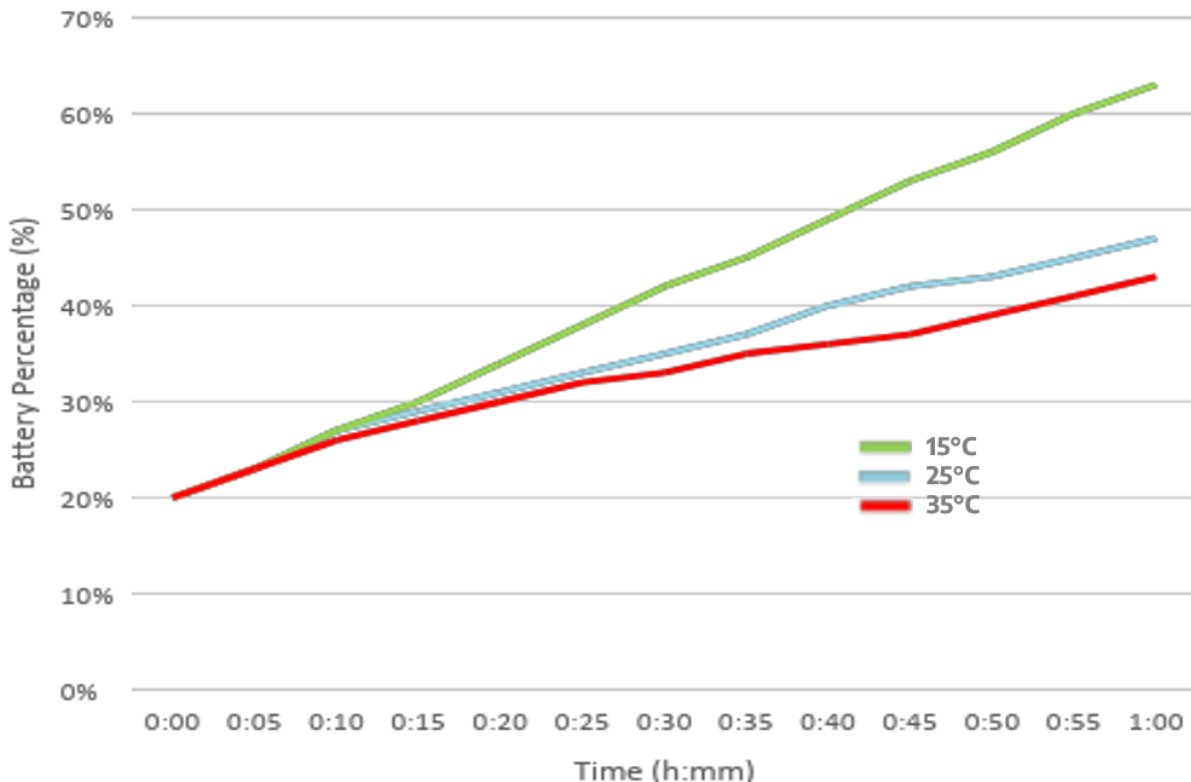
Performance Samsung S21

For situations where higher temperatures may be a factor, charging speed may slow or completely stop. To begin charging again it is necessary to cool down the phone and/or the ambient temperature around the wireless charging pad.

1. When ambient temperature increases from 15°C (59°F) to 35°C (95°F):
 - Samsung Galaxy S21 device's charge percentage decreased by ~ 26%
 - iPhone 12 Pro max device's charge percentage decreased by ~ 41%

Example: Samsung S21 Battery Charge Rate At Different Ambient Temperatures

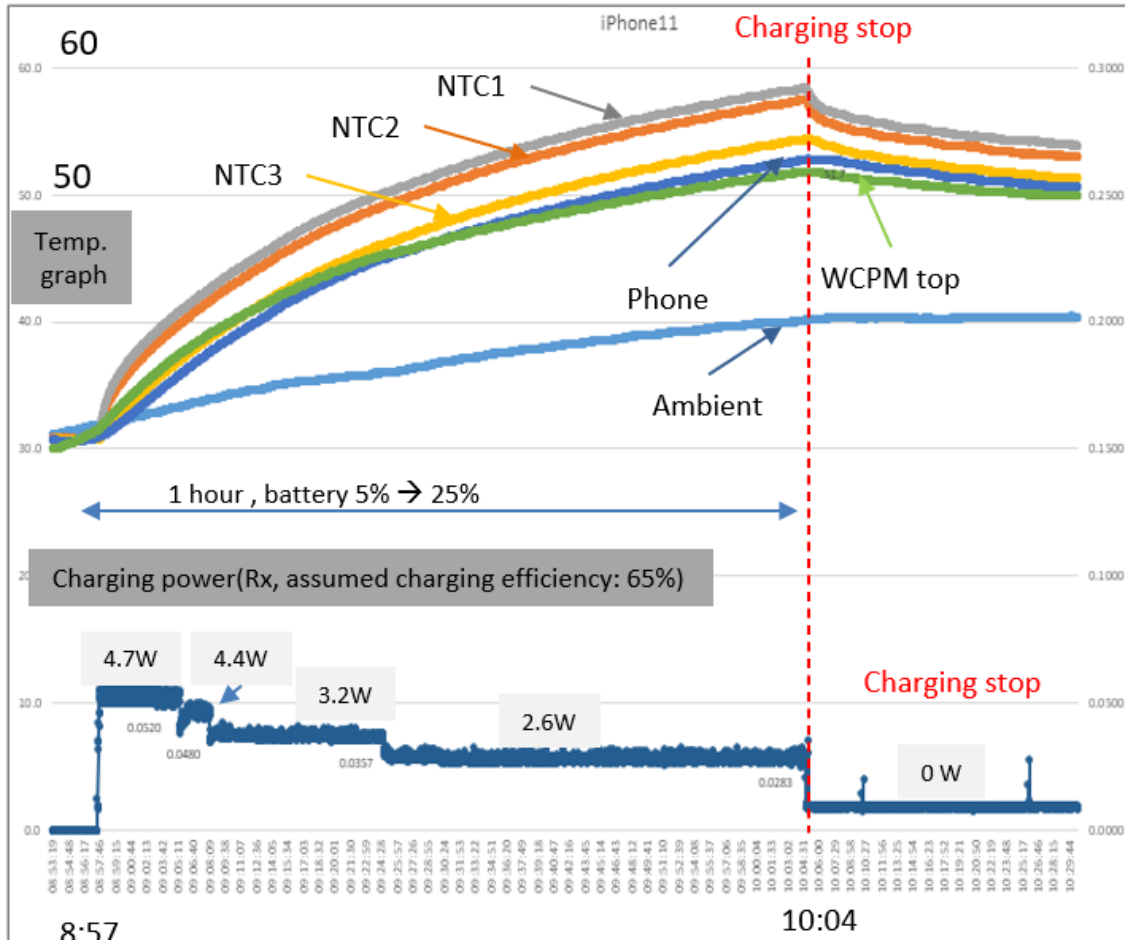
- As the Phone temperature rises, the phone reduces the charging power and stops charging by itself when the temperature rises above 45°C (each phone has a different stop charging temp)

Example: iPhone11 Battery Charging Vs Phone Temperature
