STAR ONLINE PUBLICATION

Case Number: S2609000006

Symptom: P000B Bank 1 Cam 2 Position Slow Response - Malfunction Indicator Light (MIL) - Check Engine Light (CEL)

Models Affected:

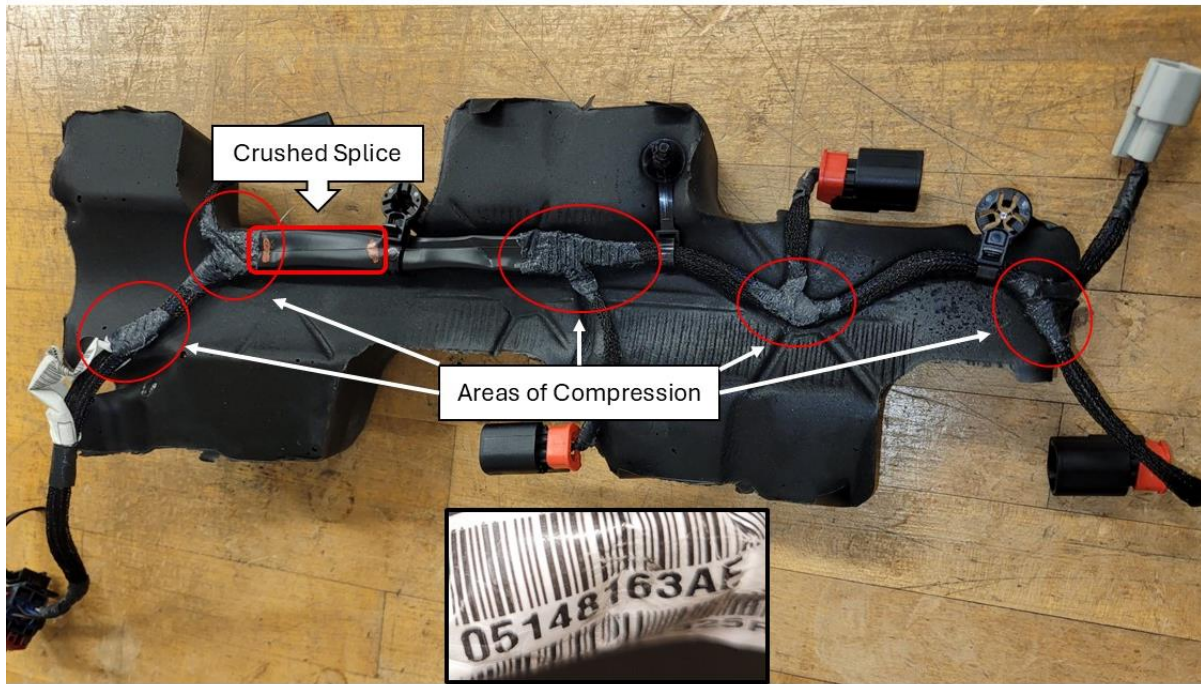
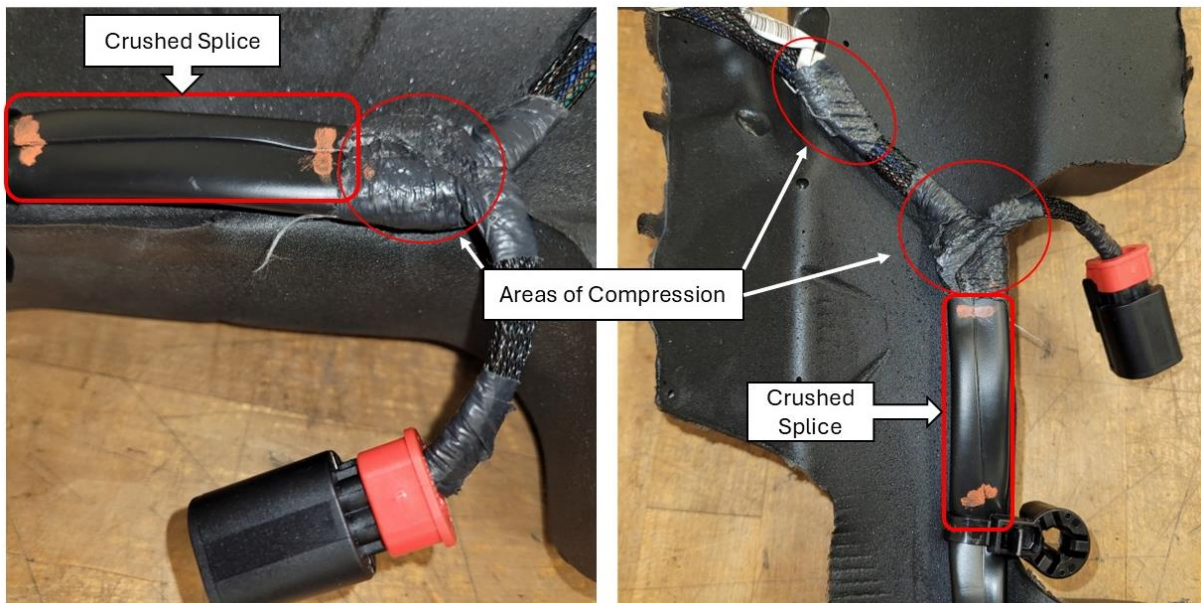
Vehicle Issue: The Intake Air Flow Module (IAFM) Foam Engine Valley Cover, PN 53013735AB, does not allow for sufficient routing of the MDS solenoid jumper harness PN 05148163AE. The wire harness is being compressed by foam.

Technician Observation: Technician observed intermittent open in MDS solenoid jumper harness PN 05148163AE. The technician found one or more of the following Diagnostic Trouble Codes (DTCs) have set on the vehicle:

Discussion: Inspect vehicle for DTC's and determine if any of the listed faults are stored or active in the system. If it is found that one of these DTC's are present, inspect the MDS solenoid jumper harness PN 05148163AE for an intermittent open connection along the harness. Test continuity between the harness to ensure proper connection within the harness. If there is an intermittent open connection, the MDS solenoid jumper harness must be replaced.
