# TECHNICAL SERVICE BULLETIN

Classification: EL26-003	Reference: NTB26-016	Date: March 30, 2026
-----------------------------	-------------------------	-------------------------

## DEFROST FEATURES UNAVAILABLE IN APP DUE TO SHORTING TERMINAL POSITION

**APPLIED VEHICLES:** 2026 LEAF (ZE2)  
**APPLIED DATES:** Built on or before August 14, 2025

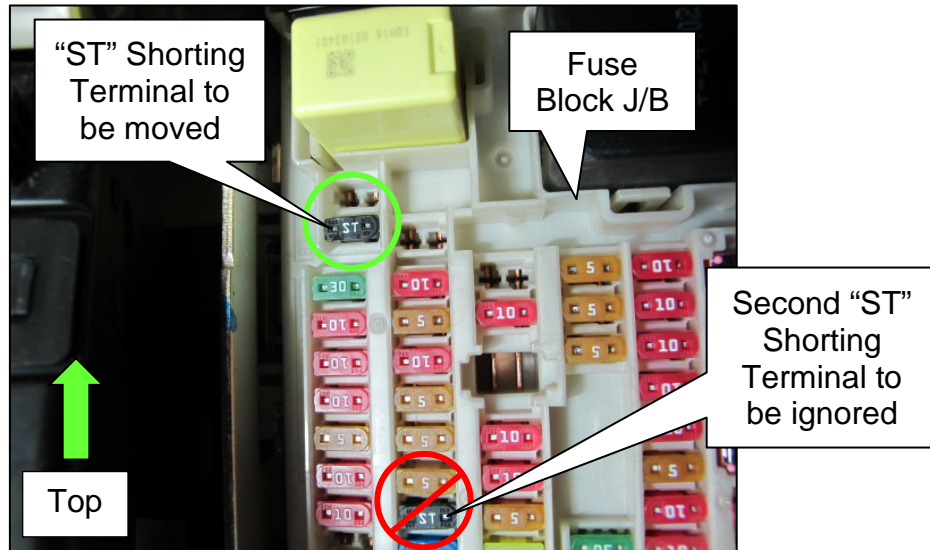
Figure 5

- There are two (2) black “ST” Shorting Terminals in the Fuse Block J/B.
- This procedure applies only to the “ST” Shorting Terminal in the upper left corner of the Fuse Block J/B.

5. Locate the “ST” Shorting Terminal in the upper left corner of the Fuse Block J/B.
