TECHNICAL SERVICE BULLETIN

Classification: HA25-001B	Reference: NTB25-032B	Date: March 27, 2026
------------------------------	--------------------------	-------------------------

HVAC INSUFFICIENT COOLING CONCERNS

APPLIED VEHICLES: 2023-2025 ARIYA (FE0)
APPLIED DATES: Built on or before April 16, 2025

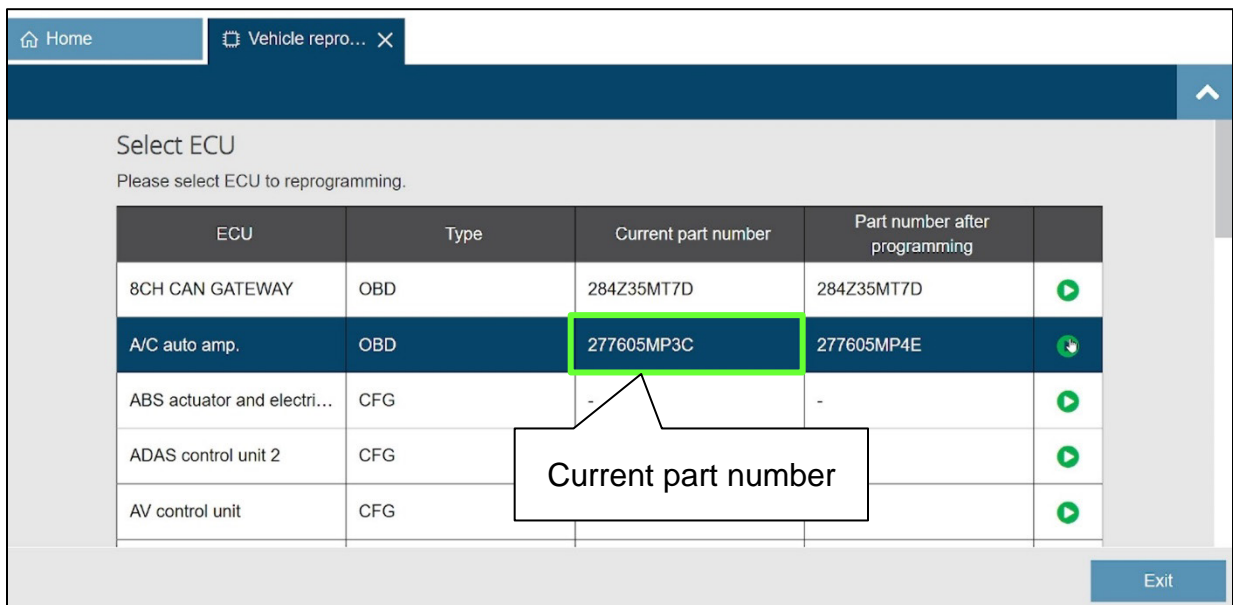
Figure 1

1. Using CONSULT, confirm the current A/C auto amp part number and write it on the repair order.
 - If it matches the part number in **Table A**, continue to step 2.
 - If it does not match the part number in **Table A**, this bulletin does not apply. Go back to ASIST for further diagnostic and repair information.

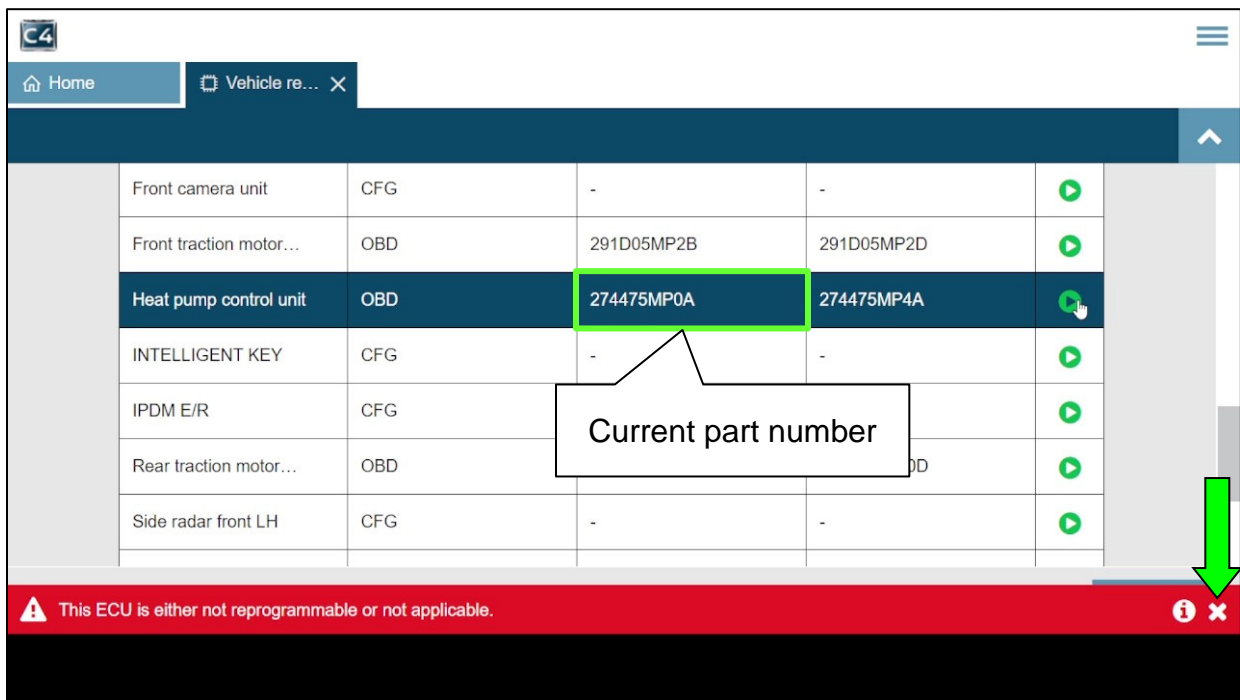
Figure 3

HINT: If an error message appears in red as shown in Figure 3, select the “X” to close.

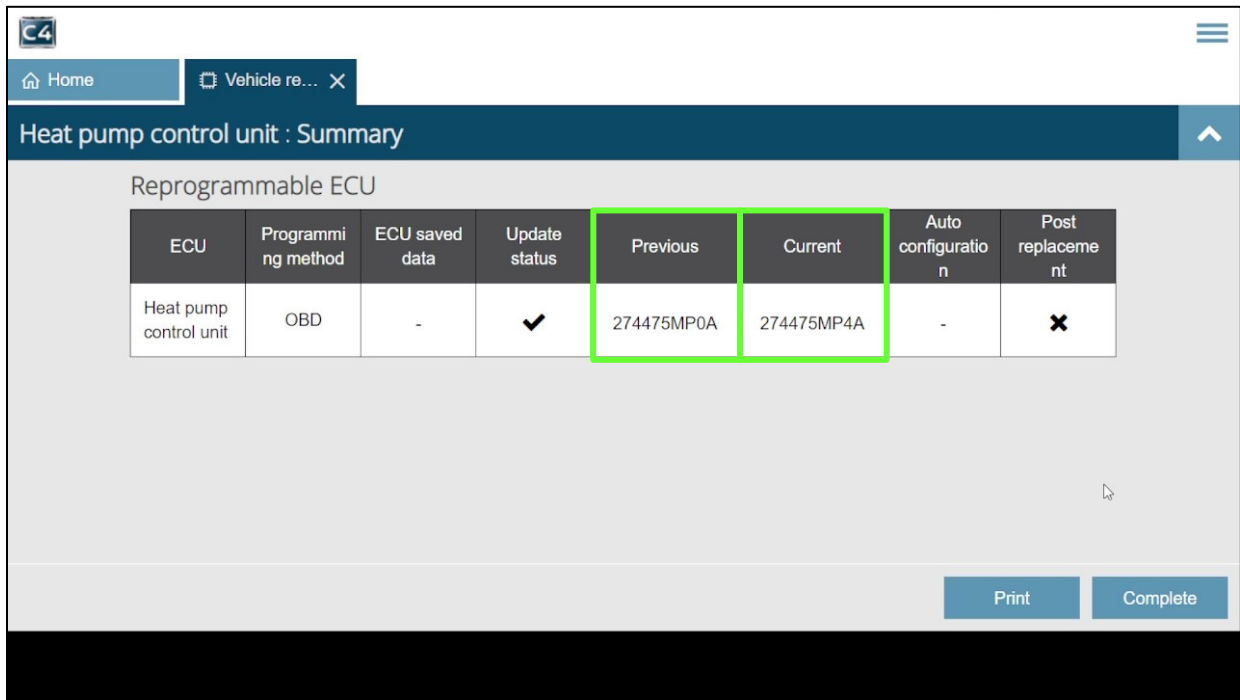
Figure 4

- Confirm the **Previous** and **Current** Heat pump control unit part numbers are different after reprogramming, as shown in Figure 4.
