I N F I N I T I

TECHNICAL SERVICE BULLETIN

BT26-004

FRONT FASCIA POPPING OUT NEAR HEADLAMP

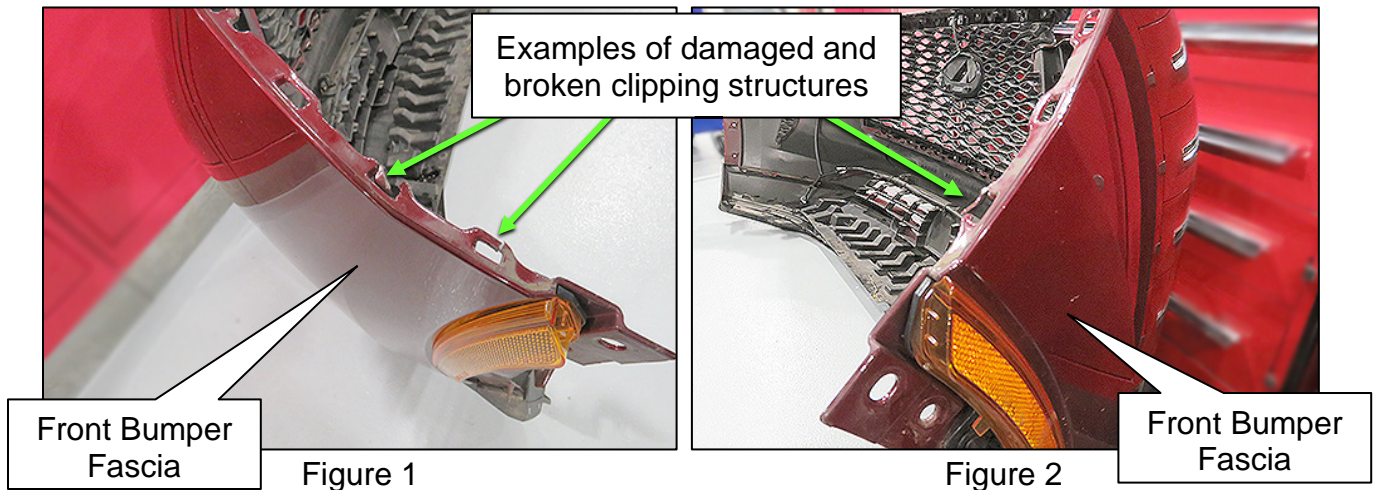
The Front Bumper Fascia is detaching from the fender under the headlamp on one/or both sides.

1. Remove the Front Bumper Fascia.
 - Refer to the **ESM: BODY EXTERIOR, DOORS, ROOF & VEHICLE SECURITY > EXTERIOR > REMOVAL AND INSTALLATION > FRONT BUMPER**
2. Inspect the clipping structures that attach the Front Bumper Fascia into the Front Bumper Fascia Side Bracket (BRACKET - FRONT BUMPER SIDE).
 - The Front Bumper Fascia should be replaced if the clipping structures are damaged or broken like shown in Figure 1 and Figure 2.
