TECHNICAL SERVICE BULLETIN

Classification: EC26-009	Reference: NTB26-017	Date: April 9, 2026
-----------------------------	-------------------------	------------------------

ENGINE NO START WITH KEY SYSTEM ERROR AND DTC B2C20-24 STORED IN THE BCM

APPLIED VEHICLES: 2025 Murano (Z53)

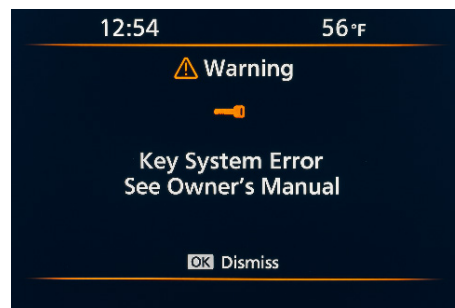
Figure 1

The customer states the engine will not start and “Key System Error” warning is displaying in the Information Display (Combination Meter) (Figure 1),

HINT: This DTC and warning message (Figure 1) may occur if the customer does not place the vehicle in Park Gear according to the Owner's Manual for shifter operation.

1. Confirm the current ECM part number.
2. Confirm the current TCM part number.
3. Reprogram the ECM, and then the TCM, if applicable.
4. Erase the DTCs.
