Service Bulletin

Bulletin No.: PIT6452D

Date: April, 2026

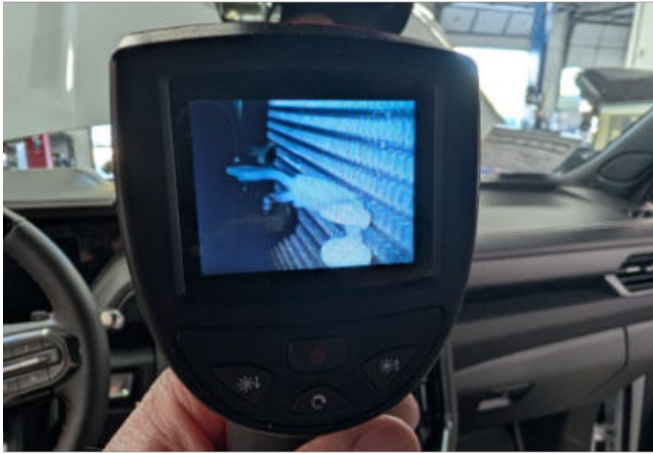
7020910

- Access the view through the upper vents or the HVAC evaporator temperature sensor openings.
- Using a borescope, inspect for a disconnected temperature door link. (Note: The mode will have to be set to the vent position, and you will have to enter at the center dash vent for the affected side.)
- Move both the driver's and passenger's temperature doors through their full range of travel while monitoring with the borescope.
- Watch for any binding or resistance that may cause the white temperature door link to separate from the doors or produce a popping noise.

If any door exhibits these symptoms, proceed to Step 2.
