Service Bulletin

Bulletin No.: PIC6620A

Subject: Diagnostic Tip - Charge Port Door Hard to Open

Brand:	Model:	Model Year:		VIN:		Engine:	Transmission:
		from	to	from	to		
Cadillac	OPTIQ	2025-2026		All	All	All	All

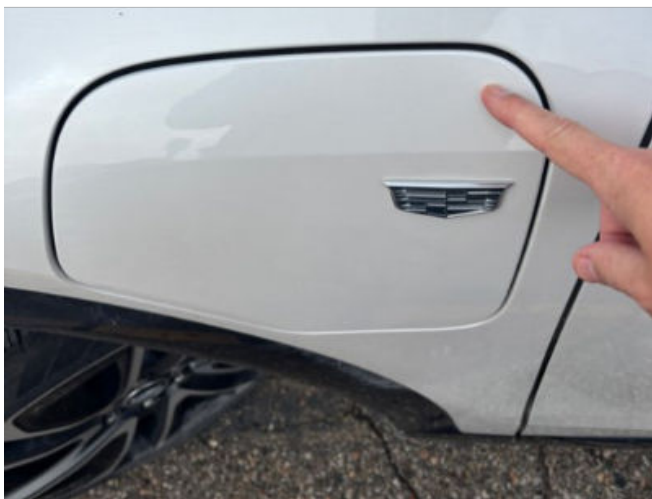
7003476

To open the charge port door, the operator needs to press in the upper RH corner of the door as seen below.

The Cadillac emblem is not a functioning button.

Before replacing parts for any binding types of complaints, technicians are asked to verify with the customer how they are trying to open the charge port door.

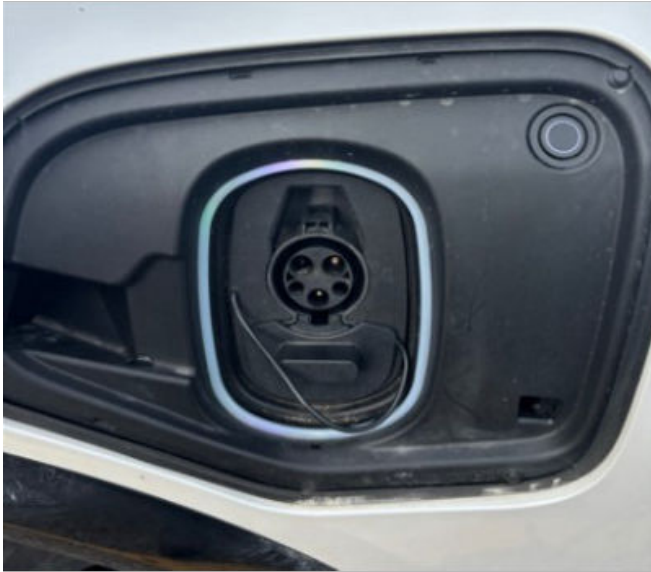
7003479

The button location is up in the top right corner behind the charge port door on the backside panel, see image below
