Service Bulletin

Bulletin No.: PIP6029A

Subject: Diagnostic Aid: Rattle or Tapping Noise Heard Near the Dashboard or a Vibration From the Shifter

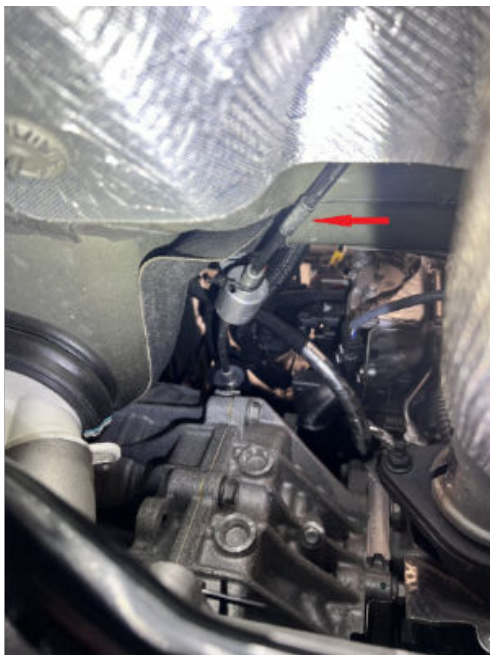
6783157

| Cause | Possible shifter cable sleeve contact or cable routing concern. |

If the noise has been confirmed, inspect the shifter cable for possible contact.

If this is found insulate the crimped metal sleeve on the shifter cable as pictured below.

Note: Do not secure the shift cable tightly to the body with a zip tie or any other method. Due to engine movement the cable must be allowed to move freely.

Note: Do not add foam tape to the large round dampening weight on the cable as this could make the concern more noticeable.
