Service Bulletin

Bulletin No.: PIC6485F

Subject: Diagnostic Tip - Noise or Vibration with A/C Compressor on

Brand:	Model:	Model Year:		VIN:		Engine:	Transmission:
		from	to	from	to		
Cadillac	LYRIQ	2023 - 2026		All	All	All	All

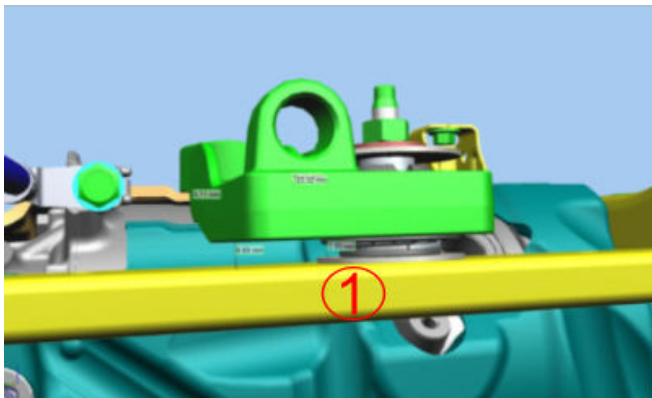
6236078

View from top side front of A/C compressor.

1. Front PEC Rail

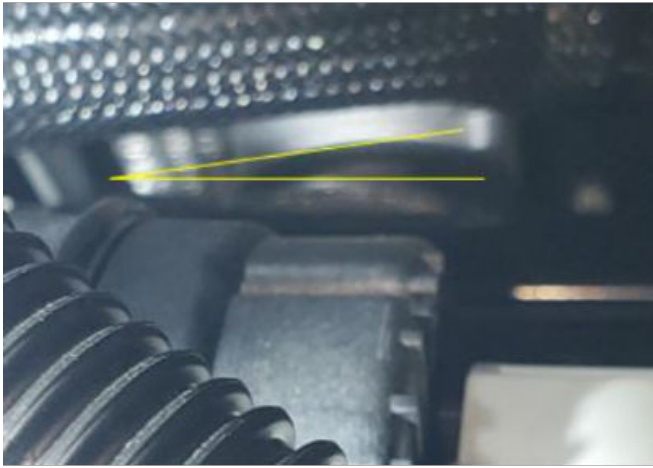
6236079

This is a View from the front of the A/C Compressor/Vehicle. If the gap between the upper Compressor mount to the front PEC rail is not even across the width of the part, then the bracket has twisted when it was installed and can cause NVH issues. If it has twisted, then the gap will be less on the passenger side of the part versus the driver's side.

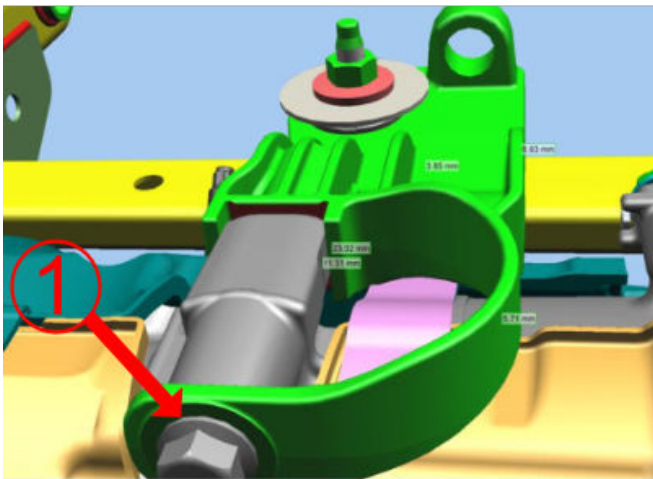
6236080

View from top side rear of A/C Compressor.

1. Loosen the through bolt that secures the compressor to the upper mount bracket enough that the bracket can rotate back to a horizontal position.

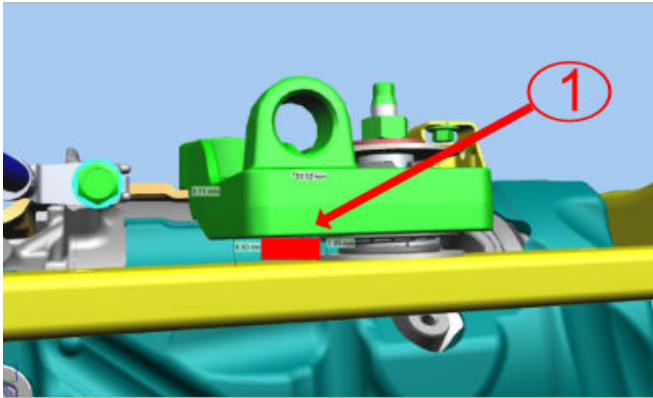
6236081

View from top side front of the A/C Compressor.

Once the bracket is parallel to the ground and the PEC rail again, slide a shim (6.5 mm thick) or a screw driver between the PEC rail and the bottom of the bracket to ensure the bracket does not twist again during re-torquing of the bolt.

Torque through bolt to 30 nm + 45 to 60 degrees.

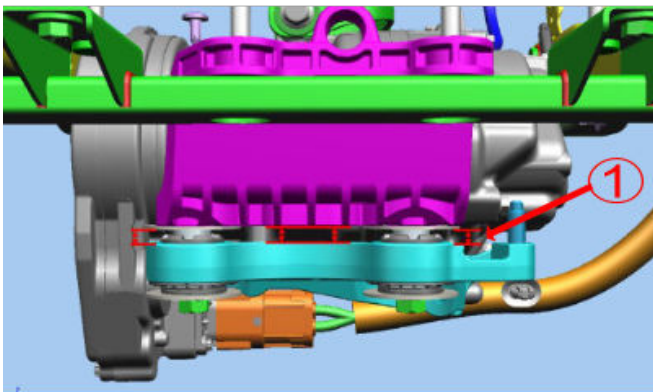
6236084

View from bottom side rear of A/C compressor.

After the fastener from the compressor to top mount bracket has been re-torqued, inspect the condition of the 2 lower mounts. The upper bracket (purple) and the lower bracket (cyan) of the lower mount system should be parallel to each other.

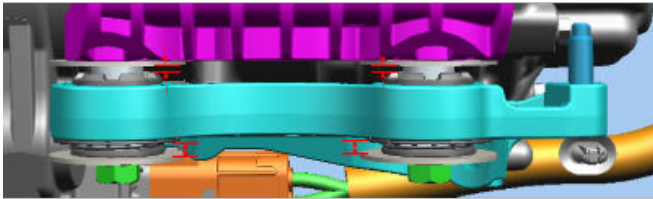
6236086

View from bottom side rear of A/C compressor.

With the compressor in static load position, there should be no contact between the rubber isolator (snubbers) and adjacent metal washers.
