# Service Bulletin

Bulletin No.: PIC6629D

**Subject: Display Diagnostic Tips and Procedures**

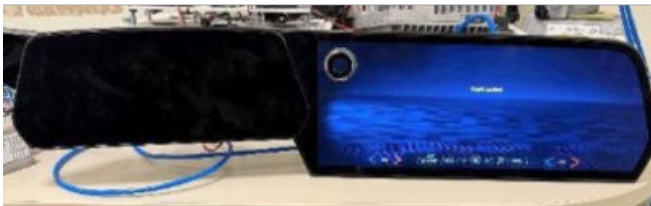
Below are examples of one, or portion of the display is blank
