Summary of communications for **CSC-2601: Model Z SlimRack+ Wire Securement**

Uploaded to NHTSA portal 4/30/26

| | | <b>SLIMRACK+ MOTOR WIRE<br/>INSPECTION AND REPAIR</b> | | <div><div>4</div><div>3</div><div>2</div><div>1</div><div>0</div></div> <div>3</div> <div>Difficulty<br/>Level</div> | |
| CSC: | CSC-2601 Model Z SlimRack+ Motor Wire Inspection and Repair | | | | |

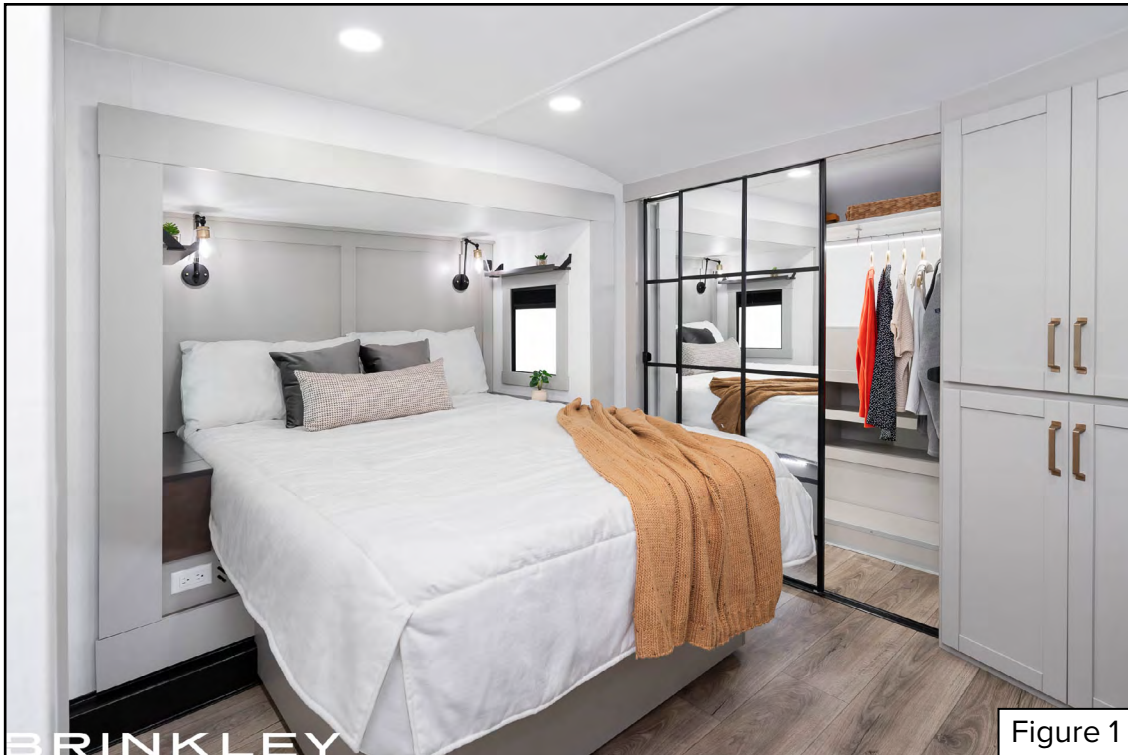
1. Locate the SlimRack+ slide outs inside your unit (Figure 1).
2. If the slide out is fully extended (as shown in Figure 1), you will need to retract the slide out about 1/2 way in to have access to the motor column, which is attached to the wall and behind the fascia boards in Figure 1. Access to the motor column will vary by floor plan.

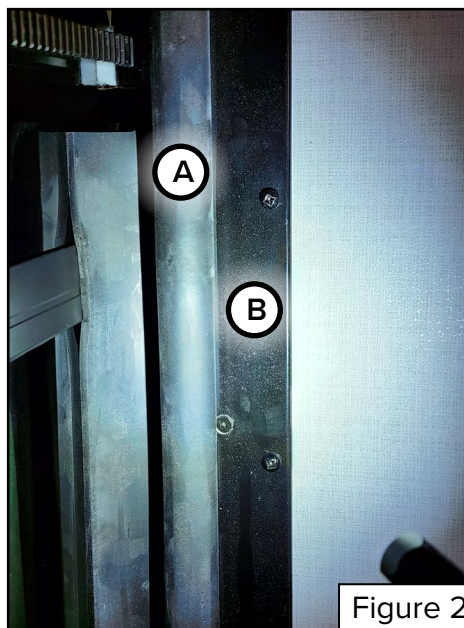
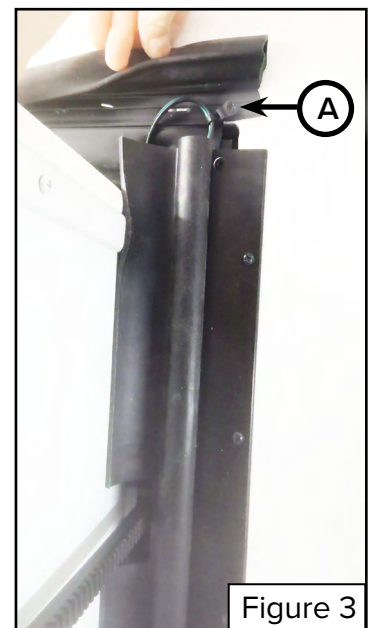
3. The motor wires should be secured behind the bulb seal (Figure 2A) on the face of the column (Figure 2B).
4. If the wires are secured behind the bulb seal and also have a screw mounted zip tie securing the wire at the top of the column (Figure 3A), the unit is safe to continue using as is and no further action is required.

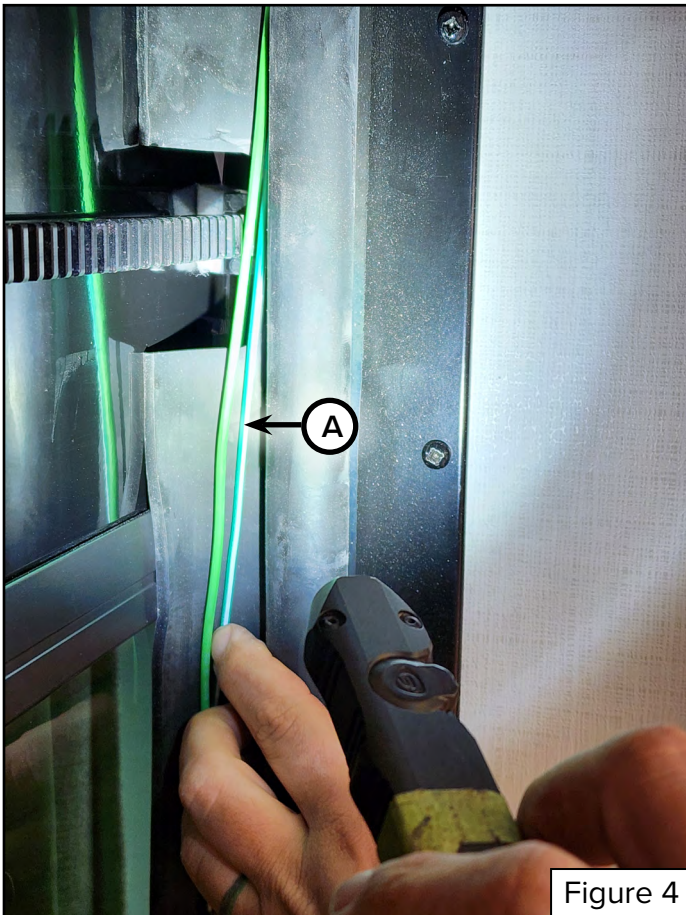
Figure 4

5. If the wires are visible outside of the bulb seal (Figure 4A), and undamaged, they will need to be tucked back into the bulb seal (Figure 5A). If the wires are damaged at all, refer the to repair section below.
6. If there is no screw-mounted zip tie securing the wire at the top of the column as shown in Figure 3A, that will need to be added as well. Be sure to trim any excess zip tie material after securing.
