Technical product information

Topic	Paint Surface Marking After Storage
Market area	Bentley: worldwide (2WBE),China 796 VW Import Comp. Ltd (Vico), Beijing (6796)
Brand	Bentley
Transaction No.	2081468/1
Level	EH
Status	Released for publishing
Release date	April 1 2026

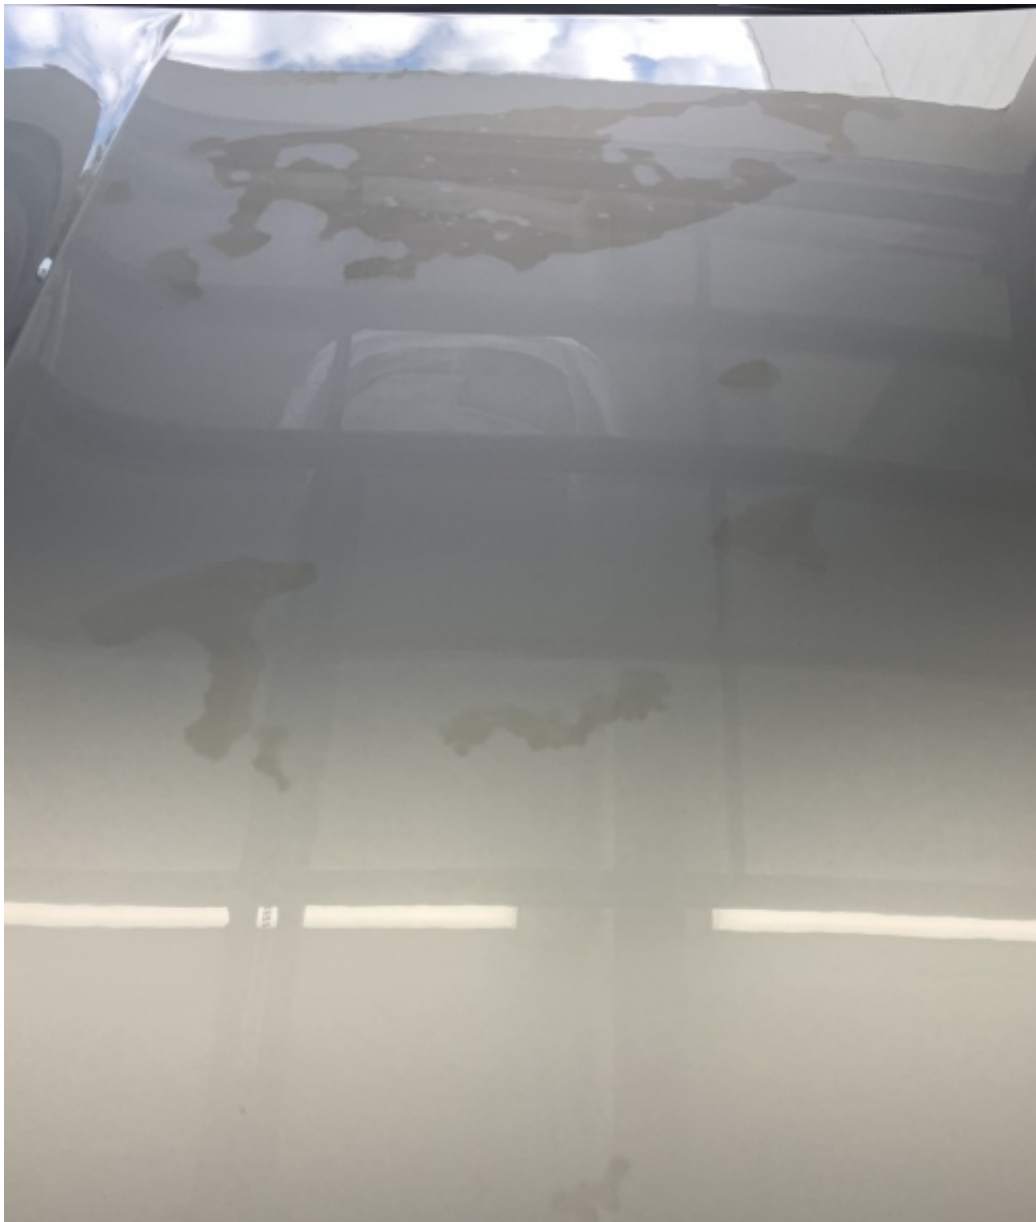
Concerns may be raised regarding surface marking on painted panels, including dull areas, cloudy patches, or pressure related patterns. These cases typically involve vehicles stored for extended periods with transport protection still fitted, allowing moisture or localised pressure to alter the appearance of the paint finish. An example is shown below.

Figure 1. Paint *marking example*

Paint surface marking can occur when transport protection film, moisture, or storage-related environmental factors exert light pressure or create chemical interactions with the clear coat.

The effect is cosmetic only and generally correctable through warming and minor finishing processes. Refer to the 'Measure' section for next steps.

1. Photograph / document the paint prior to rectification.
2. Wash the affected area using a neutral pH automotive shampoo.
3. Rinse thoroughly and dry with a clean microfiber cloth.
4. Apply Controlled Heat maintaining a target surface temperature of 20–40°C. Keep the heat source moving continuously.

Warm the paint using:

- A heat gun (low setting) or
- An infrared (IR) lamp

5. Light Polishing (If required)

If marking persists after heating

Use a dual action (DA) polisher.

- Apply a fine polishing compound only.
- Polish the smallest area necessary to restore gloss.
- Wipe clean and visually inspect the finish.
