## Technical product information

<b>Topic</b>	Water Ingress in the Door Infill Panel Area   Flying Spur
<b>Market area</b>	Bentley: worldwide (2WBE),China 796 VW Import Comp. Ltd (Vico), Beijing (6796)
<b>Brand</b>	Bentley
<b>Transaction No.</b>	2081472/1
<b>Level</b>	EH
<b>Status</b>	Released for publishing
<b>Release date</b>	April 1 2026

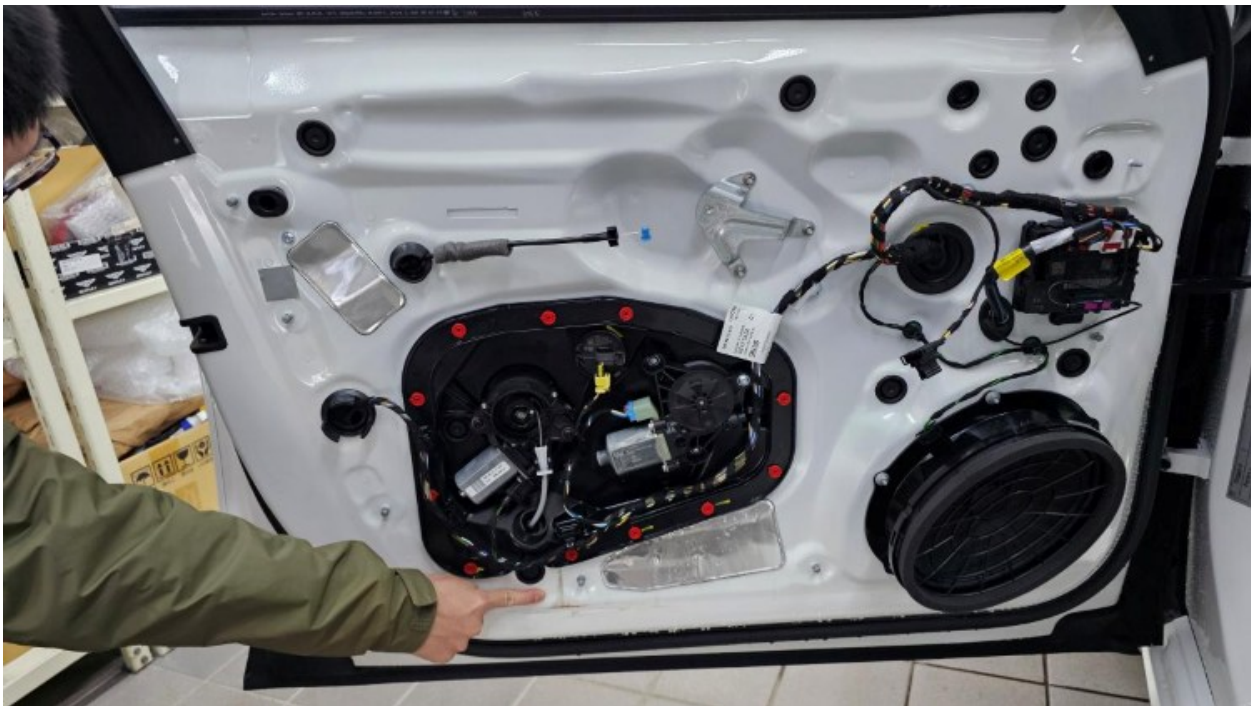
**Figure 1.** *Infill Panel Inspection*

- Water runoff tracking from the door infill closing panel into the interior cavity.
- Incorrect seating, damage, or partial detachment of the door infill closing panel.
- Water staining, moisture marks, or wet NVH foam within the lower door area.

Document findings with detailed photographs. Photographs must show the infill inner closing panel in situ with any clear water tracking evidence, see example below.

**3. Raise a full Technical DISS query for second-level review by the Body & Trim TM and wait for further guidance.**
