## Technical product information

<b>Topic</b>	Driver / Passenger door(s) creak on close - All models (front and / or rear)
<b>Market area</b>	Bentley: worldwide (2WBE),China 796 VW Import Comp. Ltd (Vico), Beijing (6796)
<b>Brand</b>	Bentley
<b>Transaction No.</b>	2071525/4
<b>Level</b>	EH
<b>Status</b>	Released for publishing
<b>Release date</b>	April 10 2026

Driver and / or Passenger door creak during the "Power close" function - Front and / or rear (Depending on vehicle type)

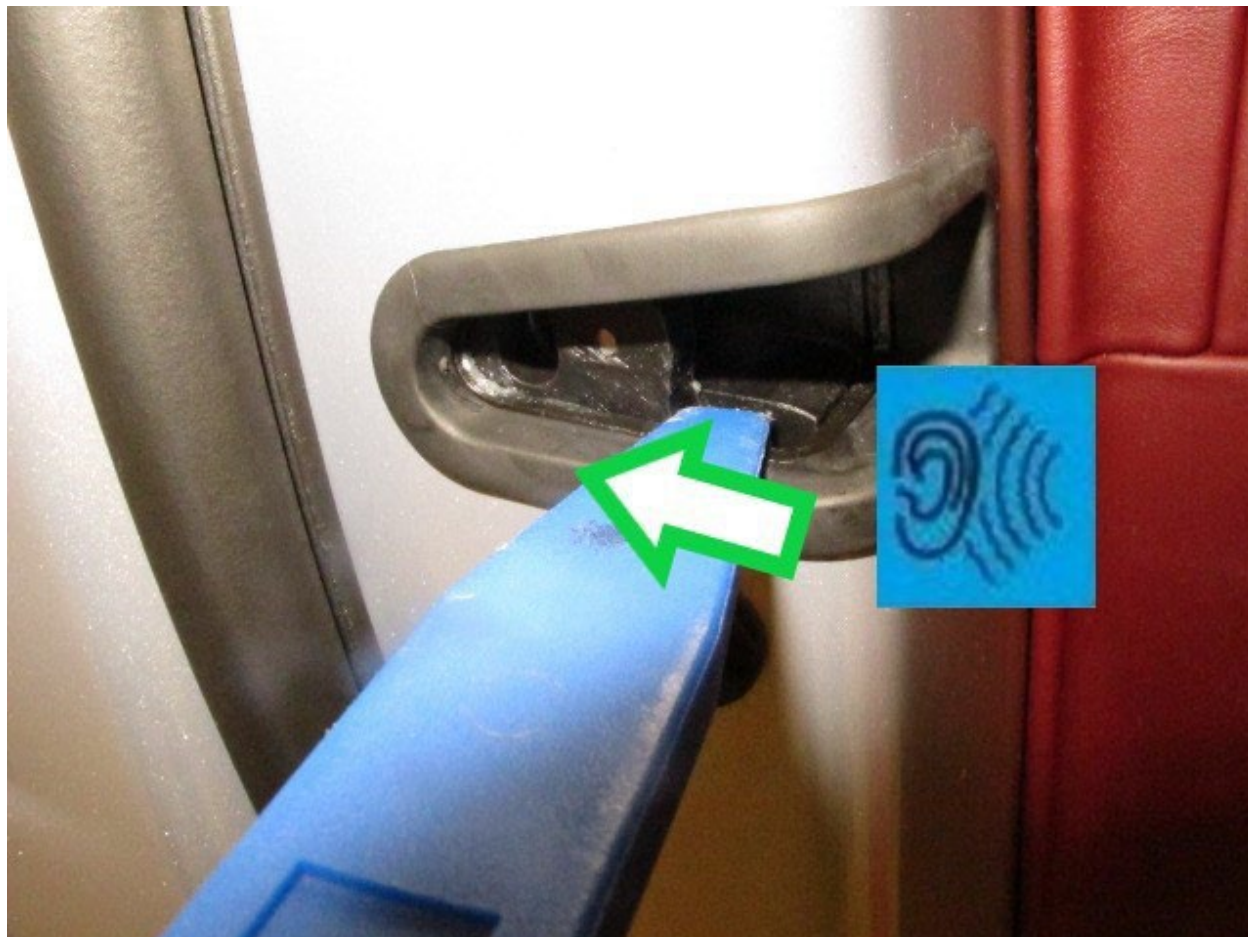
2) Referring to Figure 1 - With the door open - Use a suitable non metallic tool - Close the latch

Hint: Whilst closing the latch the operative must listen for the creaking noise

**With the door open - Does the latch creak during the power close operation?**

**YES** - Record a clear video of the noise with the door open when closing the latch using a non metallic tool - Go to Step 3

3) In the event the door latch is creaking as described in Step 2 - Refer to Rep.Gr 57 or Rep.Gr 58 and replace the applicable power close door latch motor cable as described within the onward instructions

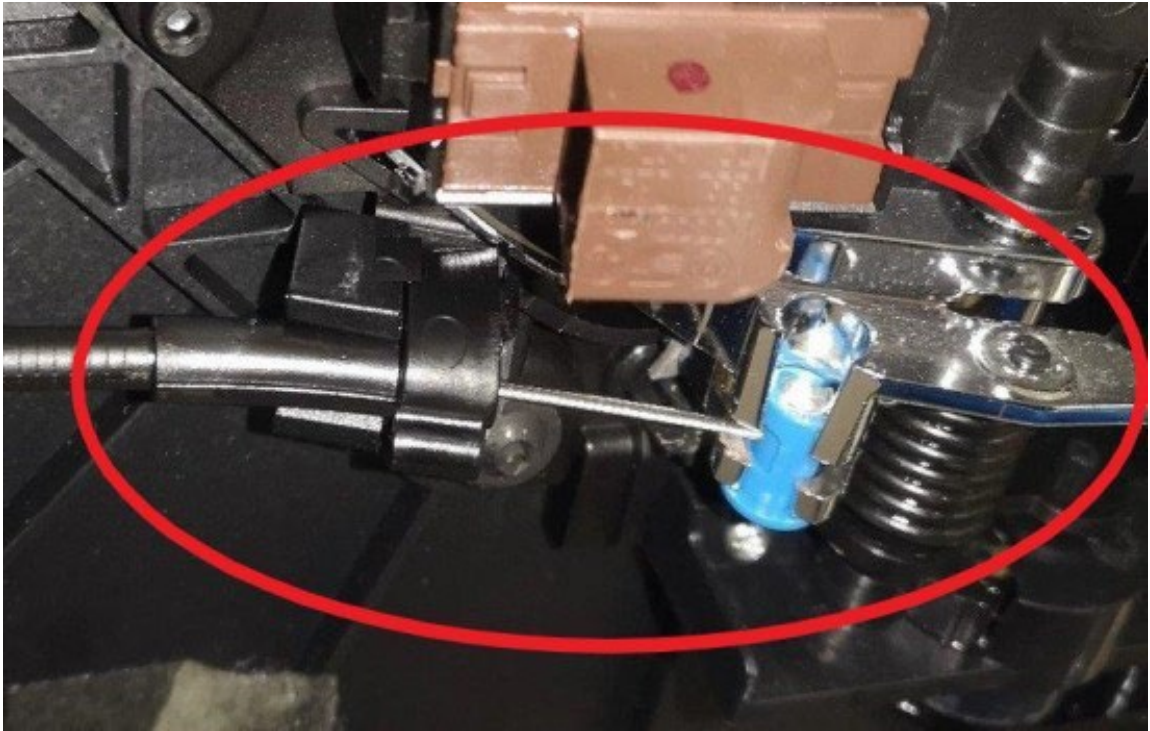
CAUTION: Referring to Figure 2 (New Continental GT, New Continental GTC and New Flying Spur) and Figure 3 (Bentayga) extra care must be taken when removing and refitting the door trim and bowden cable. Should any issues be evident or damage caused within the highlighted area shown (depending on model) the operative must raise a DISS query and await feedback before conducting any further work

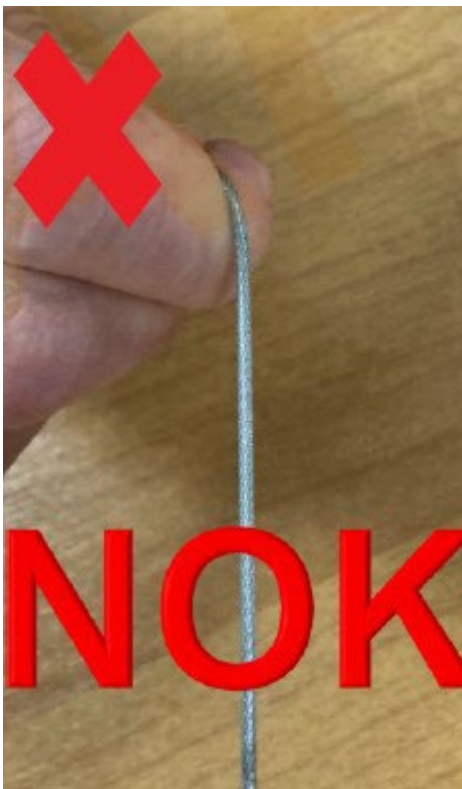
<b>CAUTION</b>
Do not grip / hold the cable as shown in Figure 6 as the cable can be easily damaged/bent (this is imperative when fitting the new replacement cable)

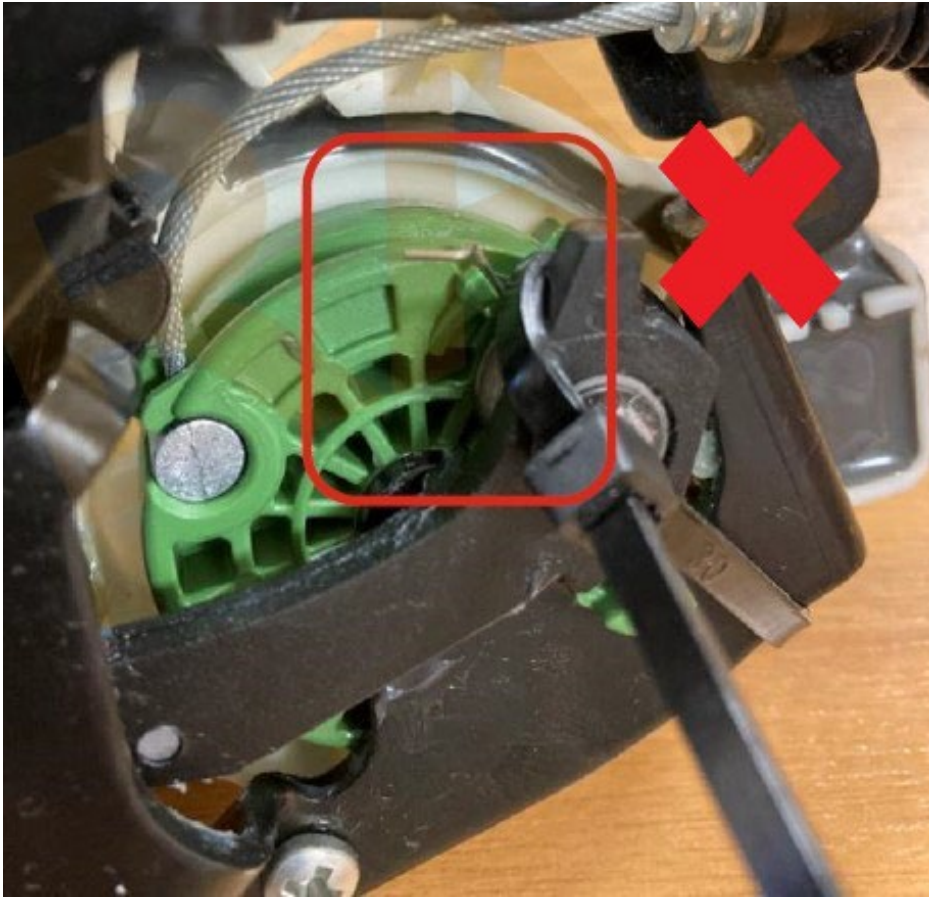
Figure 10

Take care when fitting the cable tie as the spool tensioning spring can be partially dislodged (Figure 10) or completely dislodged (Figure 11) in this scenario the spring should be relocated back to its original home position (refer back to Figure 9)

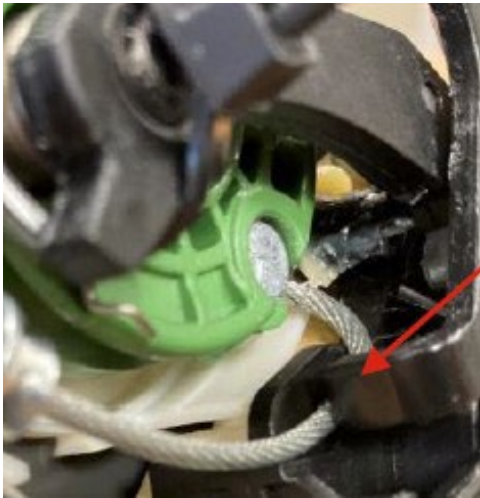
Figure 14

The cable can be easily bent / damaged during fitment into the spool, the cable could also be easily trapped under the bracket

- Figures 14 shows an example of the cable trapped/damaged during fitment
